## SAFETY RECOMMENDATION No: 67/2015

67/2015: Entanglement of the towline used for towing C/V "HAMMERSMITH BRIDGE", flag Panama, IMO 9395147 resulting to the death of the Motorman of T/B "CHRISTOS XXII", Flag Greece, IMO 7230135

**Entanglement of the towline used for towing C/V "HAMMERSMITH BRIDGE", flag Panama, IM9395147 resulting to the death of the Motorman of T/B "CHRISTOS XXII", Flag Greece, IMO 7230135.**

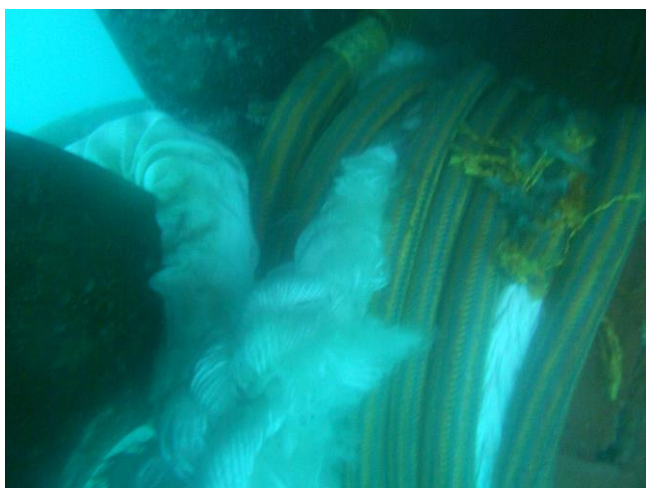
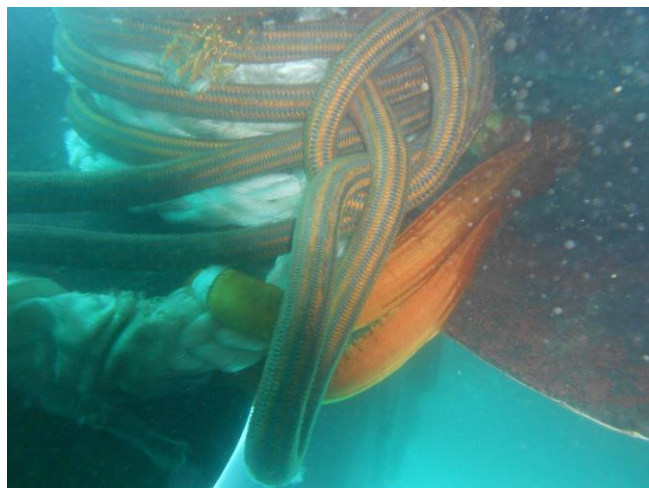
**Figures 2,3:** captures of the entangled rope on the tug boat's stbd propeller.
