SAFETY RECOMMENDATION No: 83/2013

14/2013: Death of 3rd Engineer of M/V CAPTAIN PETROS H.
(See the full Report [here.](#))

Name of vessel: CAPTAIN PETROS H

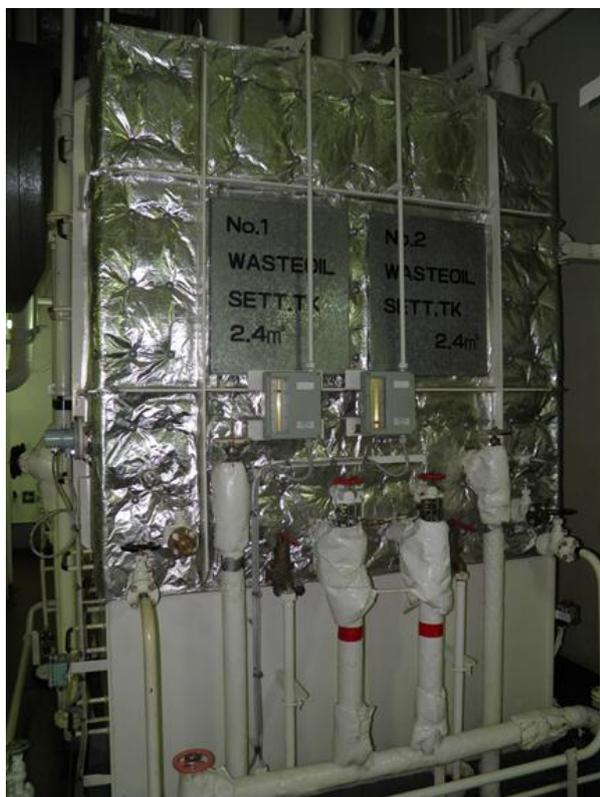
The Waste Oil Settling Tanks

- The accumulation of oil sludge mud to the bottom of the tank caused the jamming of the level gauge float and the clogging of the drain valves.
- The Waste Oil Settling tank was not fitted with sounding pipes, and the malfunctioned level gauge was the only available means for indicating the remaining quantity in the tank.

Amend the vessel's PMS with provisions for routine maintenance/cleaning operations of Waste Oil Tanks to prevent the malfunction of the level gauges due to the accumulation of oil sludge mud.

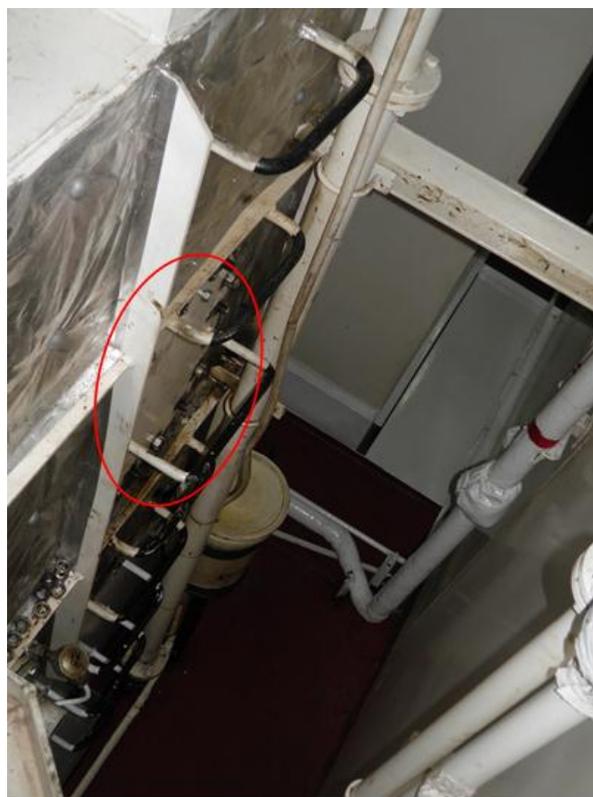
The manhole at the aft side of No2 W.O.S. Tank

- The 3rd Engineer did not apply the common practice for the safe opening of the manhole and didn't use the manhole's jackscrews.
- Potential hazards related to the remaining quantity in the tank and the faulty level gauge were not identified during the process of the Job Hazard Analysis.
