HELLENIC BUREAU FOR MARINE CASUALTIES INVESTIGATION

**MARINE CASUALTY SAFETY INVESTIGATION REPORT
01/2016**

**Fatal Fall of Bosun inside the Cargo Hold of
Bulk Carrier Doric Spirit**

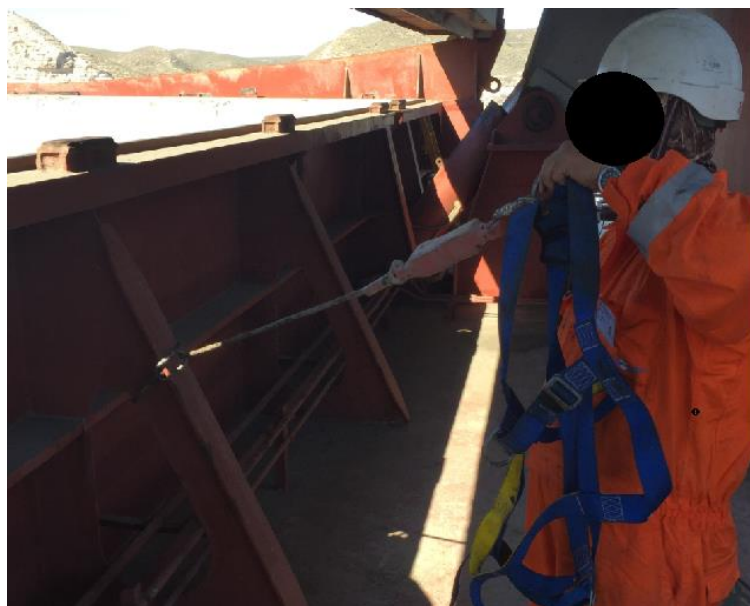
Aforementioned cleaning process required to stand on the top of the hatch coaming so both crew members were using their safety harnesses rigged to a secure point on the frames of the hatch coaming as shown in Figure 4.

Figure 4 :Simulation by a crew member securing the safety harness on the hatch coaming of cargo hold No.3.

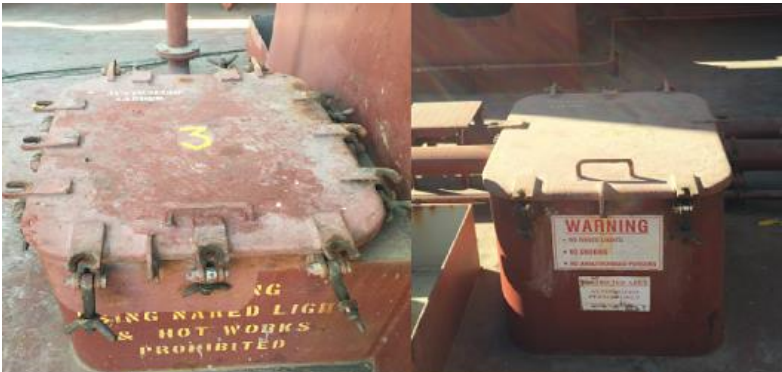
Figure 5 (upper left): No. 3 cargo hold access using the Australian ladder.

Figure 6 (upper right): No 3 cargo hold access using the vertical ladder.

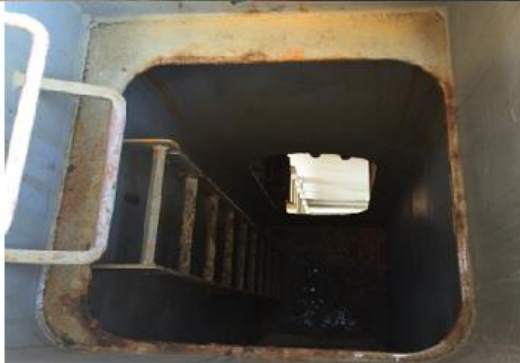
Figure 7(down centre): Cargo hold vertical ladder as seen from main deck (top-down view)

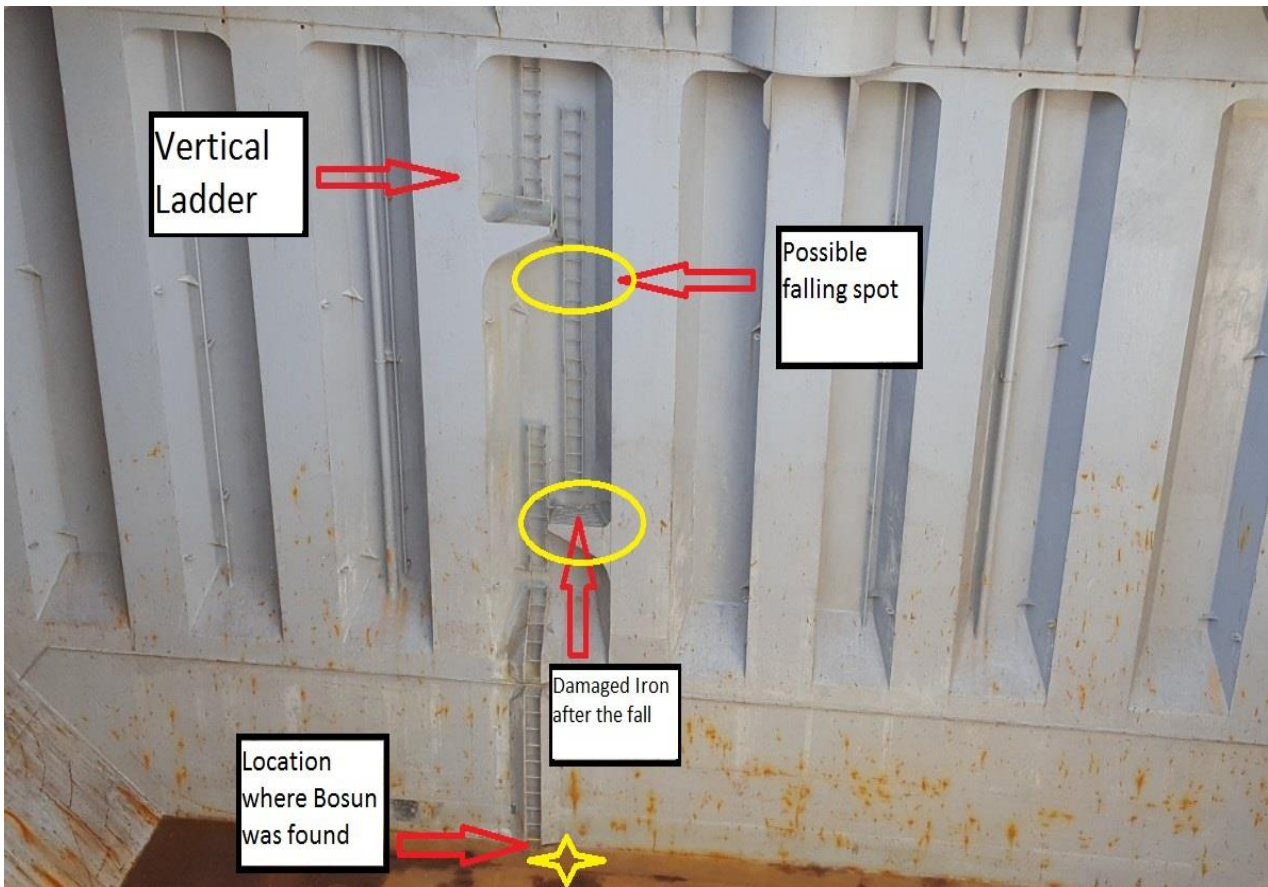
It became obvious that somehow he lost his gripping on the vertical ladder and consequently lost his balance and fell down from a height of about 10.5 m onto the tank

top. It was further deduced that based on the Bosun's body fractures and the damaged railing of the lower platform his body probably impacted on the lower platform railings before landing on the tank top. The casualty site is shown in following figure 8.

Figure 8: Cargo Hold no.3 -marine casualty site.

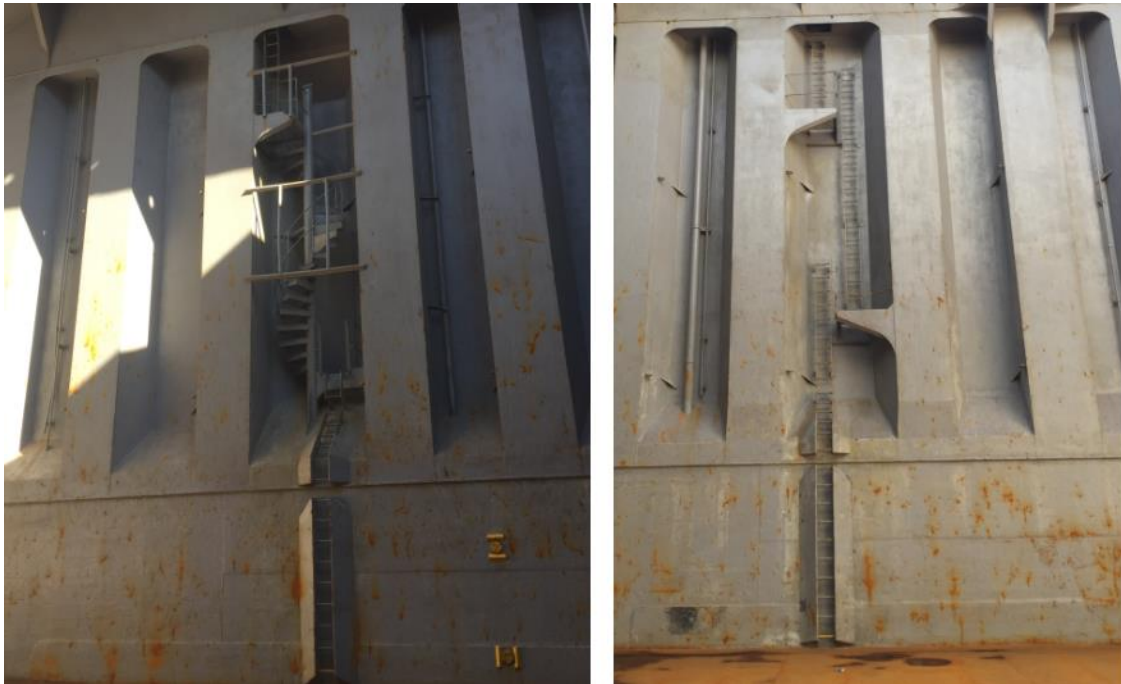
The vertical ladder is structured with a combination of separate parts that are linked with two intermediate platforms between the tank top and the deck. The platforms are fitted within approximately 4.5 m distance from each other as shown in figure 10. The vertical ladder was not structured with safety arrangements, such as a protective safety cage or housing.

However the Australian spiral type ladder was structured with protective railing for safely descending or ascending (figure 10).

Figure 10: Left: Australian ladder –Right: vertical ladder

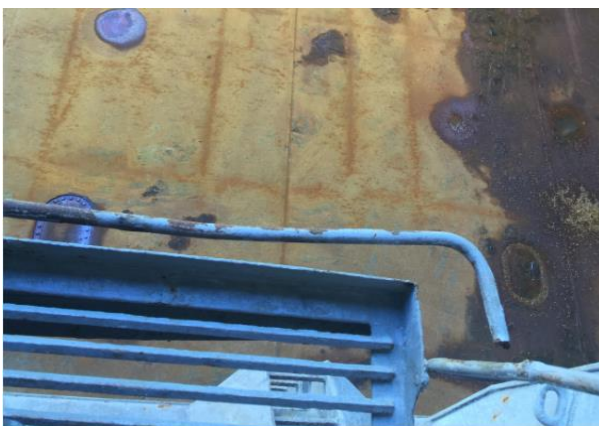
Based on the findings of the investigation carried out at the accident site it was concluded that no structural deficiencies existed, that could contribute to the Bosun's fall. It was also deduced that the deformation and the detachment that was evident at the second platform railings (figure 11), was caused by the Bosun's body impact before landing onto the tank top.

Figure 11:
The damages at the second platform railing of the vertical ladder

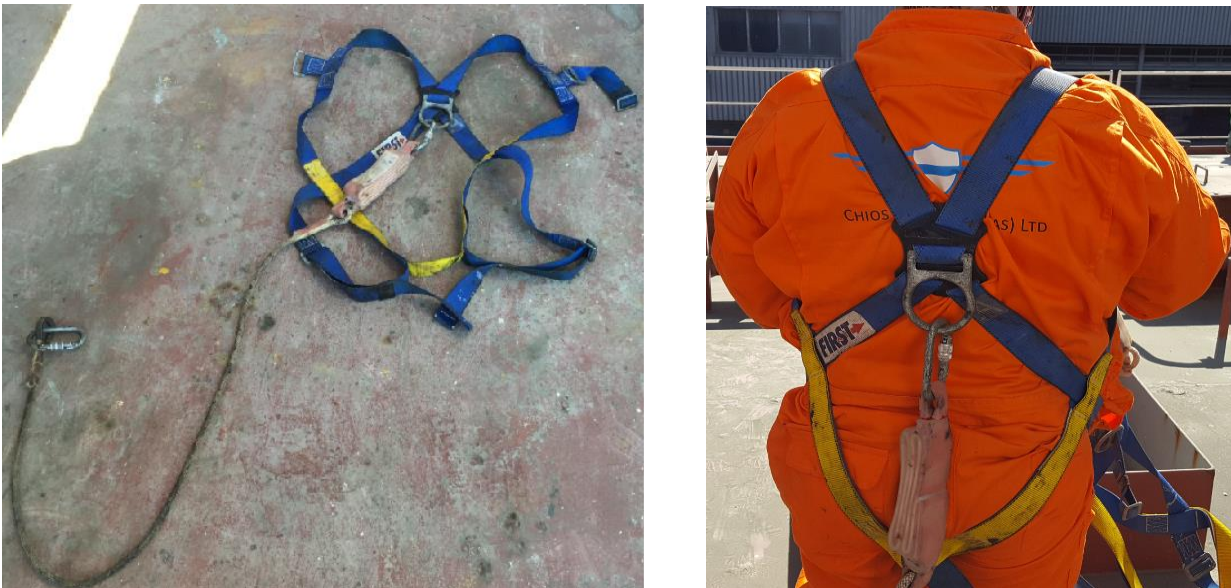
On the day of the marine casualty, the Bosun initially used a five point full body harness, as shown in Figure 12, for cleaning the cargo hatch coaming of cargo hold No.3.

Figure 12: Full body safety Harness used by the Bosun on the morning of the accident

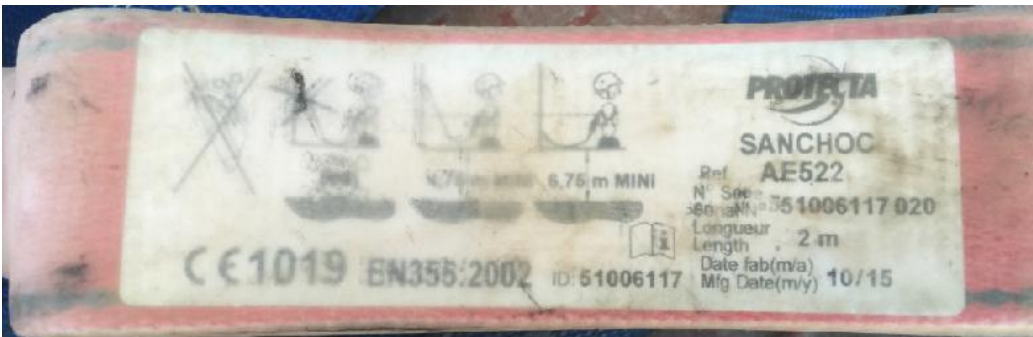
The safety harness was found to be in good condition and its label (figure 13) was marked with the following specifications that deem relevant with the case under examination:

▪ the European standards CE 1019–EN 355:2002;	
▪ the 2 m length of the lanyard;	
▪ the manufacture date 10/15;	
▪ a 6.75 m protection limit from the securing point that results by adding:	<ul style="list-style-type: none"> ✓ 2m length of the lanyard; ✓ 1.75m length of the shock absorber extended when a fall occur; ✓ 2m of the human body as provided by EU standards; ✓ 1m of safety margin as provided by EU standards;

Figure 13:
The safety harness label markings used on the day of the marine accident.

This is based on the understanding that even if the Bosun was wearing and using it while descending the vertical ladder, due to the fact that in case of falling from a height less than 6.75 m, measured from a securing point, it was highly possible that he would have landed onto the tank top and would have suffered injuries.

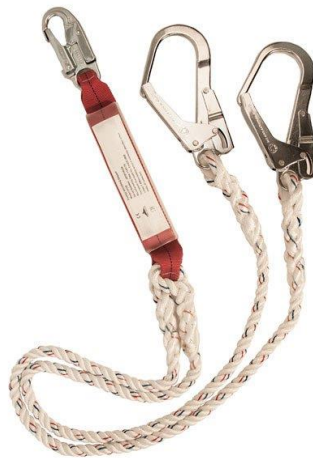
Figure 14: Fall arrestor with a double lanyard

On above grounds a fall arrestor with a double lanyard, as shown in Figure 14, deems appropriate to facilitate constant anchoring when descending/ascending vertical ladders and securing points have to be changed.

Considering the above it is deduced that a double lanyard properly used could safeguard in full a seafarer from the risk of falling when ascending/descending vertical ladders.

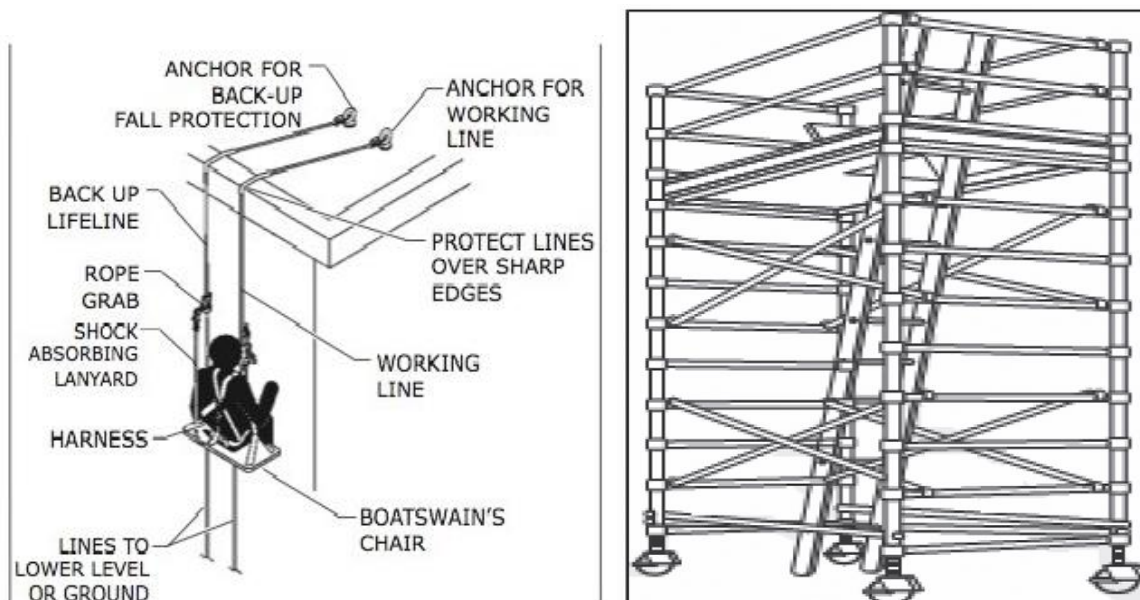
Figure 15: Left: Bosun's chair arrangement. Right: Mobile scaffold with an access ladder and trapdoor to provide the largest possible hazard-free working condition

Had other means of access used for the working aloft cleaning operation, it is highly possible that the marine casualty would not have occurred.
