HELLENIC BUREAU FOR MARINE CASUALTIES INVESTIGATION

MARINE CASUALTY SAFETY INVESTIGATION REPORT

01/2018

**PARTING OF A MOORING ROPE
OF M/T "BYZANTION", FLAG GREECE, IMO 9315898
DURING UNMOORING OPERATION
RESULTING TO THE DEATH OF AN O/S, PHILIPPINE NATIONALITY
AT DORTYOL, TURKEY ON 7TH JUNE 2018**

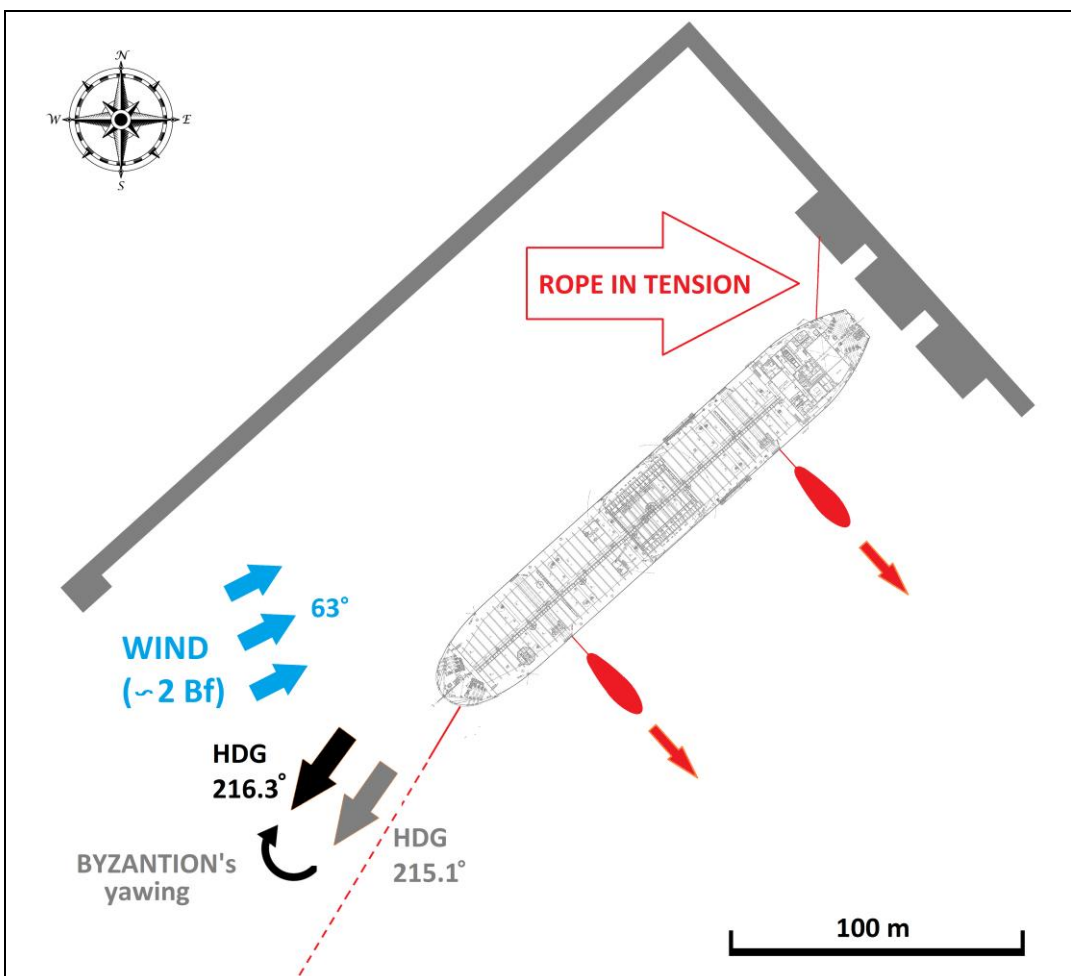
Figure 3.3/2:

Due to the effect of the T/Bs continuous pulling, BYZANTION started yawing in the clockwise direction. Her HDG started increasing slowly from 215.1° at 19:24:32", up to 216.3°, at 19:24:54". During her clockwise movement, her stbd stern started moving away from the pier, causing the remaining mooring line to be strained until it reached its breaking point.

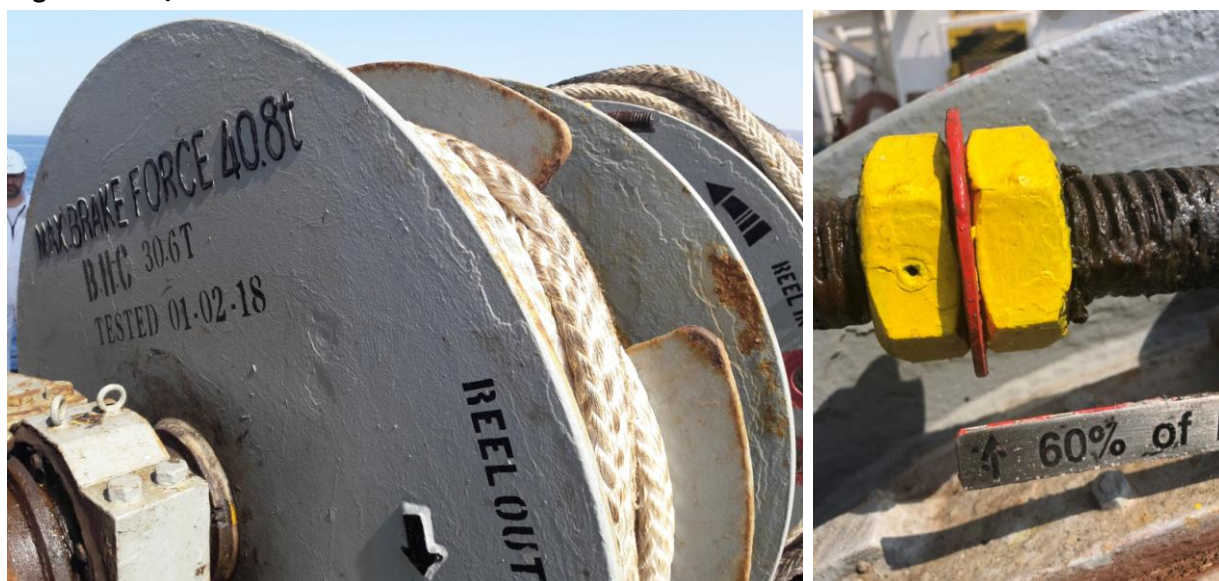
According to the vessel’s records, the last test of the mooring winch brake had been conducted by BYZANTION’s crew on 1st February 2018, after the planned replacement of its brake bands. The adjustment of the winch Brake Holding Load at 30.6 tn was confirmed by the end of the test and the relevant signings were written and fitted on the drum and on the brake tightening screw, as can be seen in Figures 4.2.1/2 & 3.

Figures 4.2.1/2 & 3: The signings written and fitted on the drum and on the brake tightening screw following the last brake test of 1st February 2018.

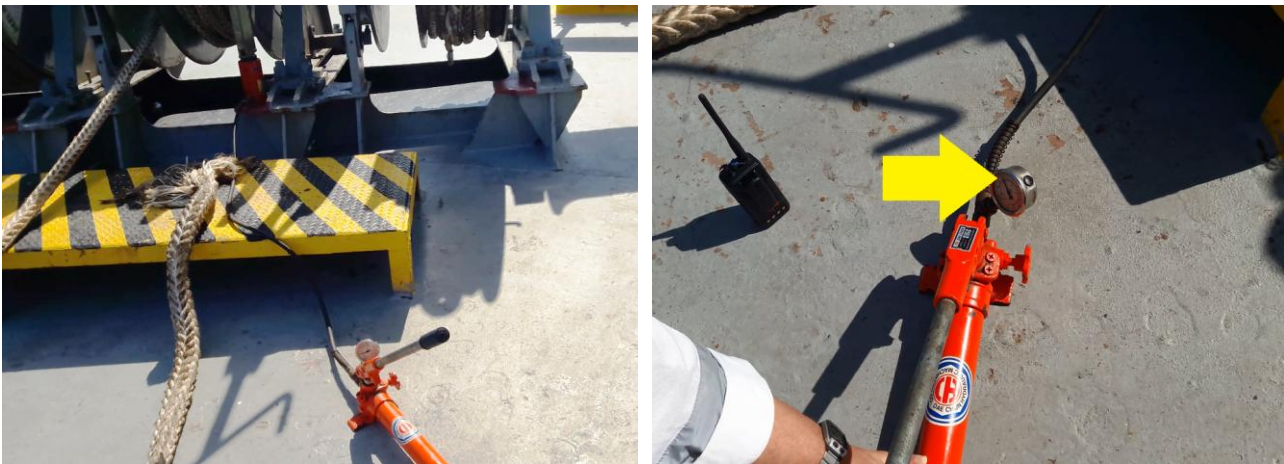
A Brake Holding Test was also carried out onboard during the HBMCI Investigators' visit after the casualty, on 13th June 2018 and the proper adjustment of the mooring winch brake was verified.

Figures 4.2.1/4 & 5: The brake holding test equipment used and the jack piston pressure indication while reaching the expected load, during the test conducted on 13th June 2018.

Although the possibility of an improper adjustment of the brake tightening screw during the casualty cannot be excluded, no evidence of malfunction of the system was found during the investigation.

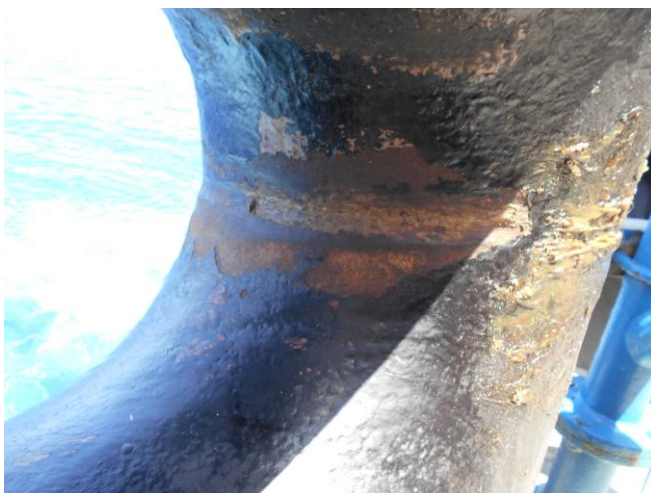
The closed chock through which the line passed for the mooring operation was thoroughly inspected by HBMCI's Investigators and its contact surfaces were found to be smooth and free from chafe points.

Figure 4.2.2/1:
The part of the closed chock against which the rope passed during the mooring operation.

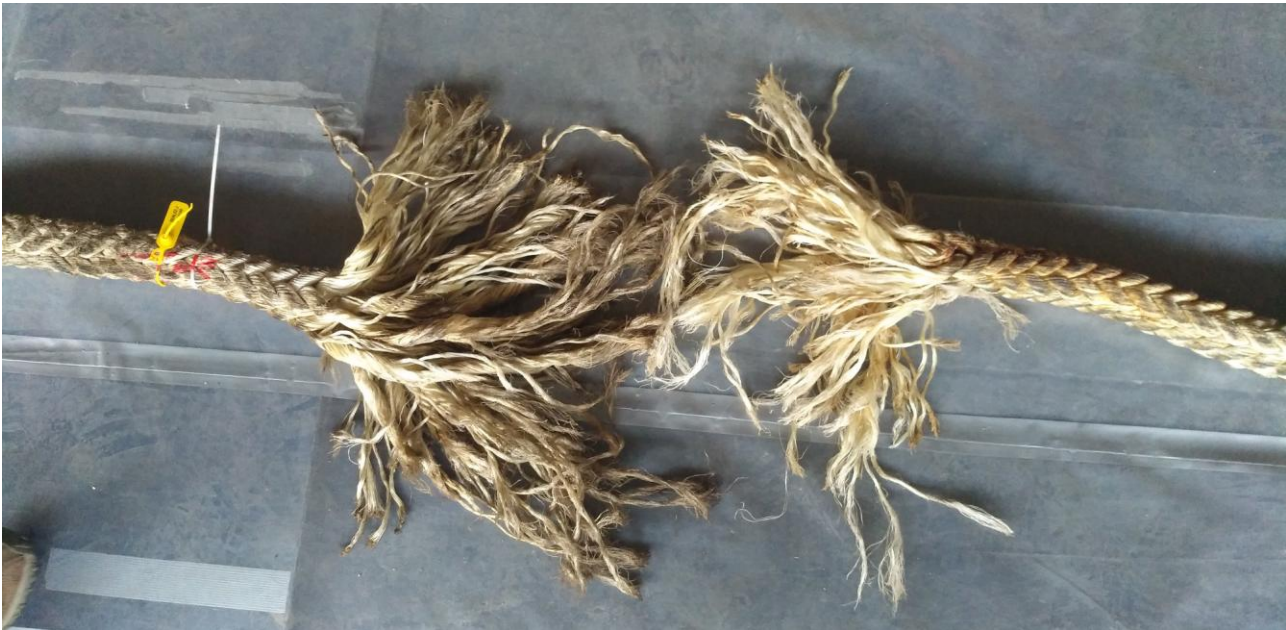
The rope was a 12-strand rope and its diameter was found to be generally consistent, varying from 48.7mm to 49.7mm.

Figure 4.2.2.1/1: The rope's breaking point at the part that remained onboard (left part of the photo) and at the part that remained on the terminal's bollard (right part of the photo).

The rope was visually inspected over its entire length and its outer filaments were found to have a furry appearance, probably caused by the normal slight abrasion while in service. No signs of abrasion due to contact with rust or untreated surfaces were evident, neither indications of fibres melted together or of localized areas of stiffness.

No powdered fibre, indicative of internal wear, was found to the parts of the rope which were practical to be opened up and no plucked or cut strands were evident either.

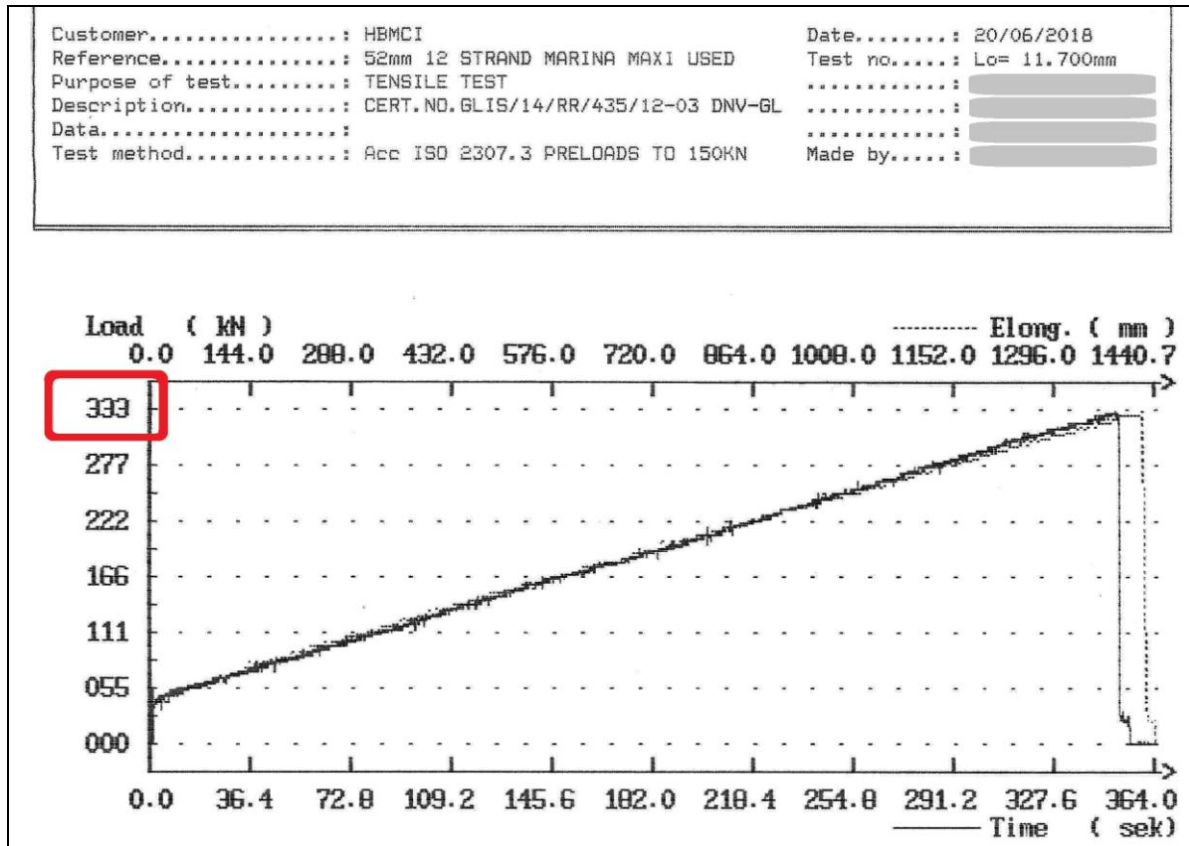
According to the above, the parted rope was found to have a **linear density 22% less than the expected one**, as per the prementioned Standard.

- A Tensile Test was conducted by use of the laboratory’s Approved Test Bench, according to ISO 2307:2010. The rope parted at 333kn (or 33.96 tn), which was about **57% of the nominal MBL of the rope**, according to the document presented as its “Test Certificate”.

Figure 4.2.2.2/1: Part of the Tensile Test result, during which the rope broke at a load of 333kN.

The breaking of the rope at the load of 33.96 tn in laboratory circumstances and following the process provided by ISO 2307:2010 (such as conducting proper pre-tensioning of the rope and maintaining a slow rate of tensioning until the breaking point), suggests that the breaking load of that rope under dynamically acting forces would be significantly reduced. This parameter is explanatory of the non-function of BYZANTION’s Mooring Winch Brake rendering, as the examined mooring rope, due to its dynamic loading, probably broke prior to its loading up to 30.6 tn, which was the Mooring Winch Brake limit.

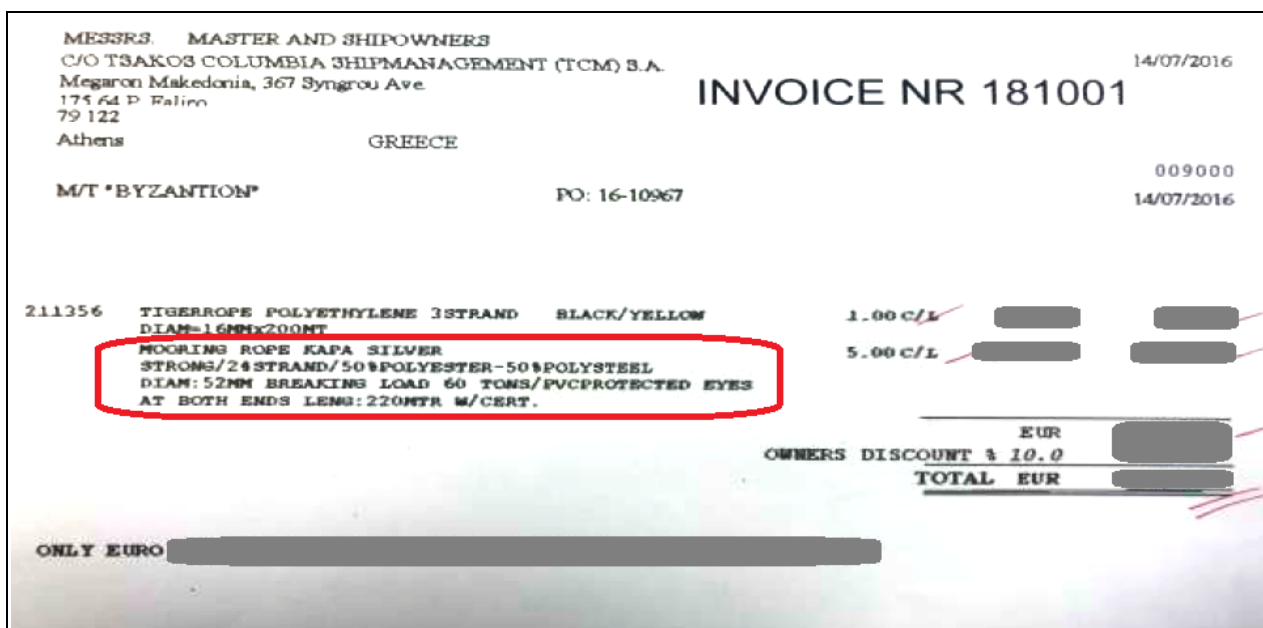
The invoice for the mooring ropes received by the Managing Company of BYZANTION described them as per vessel’s request.

Figure 4.2.2.4/1: The supplier’s description of the mooring ropes as written on the ropes’ invoice.

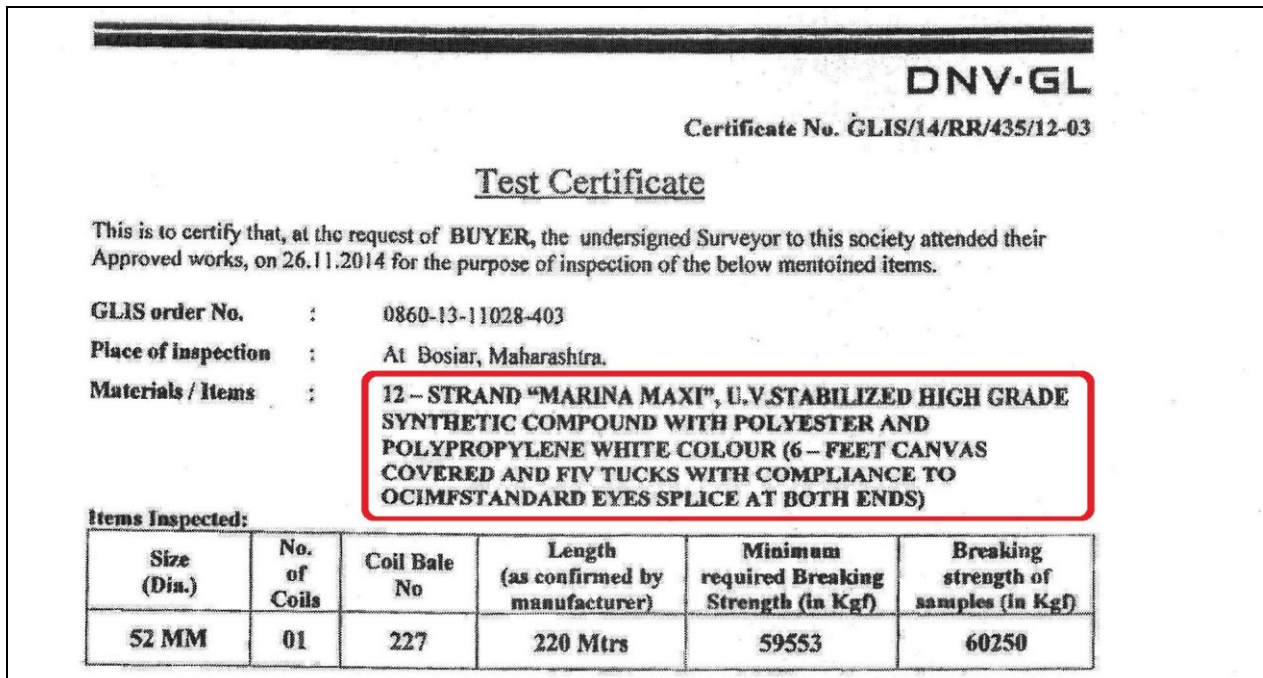
Despite the fact that the description of the mooring ropes in the ship’s requisition and in the supplier’s invoice were the same, the document entitled “Test Certificate” received together with the ropes when they were supplied onboard, on 15th July 2016, indicated a different description, as follows:

“12-Strand “Marina Maxi”, U.V. Stabilized High Grade Synthetic Compound with Polyester and Polypropylene White Colour (6-Feet Canvas covered and FIV Tucks with compliance to OCIMFStandard Eyes Splice at both ends)”.

Figure 4.2.2.4/2: The description of the mooring rope as written on the document presented to be its “Test Certificate”.

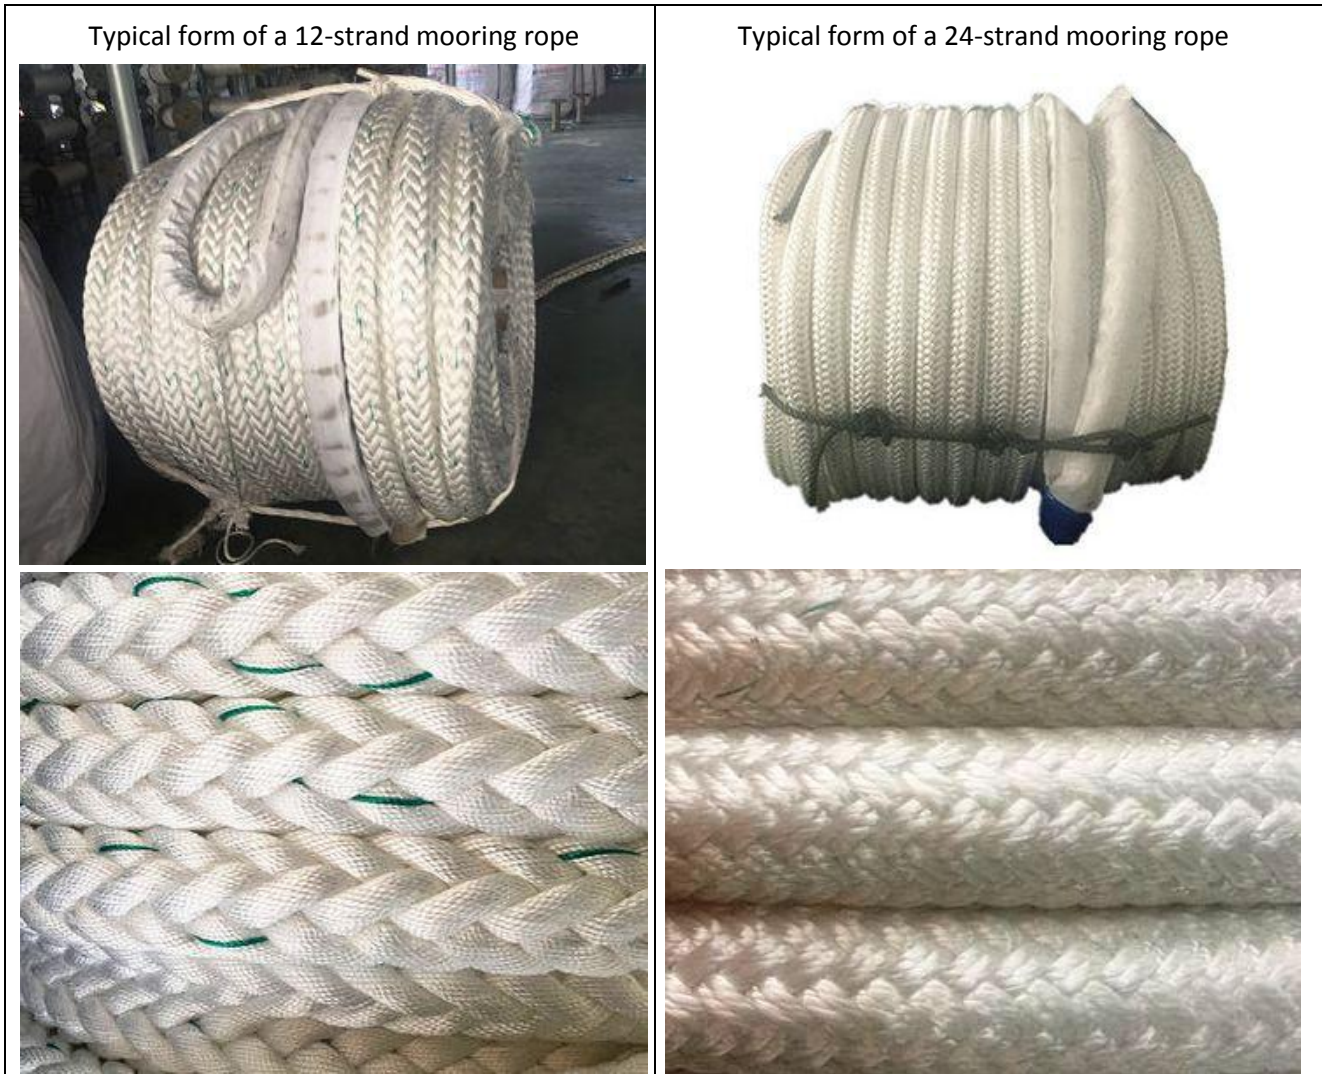
Apparently no comparison between the descriptions on the vessel’s requisition form, on the supplier’s invoice and on the document presented as “Test Certificate” was conducted during the receipt of the rope. Therefore, even the obvious difference of the number of strands of the rope (a 24-strand rope was requested whereas a 12-strand rope was delivered) was not observed.

Figures 4.2.2.4 / 3, 4, 5 & 6: Comparison of the form of a 12-strand rope (left side) and a 24-strand rope (right side).

From the above it is evident that no proper verification of the supplied mooring ropes was conducted by the crew who received them onboard.

The ad hoc selection by the Managing Company of a supplier for the mooring equipment in contrast with an effective supplier Quality Management procedure, as well as the failure of BYZANTION’s crew to conduct a proper verification of the supplied mooring equipment, are considered to have been contributing factors in the examined marine casualty.

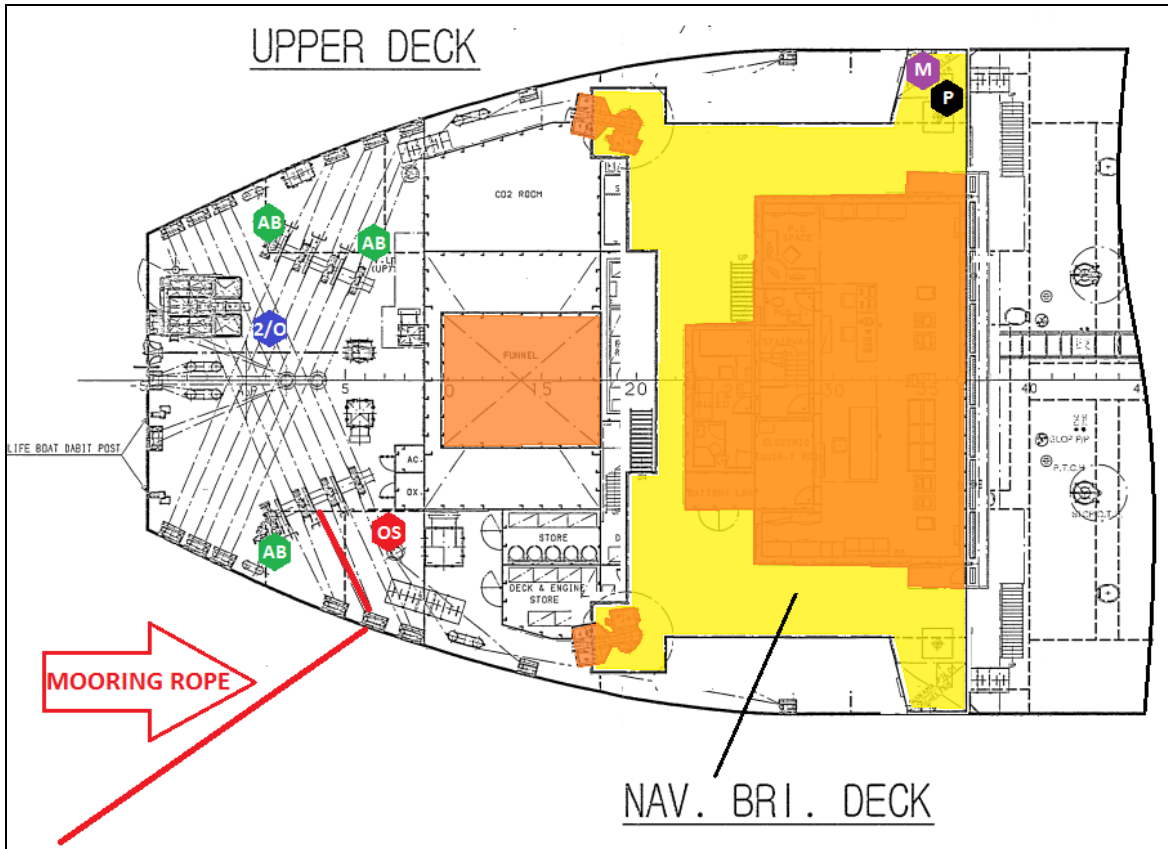
Figure 4.3/1: For illustration purposes, both Upper Deck (aft part) and Navigation Bridge Deck (yellow colour) are included in this picture. The positions of the aft unmooring team are evident, as well as the positions of the Master (M) and the Pilot (P) on the port bridge wing. Obstacles above the Navigation Bridge Deck (bridge, cranes, funnel) are coloured in orange.

Figure 4.3/1 shows the dangerous position of the victim (O/S) near the mooring rope in tension, as well as the fact that the 2nd Officer, head of the team, had no visibility of the O/S, since the stbd mooring winch was between them, hindering his view.

The Master also had no visibility of the entire stbd side of the stern from his position.

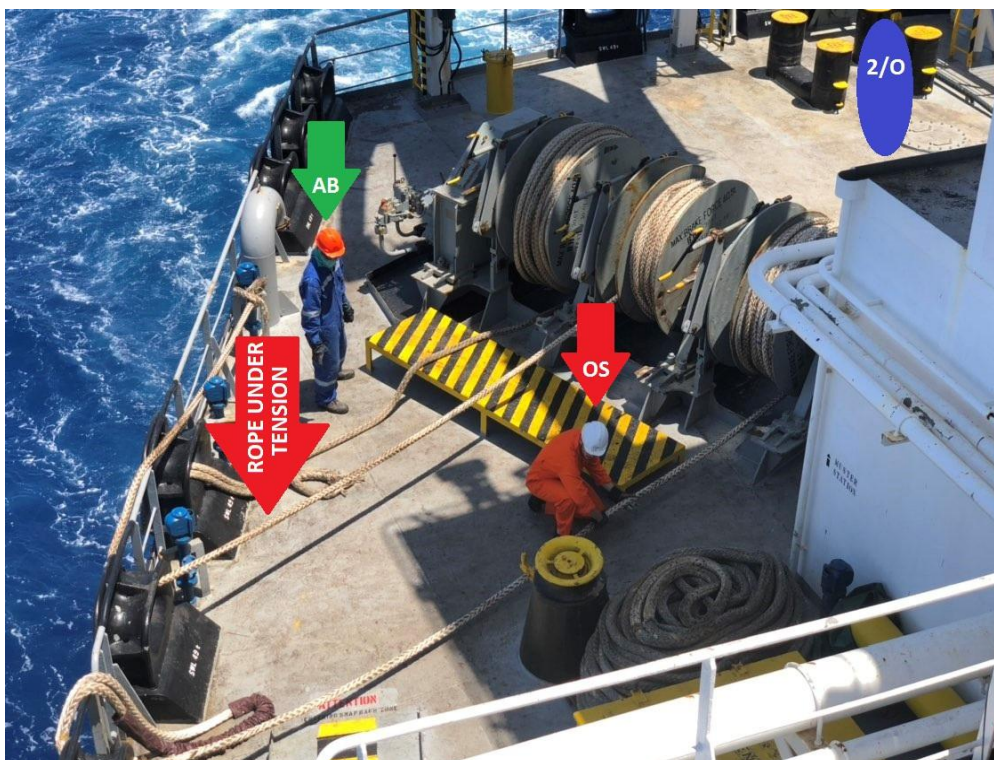
Figure 4.3/2: The actual arrangement of the stbd stern and the positions of the 2nd Officer, the A/B near the stbd winch controller and the O/S who at the time of the casualty was stowing the fore mooring rope on its drum, with his back turned to the mid mooring line, which was under tension.

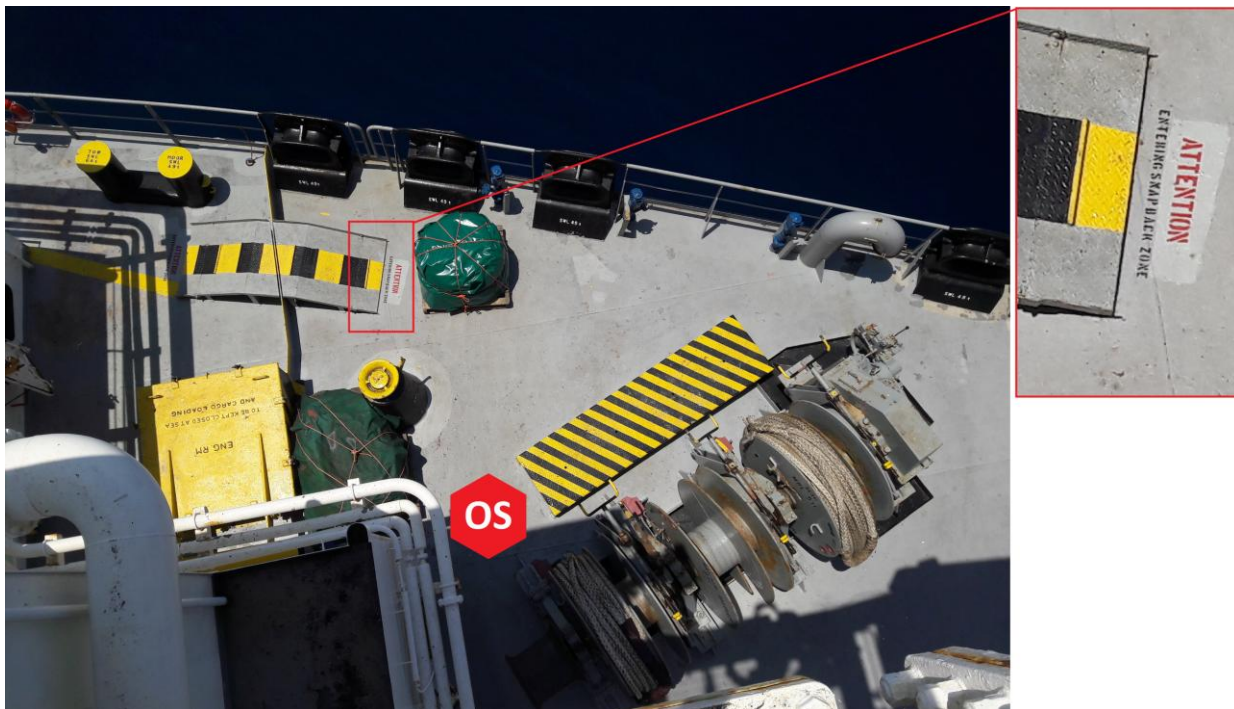
The entire stern mooring station was properly marked as dangerous snap back area. **Figure 4.3** shows an attention indication near the position where the O/S was hit by the mooring rope.

Figure 4.3: The marking for the dangerous snap back zone was near the position of the injured O/S, however he hadn't realized that he was standing inside a dangerous area.

The lack of supervision by the head of the Aft Unmooring Team regarding his team member's dangerous position, as well as the victim's lack of situational awareness, are considered to have been contributing factors in the examined marine casualty.
