**HELLENIC REPUBLIC
HELLENIC BUREAU FOR MARINE CASUALTIES INVESTIGATION**

**MARINE CASUALTY SAFETY INVESTIGATION REPORT
03/2015**

**Death by asphyxiation of the Bosun of Bulk Carrier KOSMAS V
after entering a cargo hold**

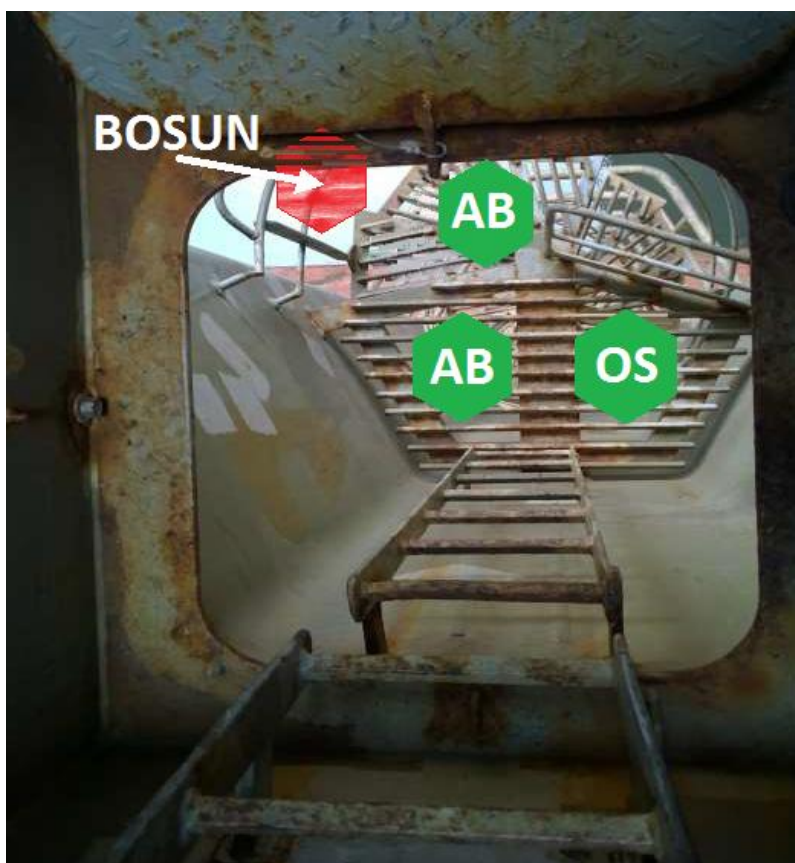
Figure 3.5/2: The positions where the 04 crew members involved in the casualty were found by their colleagues. The Bosun was lying on the cargo with his legs remaining on the ladder.

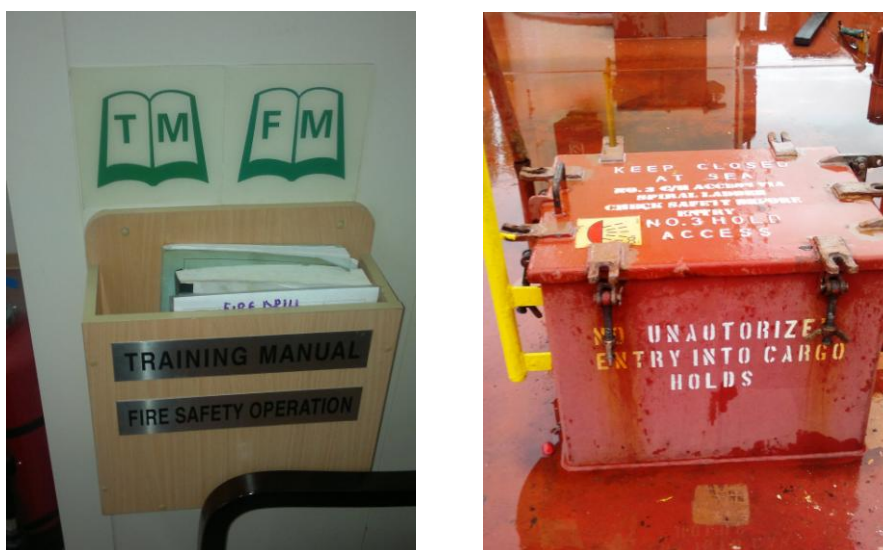
Fig. 4.3.1.2/ 1&2: Training manuals and Safety markings written in English.

Nonetheless it emerged that most of the lower rank crew members had either poor or no knowledge of English, as they could not understand basic English marine phrases and terms and consequently the interview process was carried out with the assistance of a translator.

Seeing the aforementioned, it was inferred that the Company's policy and likewise Kosmas V SMS, Manuals, check lists etc. could be neither understood nor implemented in full by most of the lower rank crew members at least, an issue that has been in general identified as a basic root cause of erroneous acts on board a ship.

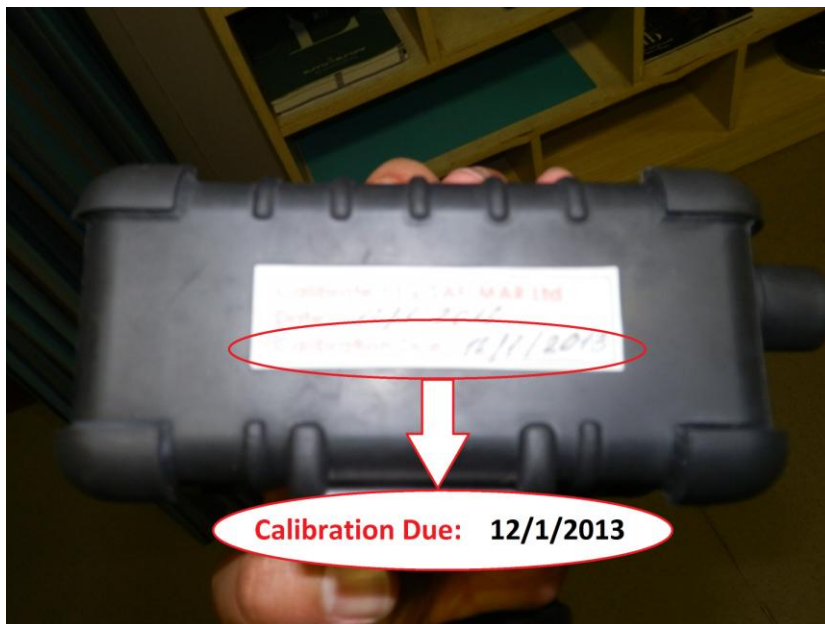
The investigation process identified that Kosmas V “Gas detection Equipment” was not operating, whereas its calibration date had been overdue since 12 January 2013 (Figure 4.3.2.2/2).

Fig. 4.3.2.2/2: Calibration due date of the gas detection equipment.

It was witnessed by the investigation team that when trying to set it in operational mode a warning “*Calibration date expired*” would appear on its screen and reported that thereon competent crew could not operate it. Furthermore, crew statements pointed out that the instrument had not been used prior to the casualty. The operation manual of the monitor included also instructions in English regarding its calibration method on board (Figure 4.3.2.2/3), however no one had managed to perform this operation until the casualty date.

Aforementioned malfunction had been reported to Kosmas V Company since 11 December 2014, together with other safety related issues found during an inspection of LSA and FFE Certificates, by noting that the last calibration date was carried out in 10 September 2010, that is before Kosmas V was even brought into service, and requesting calibration to be conducted at first convenient port.
