HELLENIC BUREAU FOR MARINE CASUALTIES INVESTIGATION

**MARINE CASUALTY SAFETY INVESTIGATION REPORT
05/2014**

**Foundering of RoRo Cargo Agia Marina 25 nm
West of Cape Gramvousa Kriti island**

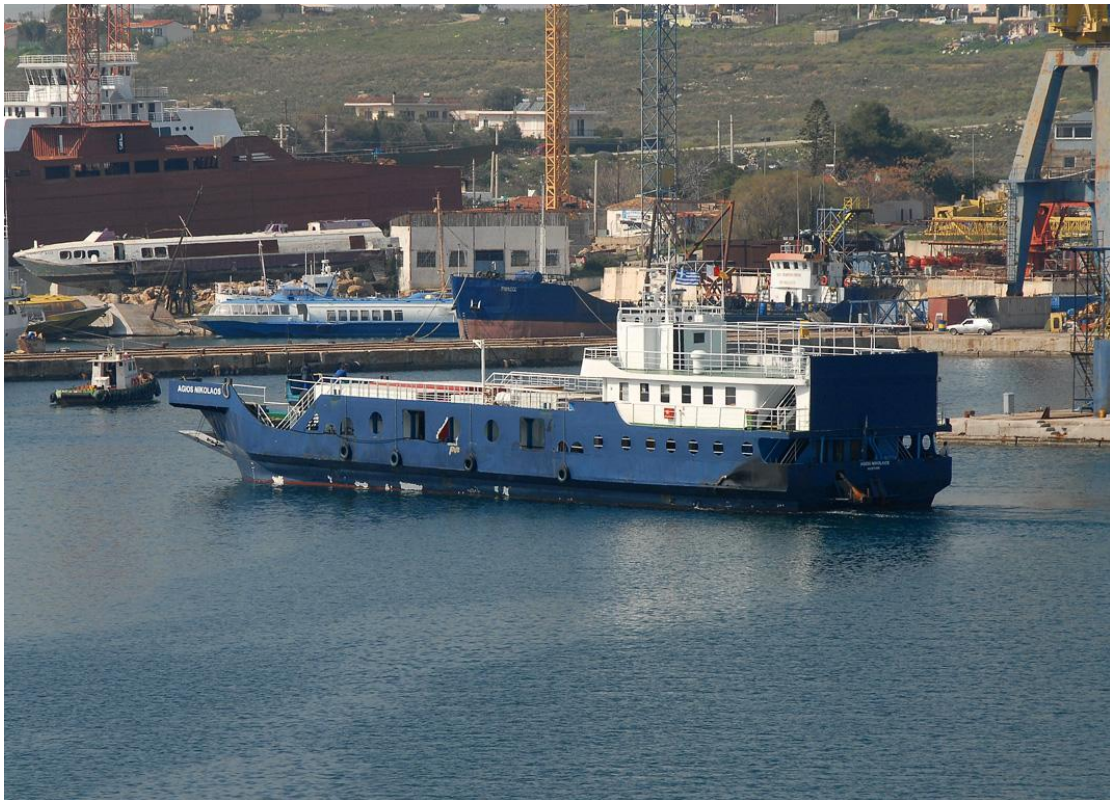
Figure 1. RoRo Cargo Agia Marina. The photo was taken by the time she was named Agios Nikolaos.

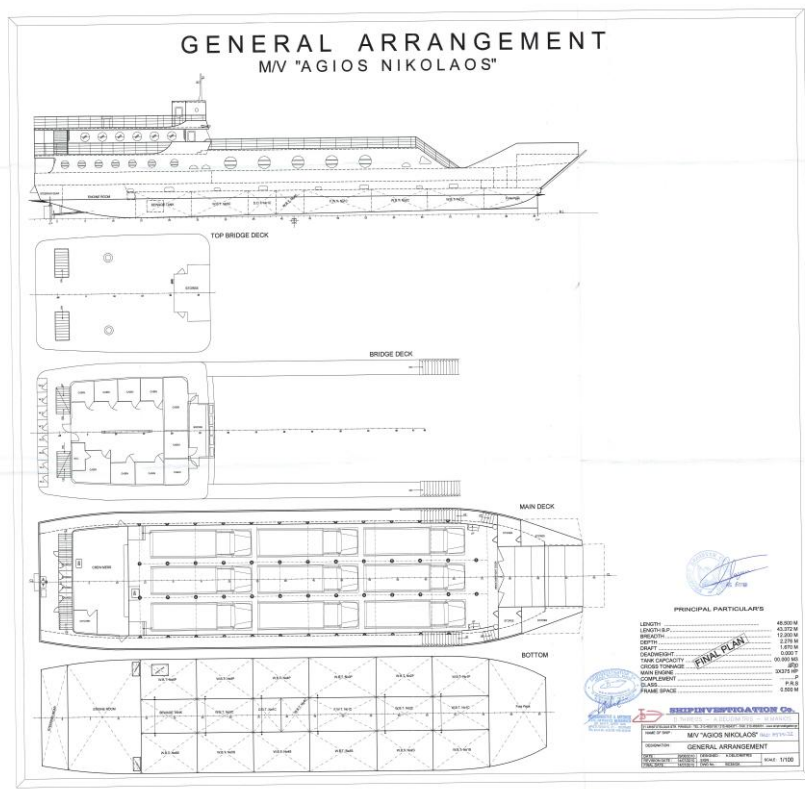
Ro-Ro Cargo Agia Marina was a small cargo ship (landing craft freighter) structured with a single open loading deck and capable of transporting tracked or wheeled vehicles between nearby ports, build in Elefsis Greece, in 1964 (figure 2).

Figure 2. The general arrangement plan of Agia Marina, issued by the Phoenix Register of Shipping under her previous name Agios Nikolaos.

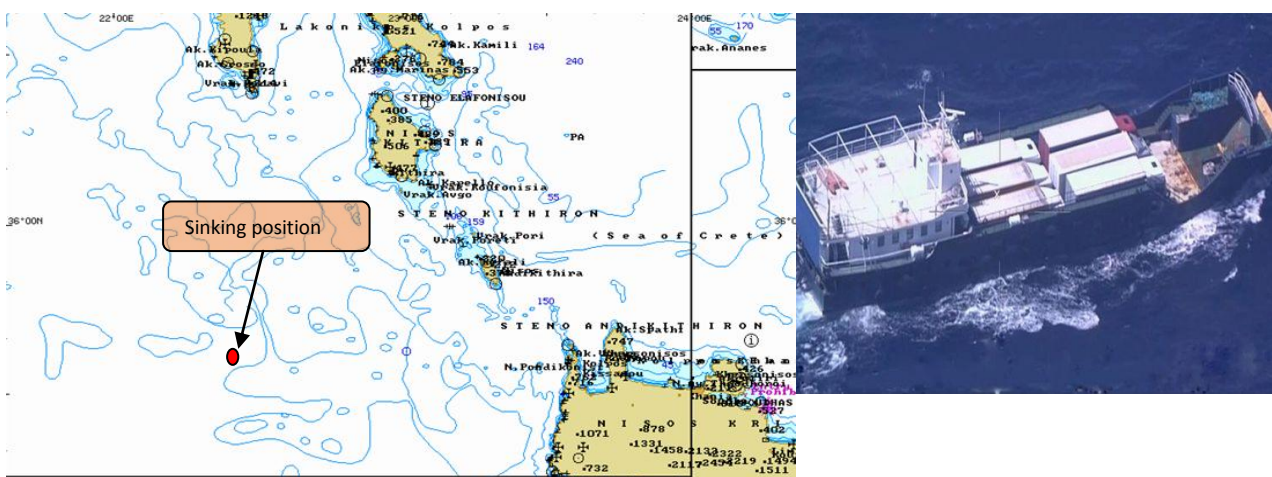
According to crew statements Agia Marina remained floating listing heavily to starboard for approximately 20 minutes. At approximately 0100 as estimated by the rescued crew members she capsized and sank within seconds, 25nm W of Kriti Island (figure 3).

Figure 3. Agia Marina loaded with trucks and her sinking position

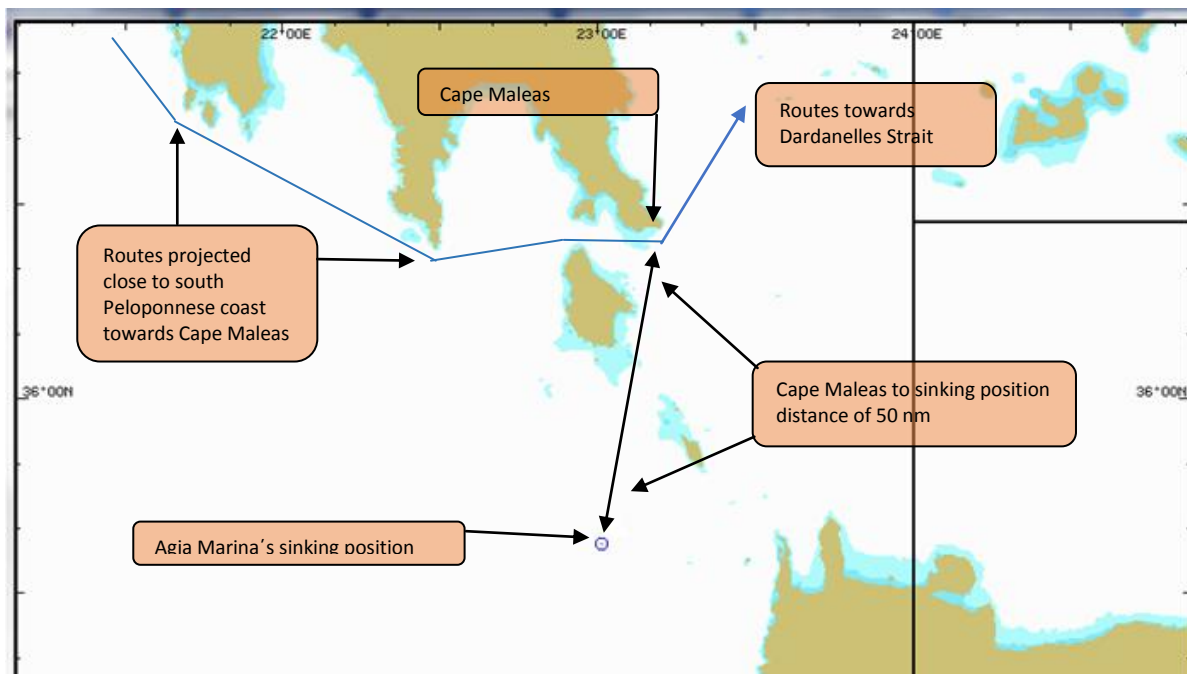
Nevertheless, as already reported, on the day of the marine casualty Agia Marina was navigating approximately 25nm W of Kriti Island, that is at least 50nm SSW of Cape Maleas, located at the SE end of Peloponnese which is the last waypoint for vessels coming from the Adriatic Sea or W sea areas of the Mediterranean Sea, heading towards the Dardanelles Strait (figure 4).

Figure 4. Sketch on electronic chart of the routes to be followed towards Dardanelle Strait compared with Agia Marina's sinking position.

In consideration of the aforementioned it derived that the Navigational Officers failed to plan and conduct an appropriate passage plan in view of the reported indented voyage disregarding basic navigational methods under good seamanship that is the knowledge
