HELLENIC BUREAU FOR MARINE CASUALTIES INVESTIGATION

**MARINE CASUALTY SAFETY INVESTIGATION REPORT
05/2018**

**Death of Security Guard
during embarkation on M/T ZEFYROS**

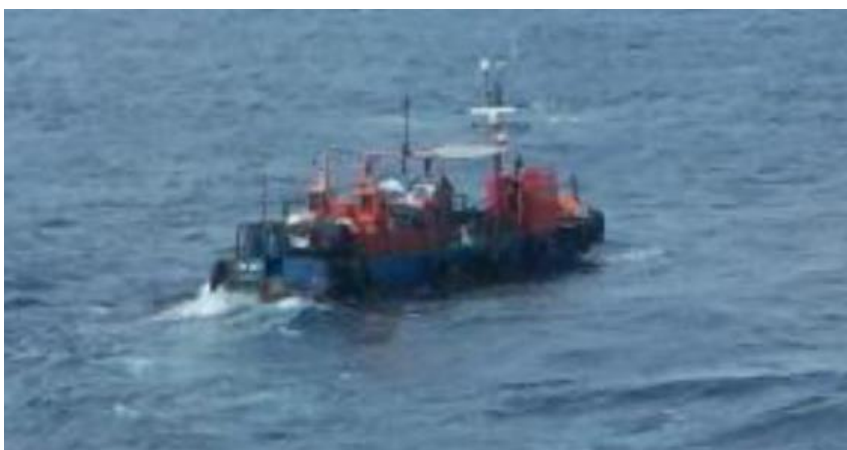
Figure 3: The service boat “OW267” (photo taken from M/T ZEFYROS)

At 10:30 LT the service boat “OW267” (fig. 3) left TRINITY LONDON with two SGs and picked up another one from another service ship named ALADIN at around 10:40 and headed to towards the meeting position with ZEFYROS.

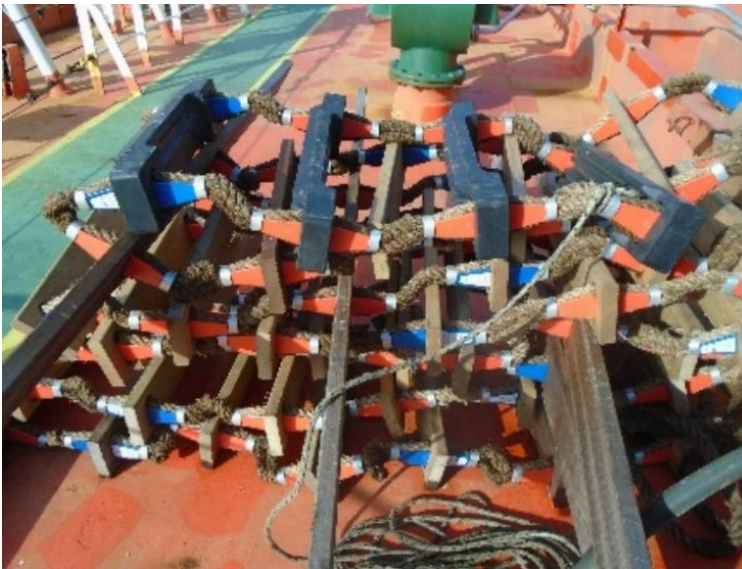
Figure 4. The pilot ladder that was used for the embarkation of the Security Guards.

The pilot's ladder (fig. 4) was rigged on to the ship's port side almost 1.5 meters above the waterline and was securely fixed on the main deck. Additionally, two-man ropes were fitted on each side and were securely fixed on ship's rails. An indicative sketch of the arrangement is shown in fig. 5.

The investigation process did not consider the pilot ladder's condition to have been a contributing factor to the marine casualty.

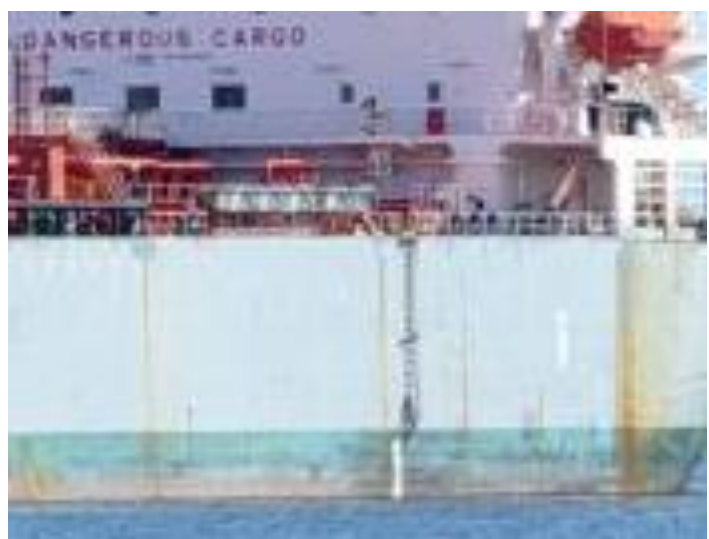
Fig. 6: Pilot's ladder arrangement

Figure 6, was sourced through the web and it depicts indicatively the pilot ladder arrangement on Zefyros port side. It does not represent the actual pilot ladder rigging on the day of the marine casualty.

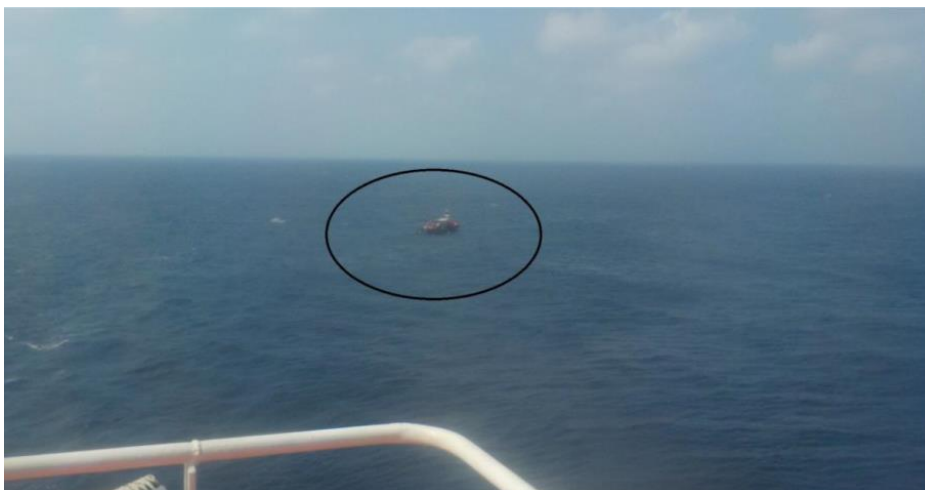
Figure 7: The service boat is proceeding towards the "man over board".

According to information collected during the investigation process, the Security Guard overboard was seen to be conscious and was asking for help by waving his hands. Soon after, the service boat maneuvered towards the "man over board" and approached him (figures 7 & 8).

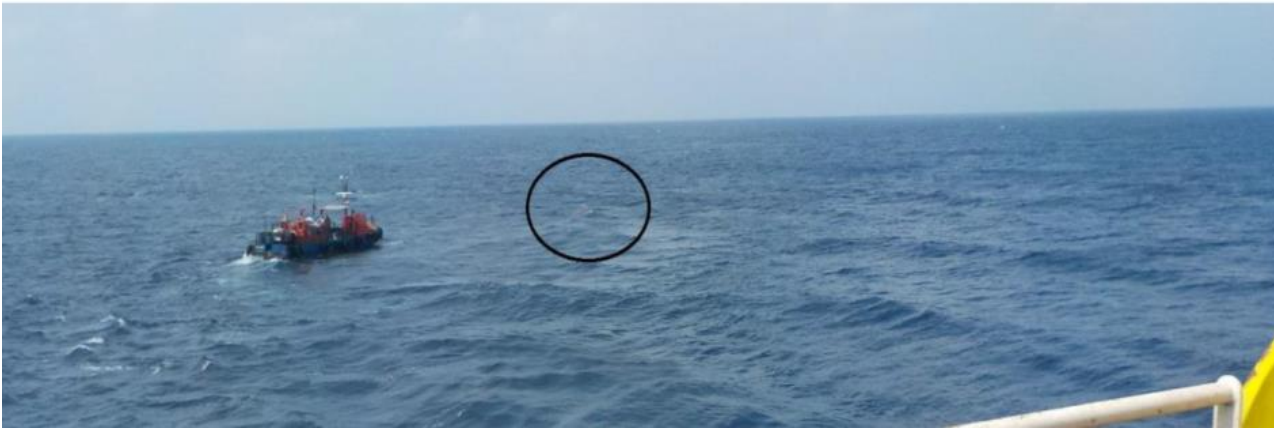
Figure 8: The service boat is approaching the “man over board”.

The first attempt to recover him from the sea was not successful. Finally, at approximately 11:20, almost ten minutes after the occurrence, the SG overboard was recovered from the sea by his colleague and the crew of the service boat. The Skipper of the service boat immediately headed to TRINITY LONDON that was about 20 minutes of sailing away in order to seek for First Aid and Medical Assistance.
