**HELLENIC REPUBLIC  
HELLENIC BUREAU FOR MARINE CASUALTIES INVESTIGATION**

**MARINE CASUALTY SAFETY INVESTIGATION REPORT**  
**06/2014**

**FATAL FALL INTO THE SEA OF TECHNICIAN DURING  
DISEMBARKATION  
FROM OIL TANKER ROYAL OAK TO LAUNCH BOAT DRAKON  
TAXIARCHIS**

--- Piraeus January 2017 ---

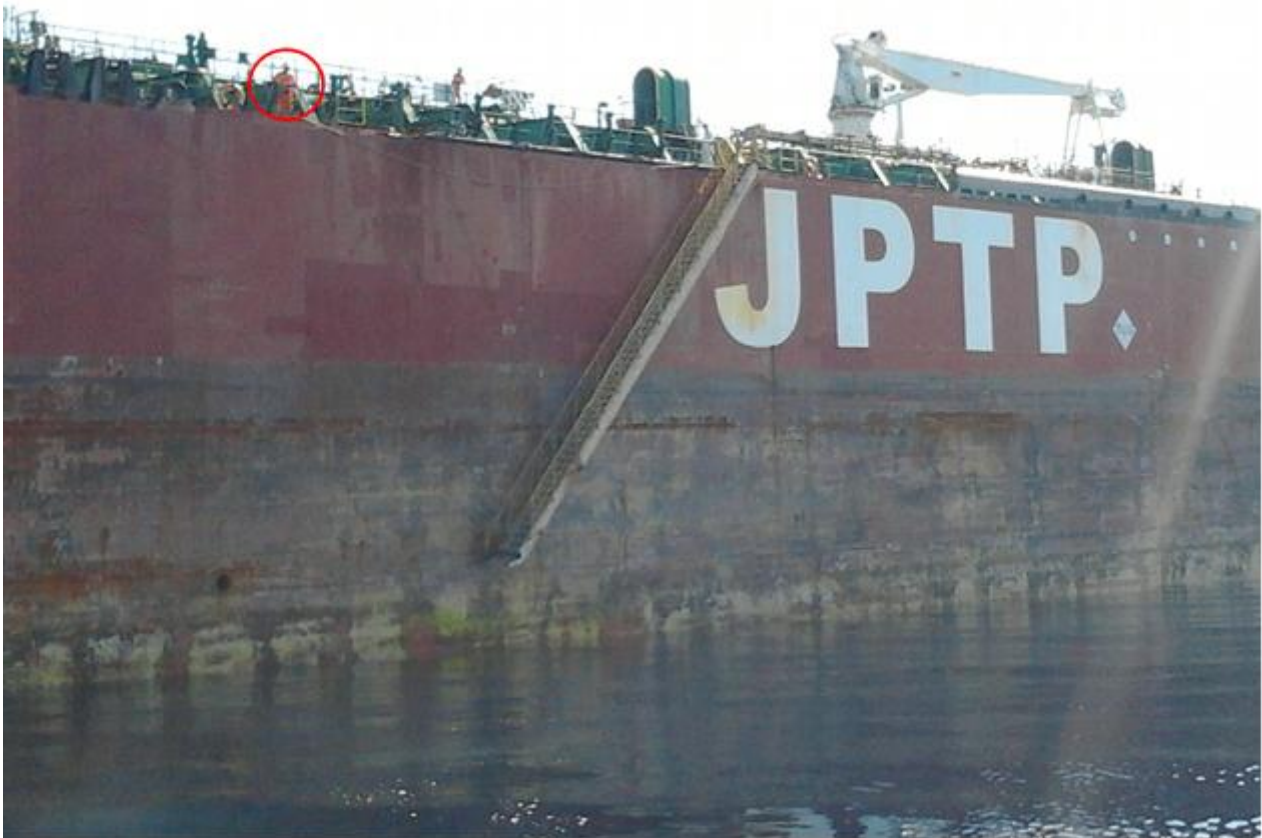
During the disembarkation of the two technicians and the one Chief Officer, Bosun had the control of the accommodation ladder and he was standing at the ladder's control post while the process was supervised by the other C/O who was standing towards the aft at approximately 10m distance from Bosun (Figure 4).

**Figure 4:** The Starboard accommodation ladder at ROYAL OAK main deck and the position of the ladder's control post where Bosun was standing.

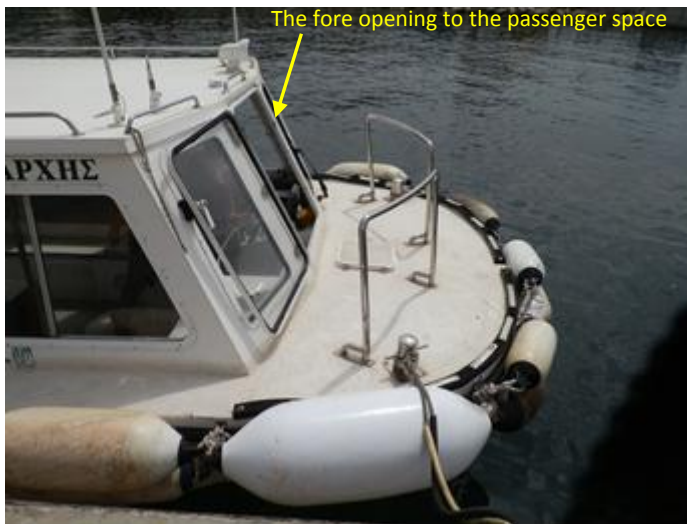
When the two technicians and the C/O got at the main deck and were ready to disembark, the launch's Skipper approached the accommodation ladder's lower platform with the bow, as he was about to embark the passengers from the fore embarkation deck, while the Bosun lowered the accommodation ladder at approximately 0,2m higher from the launch's embarkation deck (Figure 5).

**Figure 5:** DRAGON TAXIARCHIS bow arrangement and the fore opening leading to the closed passenger accommodation area.

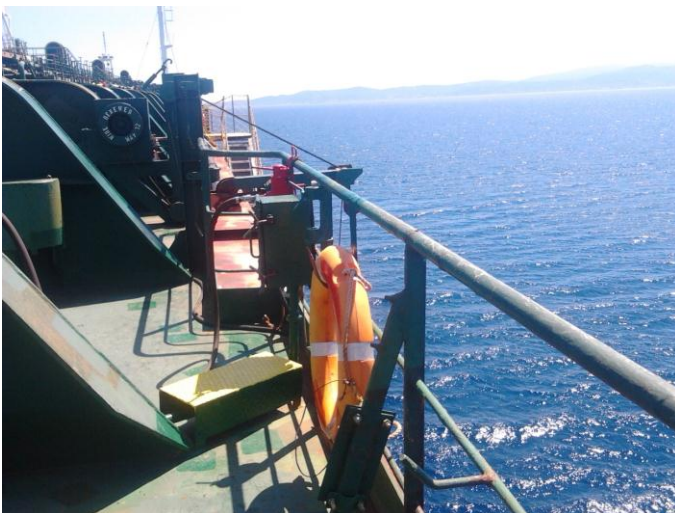
The fall of the technician in to the sea was noticed by the Bosun and the C/O of ROYAL OAK who threw a lifering located near Bosun's position at a close distance from the technician, and reported the incident to the Master through his portable VHF device. It was reported that when the technician fell overboard he attempted to remove the backpack with the tools from his back but as he couldn't get rid of the extra weight he swam for a short time towards the lifering.

**Figure 6:** The lifering located close to the accommodation ladder control post.

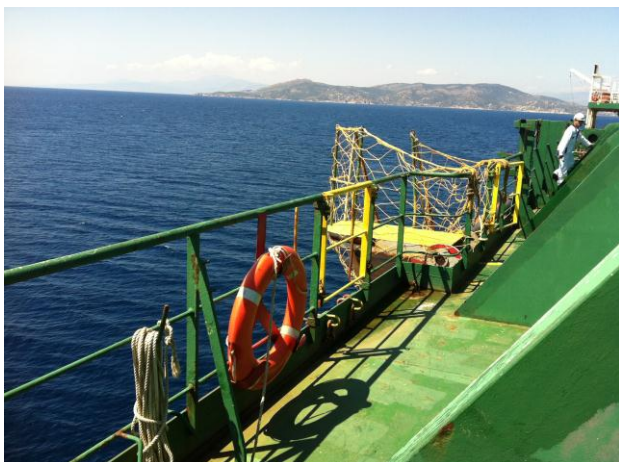
who was unconscious. Simultaneously, Bosun and the C/O from ROYAL OAK took a lifering with rope and went down at the ladder's lower platform, from where they threw it to the C/O, while the launch's skipper maneuvered the launch and approached the casualty and threw also a lifering with rope.

**Figure 7:** The lifering with rope which was placed close to the Stbrd accommodation ladder towards the fore.

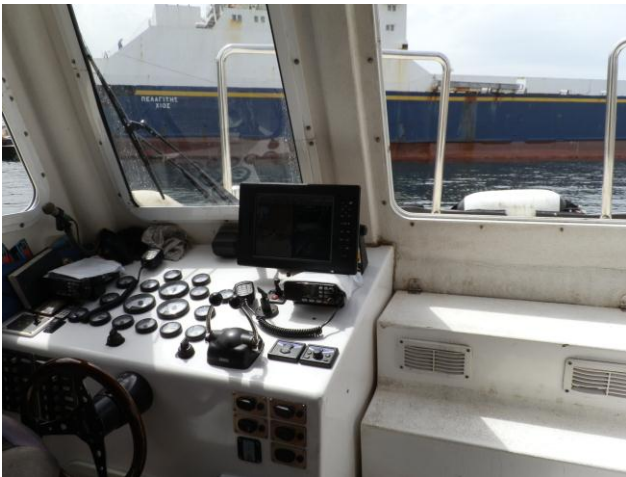
Figure 8: The fore control station.

The main control station provides a good visual field to the skipper when approaching a vessel's accommodation or pilot ladder and the embarkation / disembarkation is performed from the launch's fore deck. However, according to the data collected during the investigation process, when the technician fell into the sea, the skipper was looking at the engine monitoring instruments on the control panel and he didn't notice the cause of his fall.

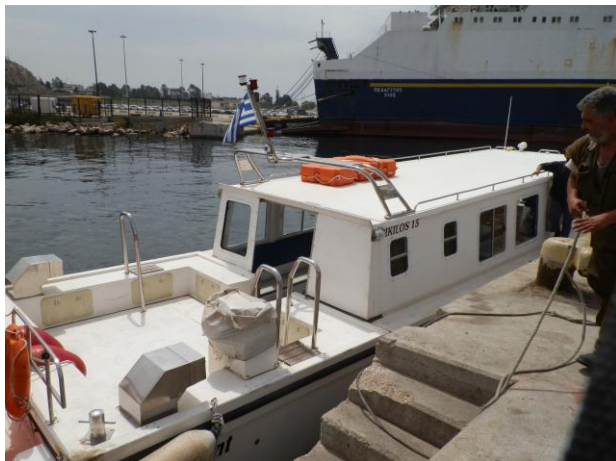
Figure 10: The aft embarkation deck.

either at the bow's or at the stern's deck area since no relevant specific provision or instruction is recorded in the launch's General Inspection Certificate. The fore embarkation deck is slip resistant coated with two guard railings. Passengers passage to/from the enclosed passenger area is performed through a weather tight opening located at the fore part of the launch's superstructure.

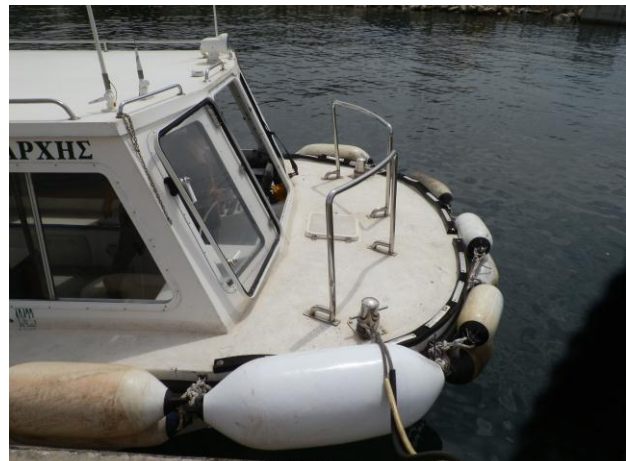
Figure 11: The fore embarkation deck with the weather tight opening for the access to the passenger area and the railings.

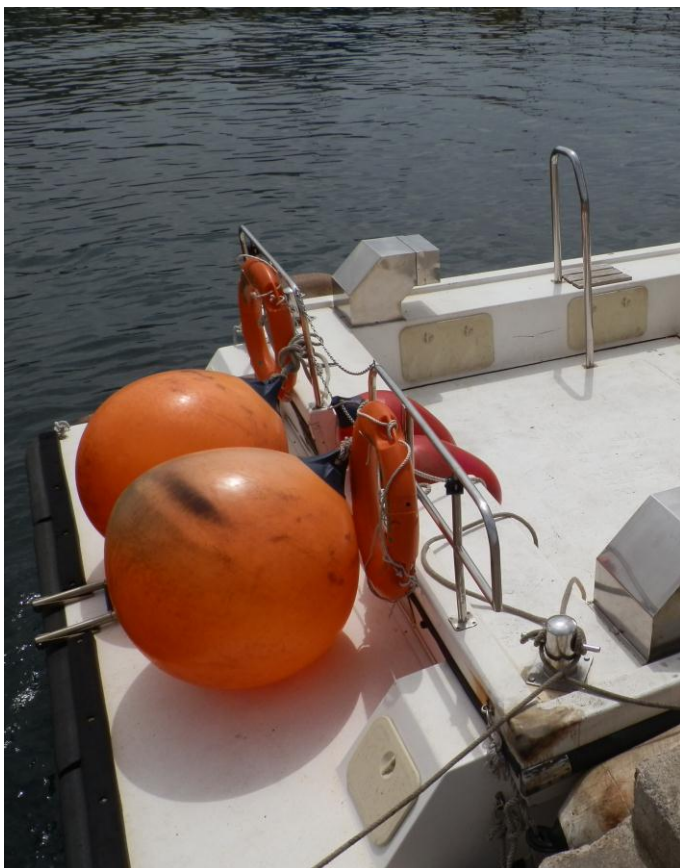
The provided lifesaving equipment for the launch boat DRAKON TAXIARCHIS according to P.D. 270/1988 was, inter alia, a lifering with 15 m rope and a lighting device fitted in a way that its use would be easy and immediate. Launch boat DRAKON TAXIARCHIS was equipped with two liferings with rope that were placed at the stern outside of the protective railing.

Figure 14: The two liferings placed on the aft railing.

After the technician's fall into sea, his assistant, who was in the passenger compartment rushed to the stern, took a lifering and handed it over to the C/O at the bow. Meanwhile and before throwing the lifering to the "man overboard" the C/O noticed that the technician had lost consciousness and fell into the sea to catch him. Considering the above, in relation to the reaction of the human body after the fall at sea as described in par. 4.6, it is deduced that the time response margin of the persons in the launch after the technician's fall was limited, thus the immediate throwing of the lifering was required.
