**HELLENIC REPUBLIC
HELLENIC BUREAU FOR MARINE CASUALTIES INVESTIGATION
MARINE CASUALTY SAFETY INVESTIGATION REPORT**

07/2014

**FATAL FALL OF BOSUN
FROM THE DECK CRANE OF B/C «PANORIA»**

January 2017

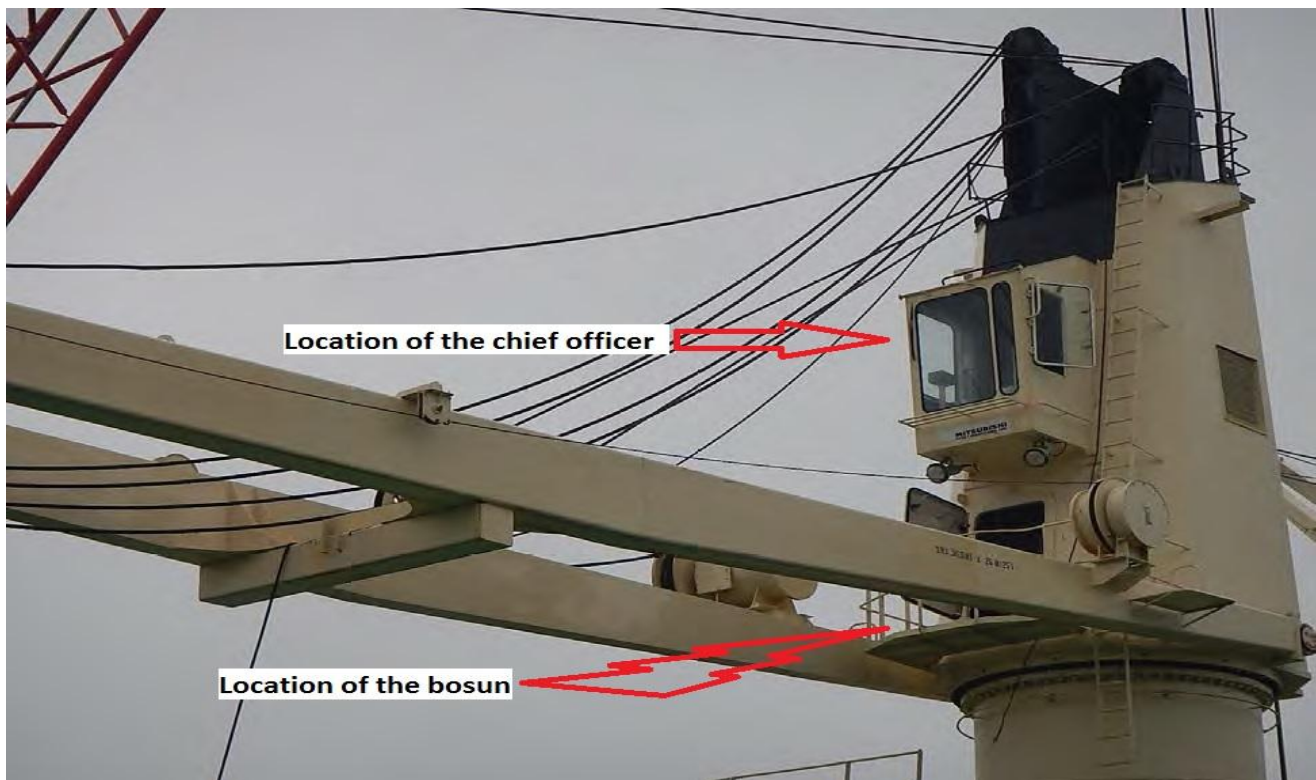
Figure 2: The location of the Chief Officer and the Bosun during the wire replacement procedure.

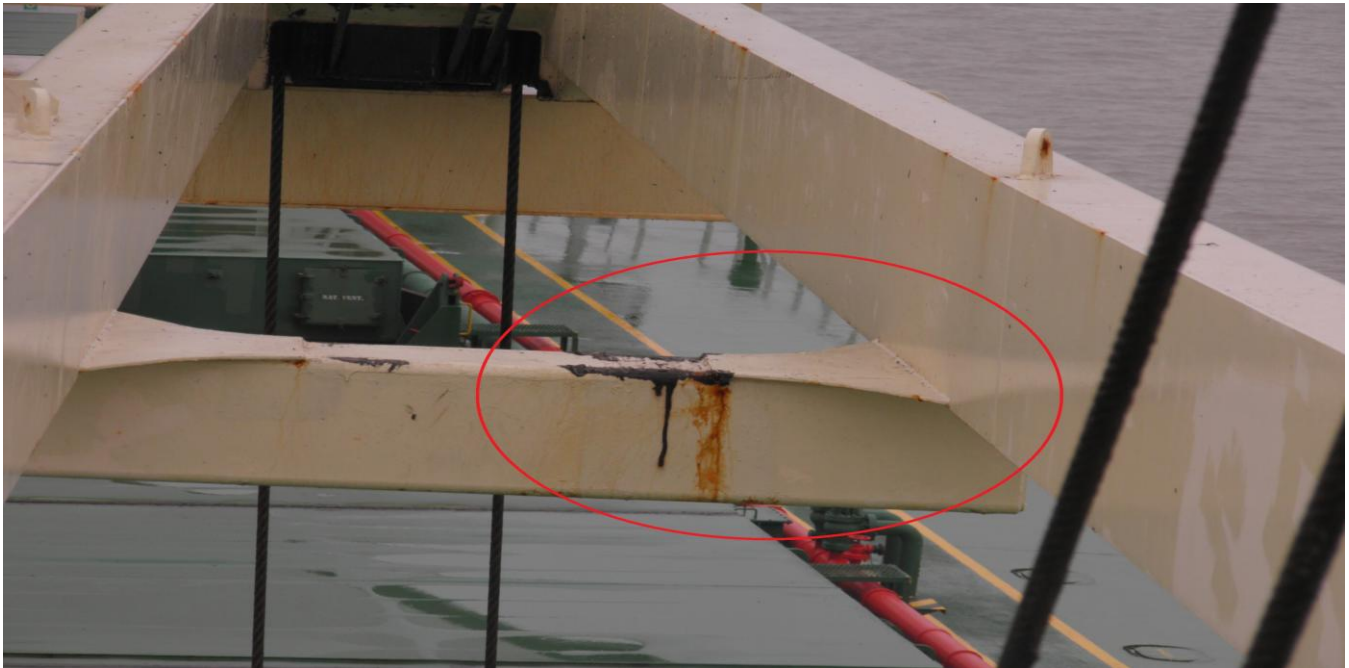
However, at the same time the connecting sleeve got snagged while passing the corner of the horizontal cross section member of the jib (figure 3). C/O didn't notice that the connection sleeve got snagged at the jib's cross section, while Bosun did not reported it to him.

Figure 3: The point where the wire sleeve got snagged.

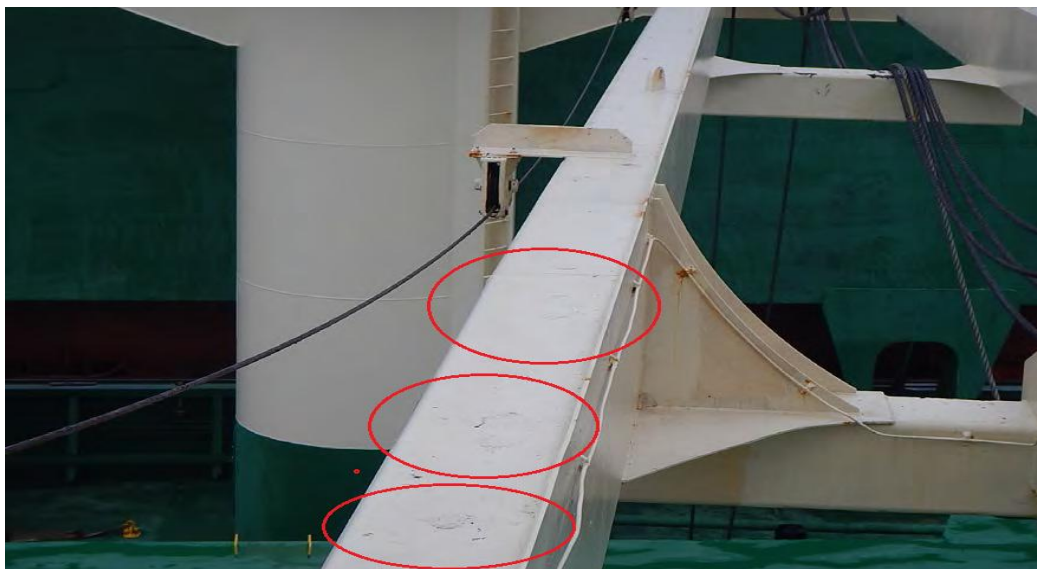
Without notifying the C/O, Bosun jumped over the crane's platform railing, walked onto the left side of the crane's jib and crawled towards the cross section to release the connection sleeve (Figure 4). His attempt to release the wire was noticed only by the AB stationed at the top of No.3 cargo hold hatch cover (Figure 5).

Figure 4: Bosun's footprints after walking out on the left hand side of the crane boom as viewed from the crane platform (source: MARICOT INC)

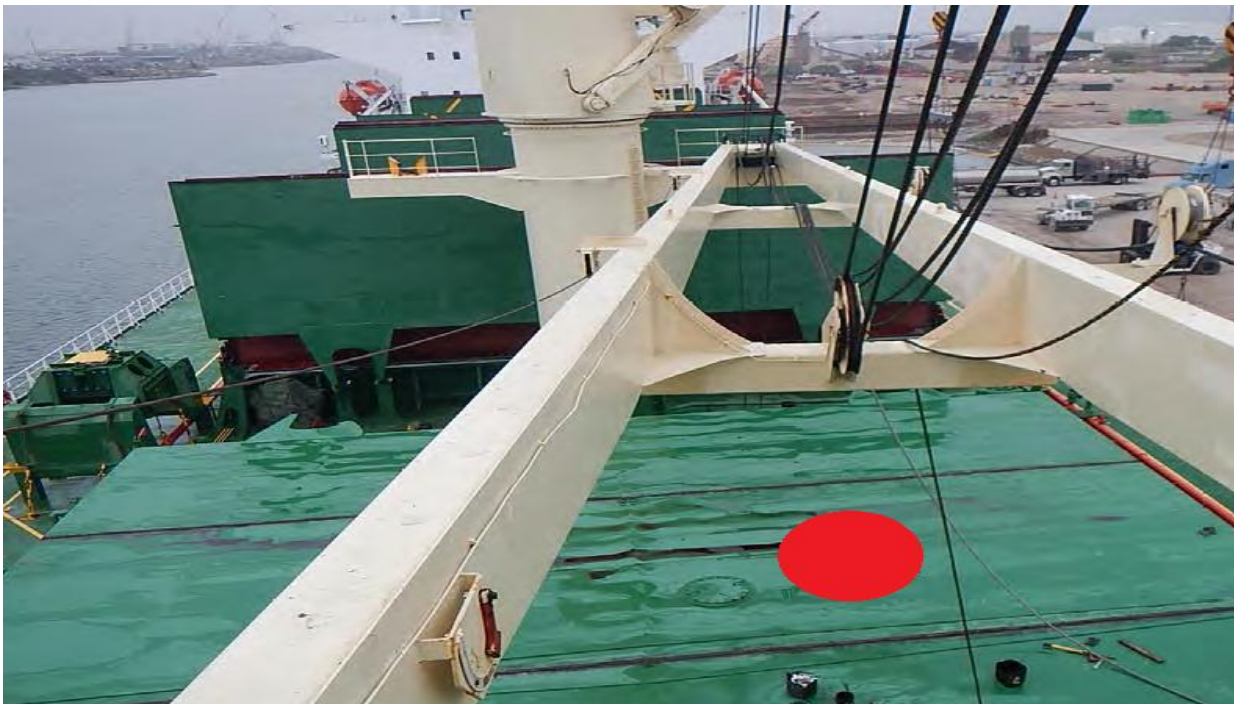
When Bosun reached the jib's cross section he hooked his fall arrester to the old wire that was being replaced. When he managed to release the wire rope he lost his balance and fell from a height of 9.5 meters on the hatch cover (Figure 6). His safety harness which was secured on the old wire could not restrain his fall.

Figure 6 : The location where the Bosun fell on top of cargo hatch cover No.3 (source: MARICOT INC)

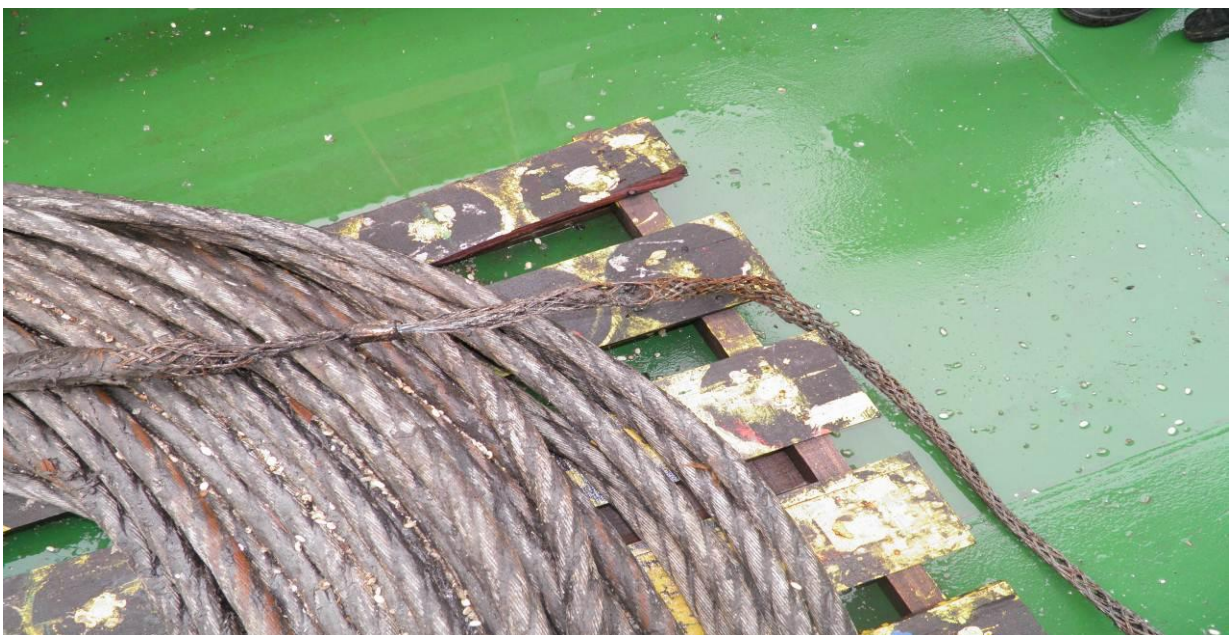
Special attention should be given when the wire sleeve passes through structural parts of the crane, like wire guards, falling blocks and sheaves.

Figure 13: The wire sleeve that was used to connect the old with the new hoist wire on board “Panoria”

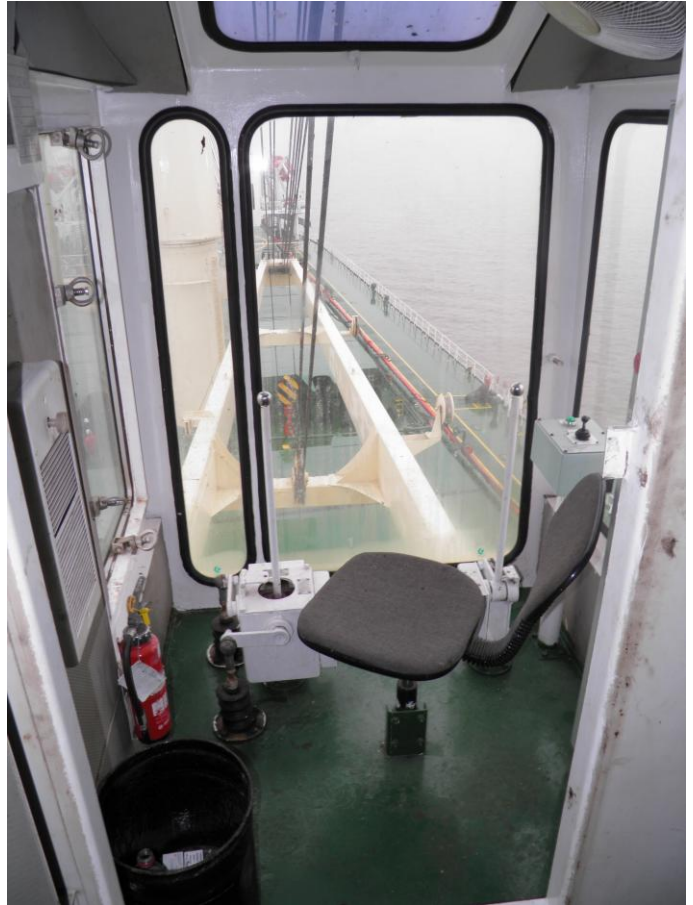
In view of the above it can be inferred that during the winding procedure Chief Officer's attention was mainly focused on operating the winch and the proper winding of the wire on the hoist drum inside the crane's tower. This prevented him from noticing the snagging of the wire at the boom's cross section and the Bosun's movement to jump the railing and walk on the boom without any precaution. The lack of efficient supervision is considered a contributing factor to the examined marine casualty.

Figure 15: View of the crane's control cabin

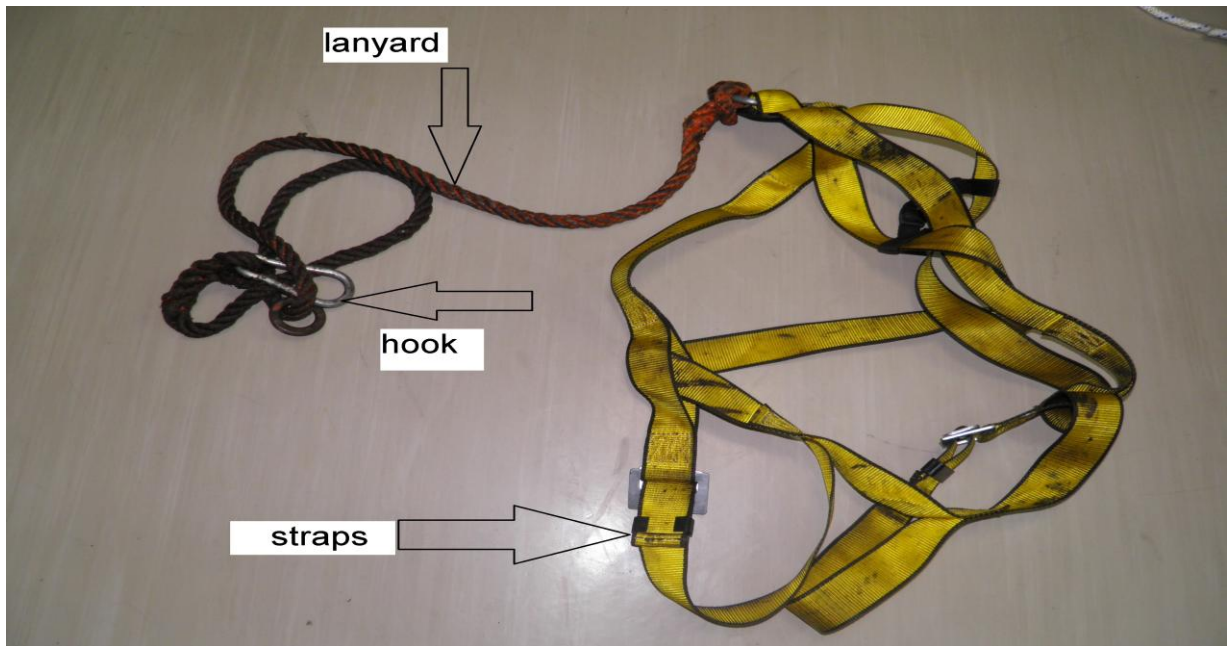
When the Bosun walked on the crane boom he was wearing a full body safety harness as shown in Figure 16, consisting of straps passed over the shoulders, across the chest, and around the legs. The safety harness was in turn connected with a rope lanyard and a hook.

Figure 16: Full body safety Harness used by the Bosun on the day of the accident

The selection of this equipment is generally appropriate when working aloft, since a full body harness can protect someone better than a safety belt, because it distributes the force of the impact over a greater area of the body avoiding severe back and abdominal injuries.

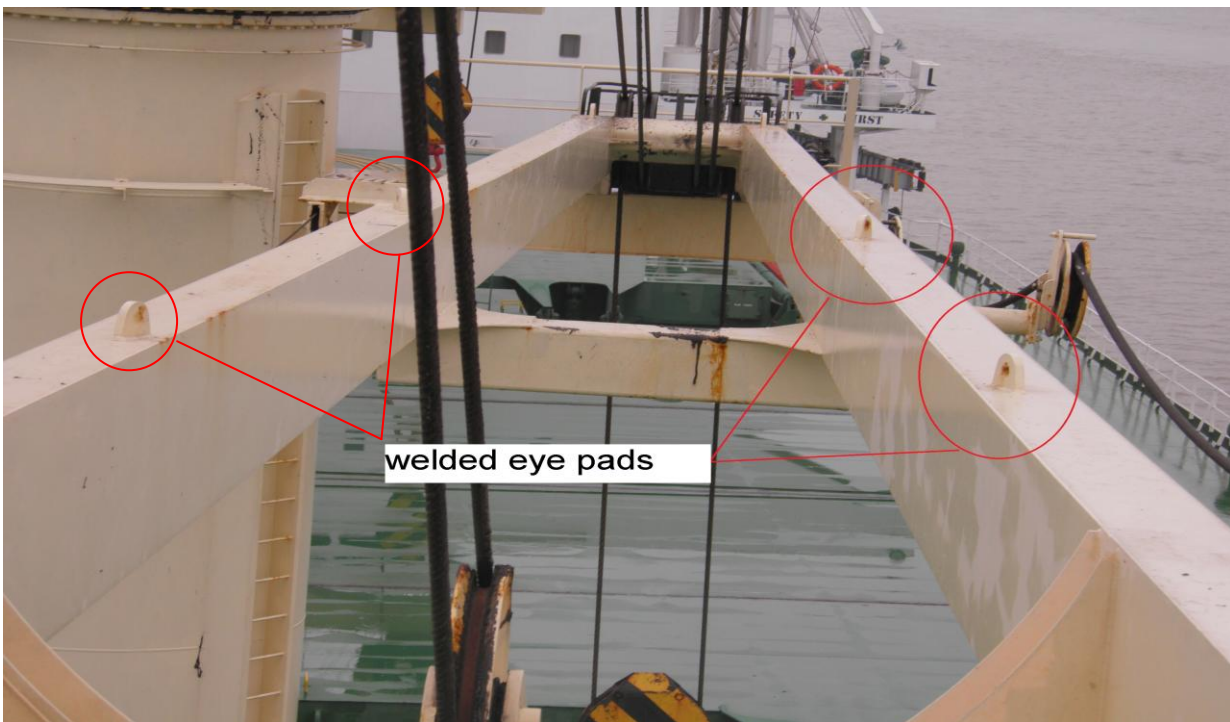
On the top side of the boom there were welded pad eyes, as shown in Figure 17, which were used during the manufacturing process of the cargo crane to rig and lift the jib in place. These pad eyes if used as a fixed point to secure the lanyard of the safety harness theoretically would provide a better protection in case of falling. However, practically it is considered difficult and dangerous to secure the hook in these eye-pads, while keeping balance at the same time on the narrow passage of the crane's jib. The crane boom had neither a protected guard rail nor could provide a safety access, as it is not designed to be used as a walkway and therefore it's not considered as a safe working area that can be used to carry out maintenance or any other work in any case.

Figure 17 :The welded eye pads on the top of the crane boom

When the Bosun got at the boom's cross section where the hoist wire got snagged, he connected his lanyard to the loose wire which was not connected to any secure point and in fact was hanging free. Had the Bosun connected his safety harness to one of the two pad-eyes close to the boom's cross section would have prevented his fall onto the cargo hold cover and may have prevented his fatal injury.
