**HELLENIC BUREAU FOR MARINE CASUALTIES INVESTIGATION**

**MARINE CASUALTY SAFETY INVESTIGATION REPORT  
08/2013**

**PARTING OF A MOORING LINE**

**ON CRUISE SHIP NORWEGIAN JADE**

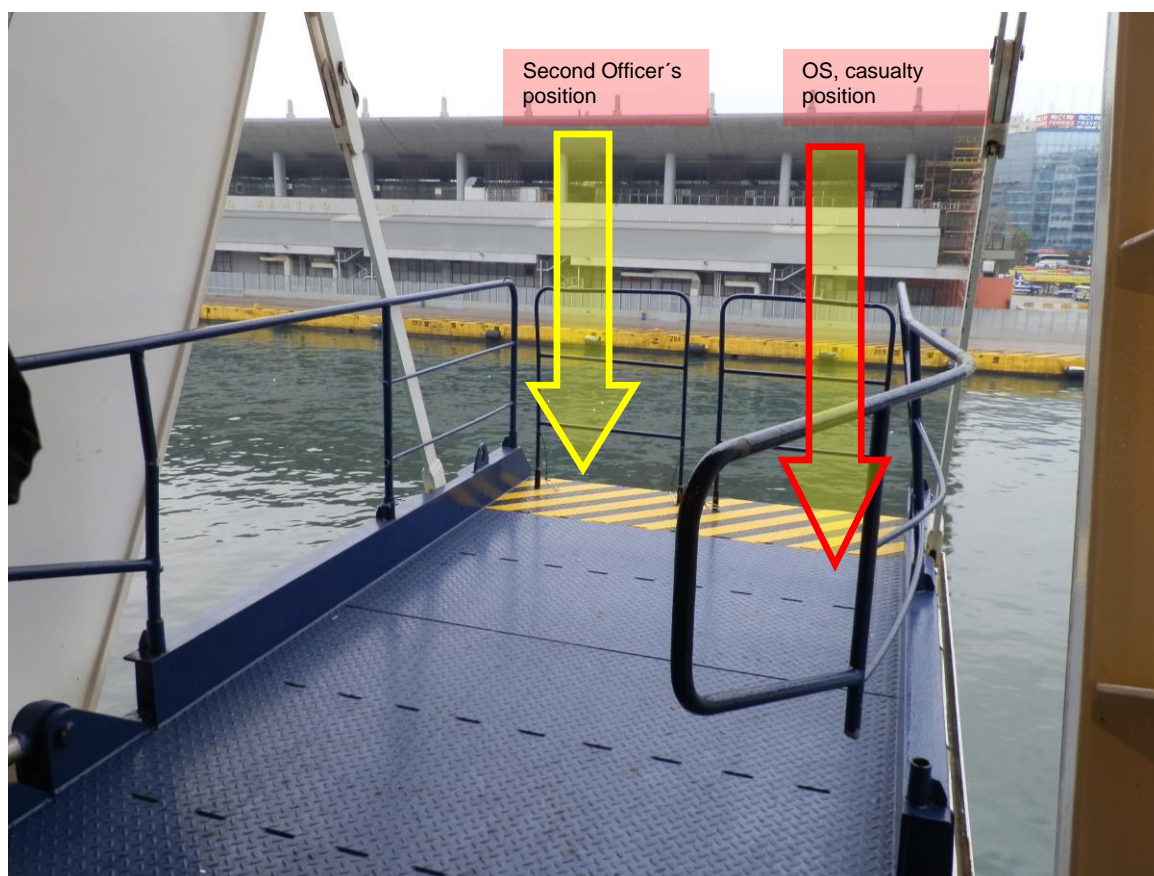
During the preparation of the winch for hauling in no 1 fore spring line, not under tension and still under the platform, no 2 fore spring line parted at a point of approximately 20 meters from the quayside's bollard. The parted line attached on Norwegian Jade snapped back towards her bow and the mooring platform under extreme force, struck the OS standing on it, forced him towards the guard rails and pulled him overboard while the Second Officer stationed at the edge of the mooring platform was not accidentally injured (figure 5).

Figure 5. Mooring platform. Guard rails distorted. Positions of Second Officer and OS.

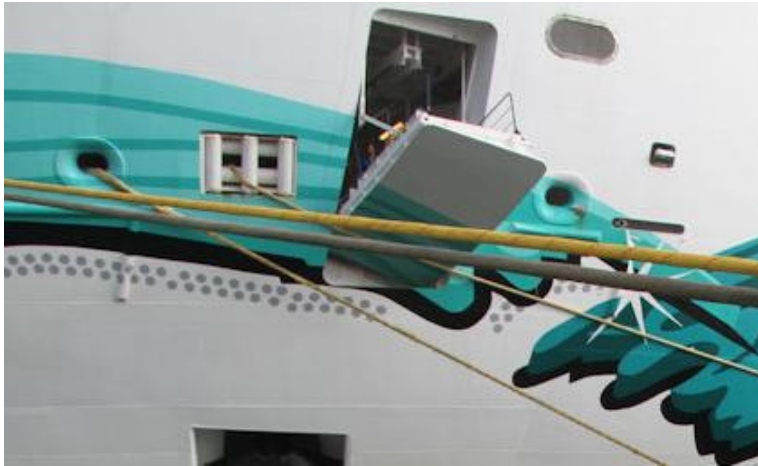
The spring line attached on quayside's bollard coiled towards the bollard fortunately without causing any injuries to dock mooring personnel as they had accidentally moved away from the area. Norwegian Jade shifted slightly forward until restrained and stopped by no 1 fore spring line, which unexpectedly got under tension and stretched, causing distortion on the fittings supporting the mooring platform (figure 6).

Figure 6. The damaged mooring platform following the marine casualty

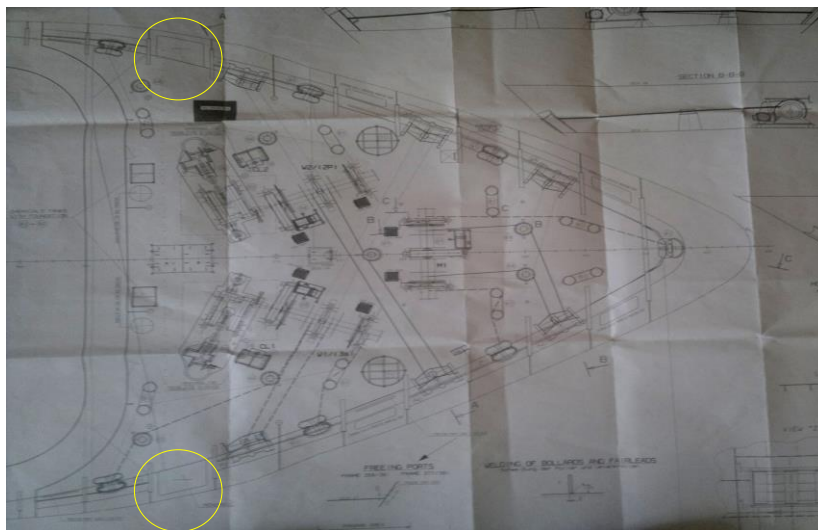
Figure 12. Plan view of the fore mooring deck. Mooring platforms openings are shown in yellow circles

The lack of controls taken in the direction of crew safety when undertaking duties on the mooring platform has been identified as a contributing factor into the examined case.

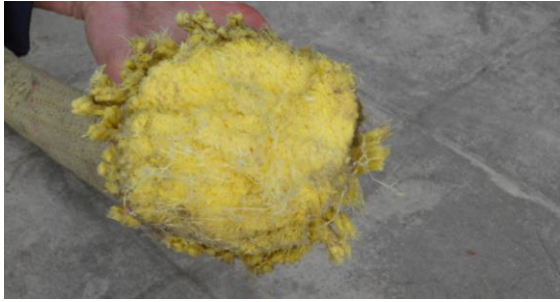
- ✓ the rupture of the rope was caused by tensile overload stress.(fig.19, 20, 21);
- ✓ no surface external abrasion was found as the line was stored in the covered forward mooring deck and therefore it was not exposed to external environmental conditions;
- ✓ its diameter was measured at 78 mm, that is 2,5% less than its nominal diameter;
- ✓ no signs of kinks or twists were observed.

Figure 19. Cross section of the parted line very close to breaking point

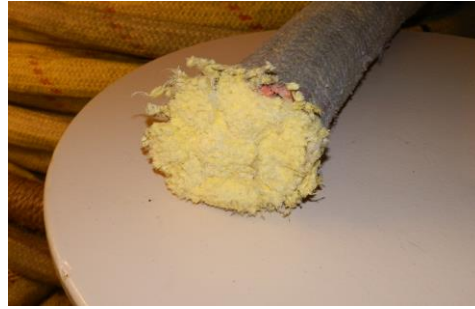
Figure 20 . Cross section part of the parted line found onboard

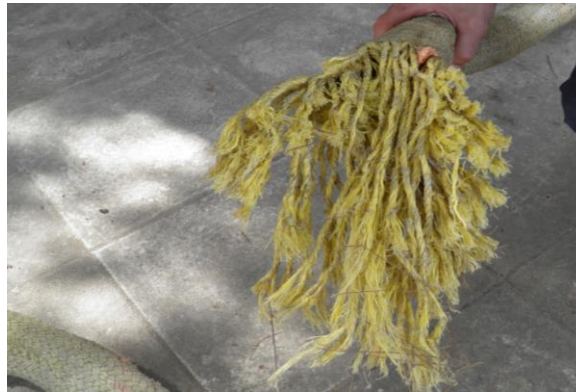
Figure 21. Damaged cross section of parted mooring line

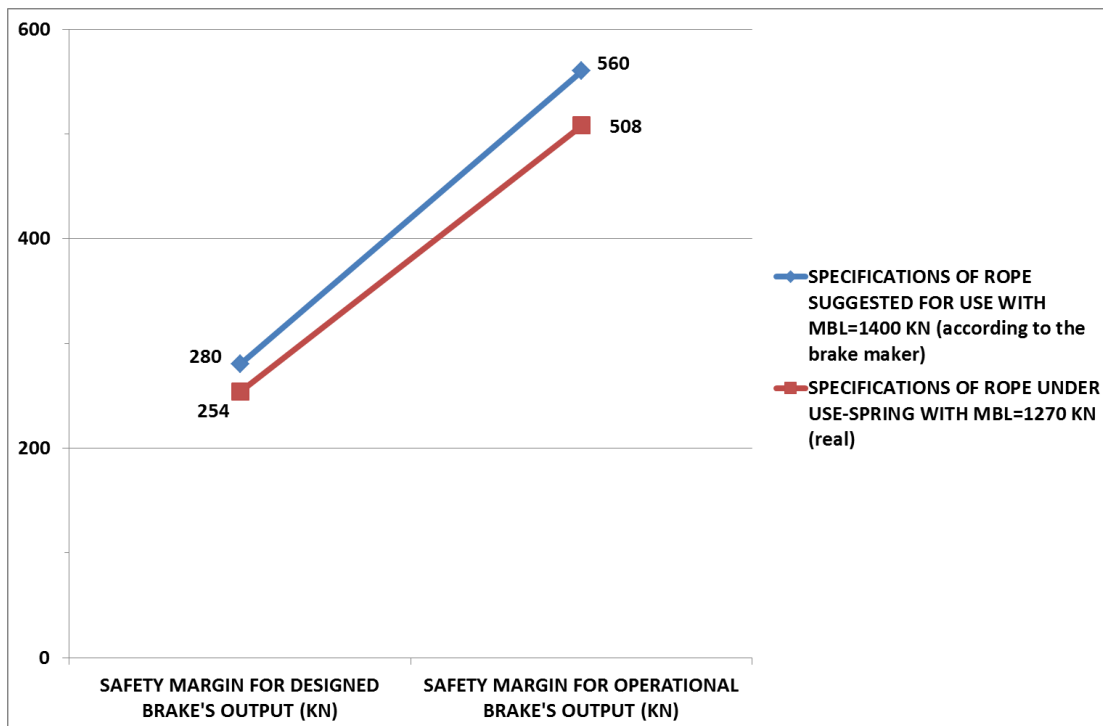
Consequently the range of the above mentioned safety margin for the overloading of the line was reduced from 560kN to 508kN. Inductively, the width of the resultant safety factor range according to the designed band brake holding capacity was reduced too, as indicated in the following diagram (figure 22).

*Figure 22. Diagram showing the reduction of the safety levels by using a rope with a MBL smaller than the one provided by the winch manufacturer.*

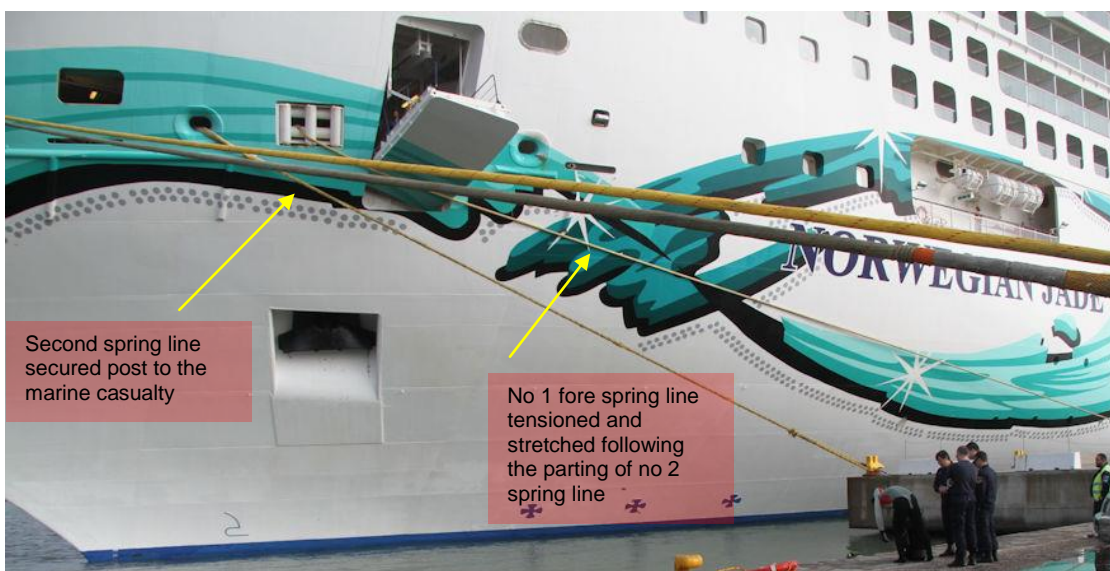
It is to be noted that the forward motion of Norwegian Jade generated, following the failure and parting of no 2 fore spring line was restrained by no 1 spring line, being slacked until that time, as concurrently the aft spring, breast and stern tensioned lines, got slightly slacked as the vessel shifted forward and consequently stopped from acting forces upon no 1 single headspring. A second additional spring line was released and secured post to the occurrence, guided through no 5 panama chock, mounted forwardly of the roller fairlead that serviced the restraint capacity of no 1 fore spring line, as shown below. (figure 25)

Figure 25. Port bow's mooring configuration post to marine casualty

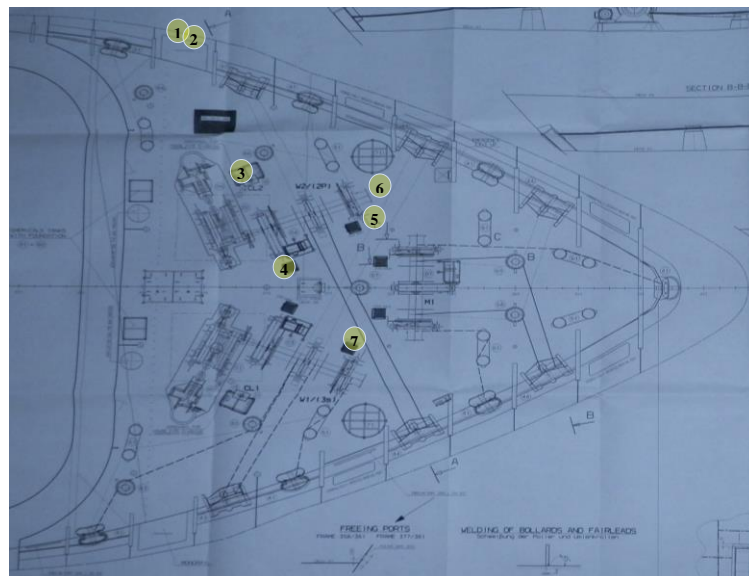
Based on the above it follows that the lack of informing mooring dock personnel for ship's warping operation could have caused injuries to a mooring gang member.

**Figure 28:** The fore mooring deck of Norwegian Jade with the positions of the crew at the time of the marine accident

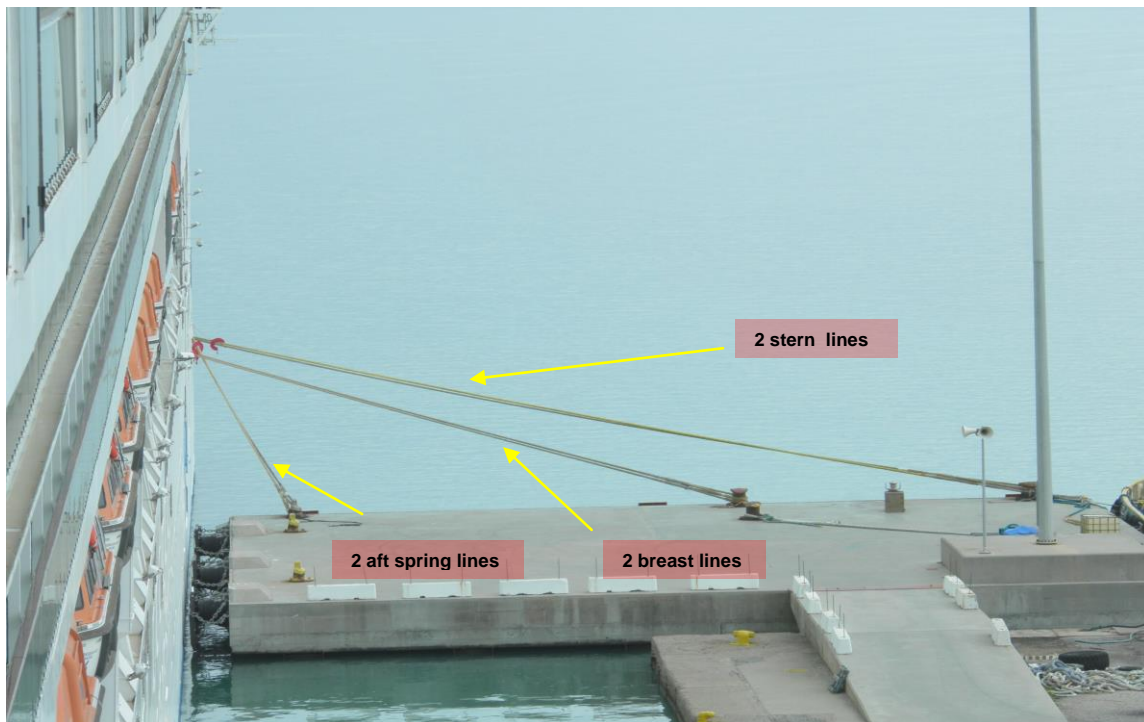
Bearing in mind that at the time no 2 fore spring parted, the release of its tension allowed Norwegian Jade to move forward, it is highly possible that the retraction of aft spring and breast lines as well as stern lines, secured on the winches caused the development of overloaded tension to the foreward spring line which led to its rupture.

Figure 29. Aft mooring lines configuration. Breast and stern lines forwardly oriented.
