HELLENIC BUREAU FOR MARINE CASUALTIES INVESTIGATION

**MARINE CASUALTY SAFETY INVESTIGATION REPORT
12/2013**

**Foundering of General Cargo Nour M
In the port of Rhodes Island - Greece**

October 2016

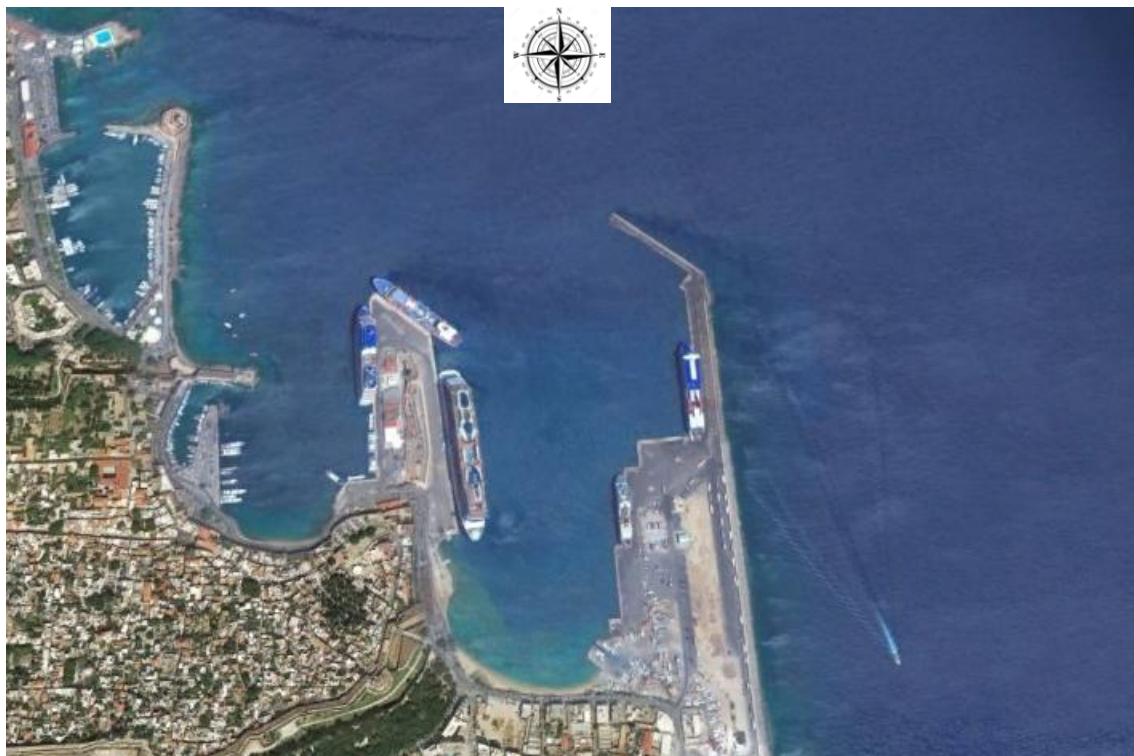
The port of Rhodes (figure 6) due to its topography and its entrance open to North directed winds (figure 7) is affected as the wind force of open sea is hitting the port, while depending on its direction the encountering waves in the port may be significant high affecting moored vessels safe berth.

Figure 7. The port of Rhodes topography, opened to Northerly winds (source google earth).

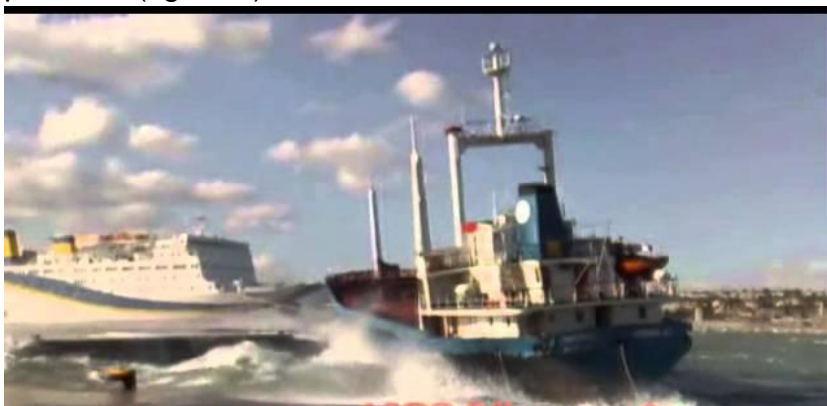
At approximately 1000, NOUR M while under strong drift by the prevailing weather conditions in the port, impacted on “Dorieas” dock and was hauled alongside with her port side (figure 8).

Figure 8. Nour M by the time her port bow impacted on Dorieas dock. ROPAX Prevelis seen berthed at the next docking arrangement (source local press).

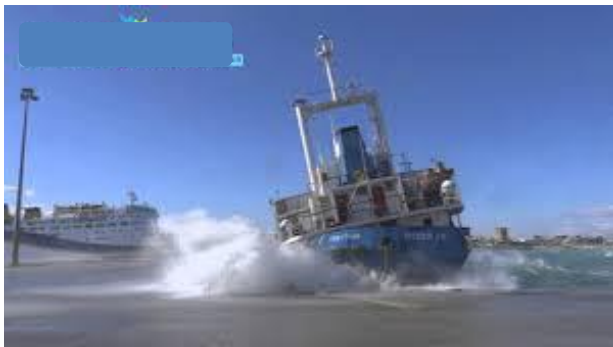
NOUR M under excessive rolling started heavily impacting on the dock with her port aft section as well as with her port side. Due to the continuous slamming on the dock, cracks and deformations were caused on her aft quarter shell plating.

Figure 9. Nour M hitting on the dock (Source local press).

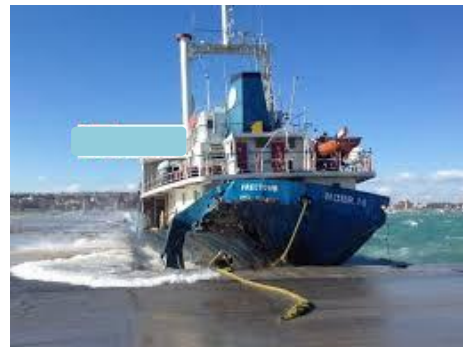
Figure 10. Nour M hitting on the dock under heavy rolling (source local press)

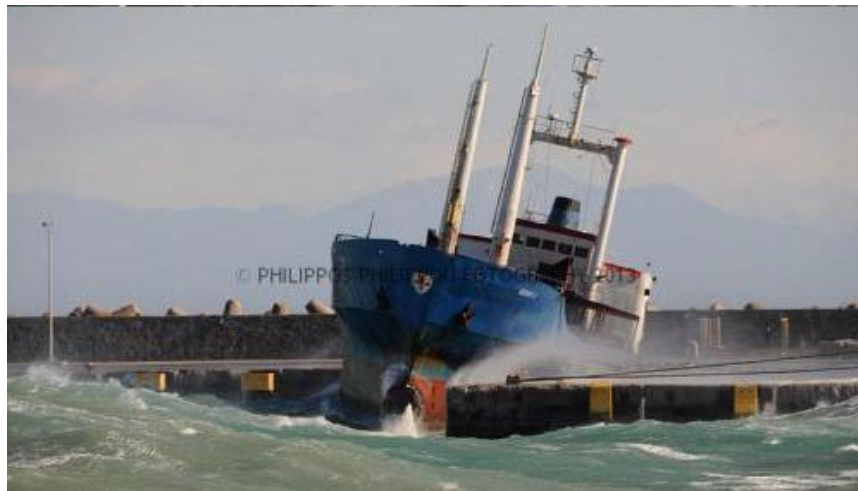
Figure 11. Nour M hitting on the dock under heavy rolling (source local press).

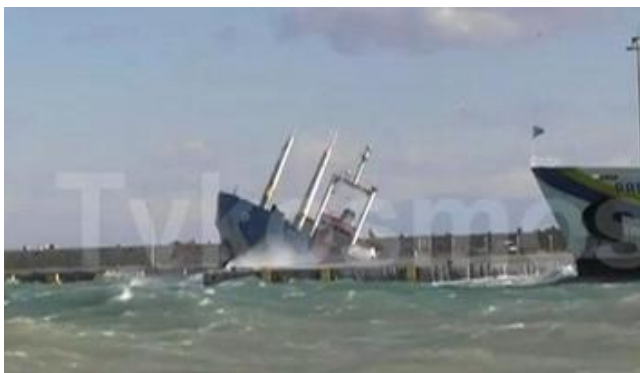
NOUR M continued hitting the dock under heavy rolling and eventually started listing to port due to water ingressing into her engine room through the extended cracks below and over the waterline as well as through cargo holds (figures 9, 10, 11, 12 & 13).

Figure 12. Nour M eventually listing to port (source local press).

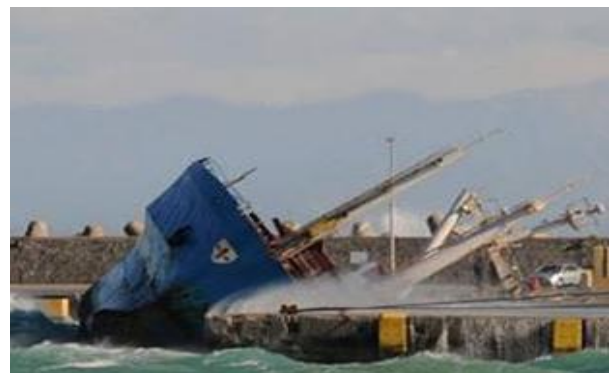
Figure 13. Nour M has listed to port (source local press).

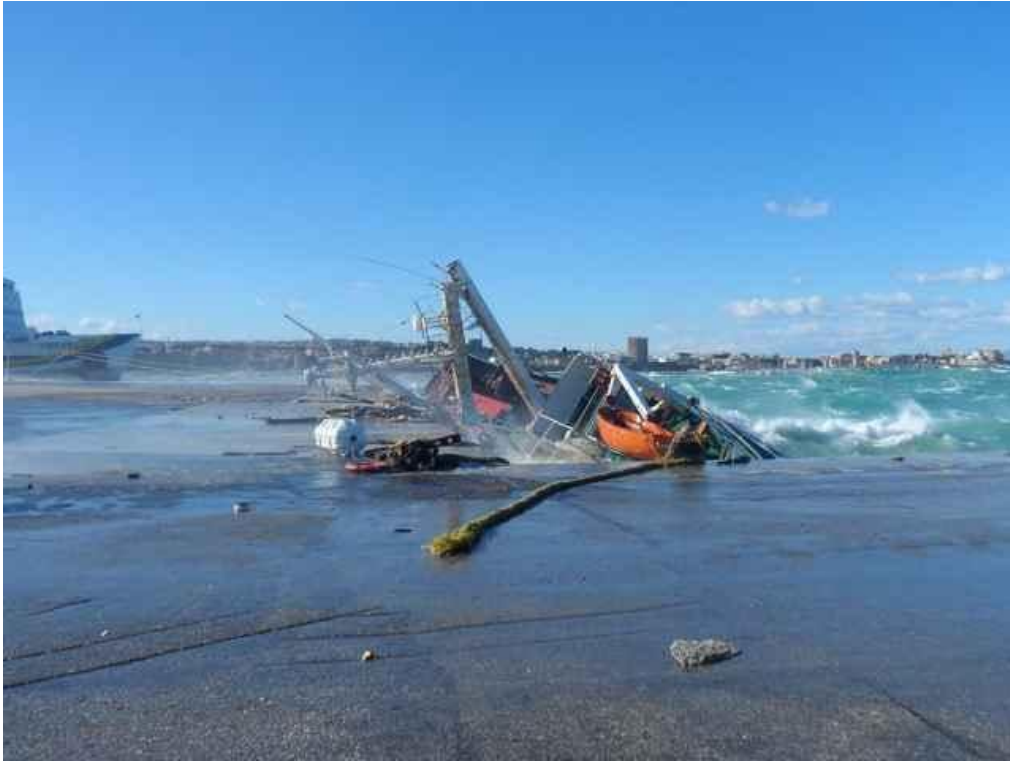
At approximately 1230, she was finally sunk at “Dorieas” dock wall at a depth of approximately 7 meters (figure 14).

Figure 14. Nour M sinking (source local press).

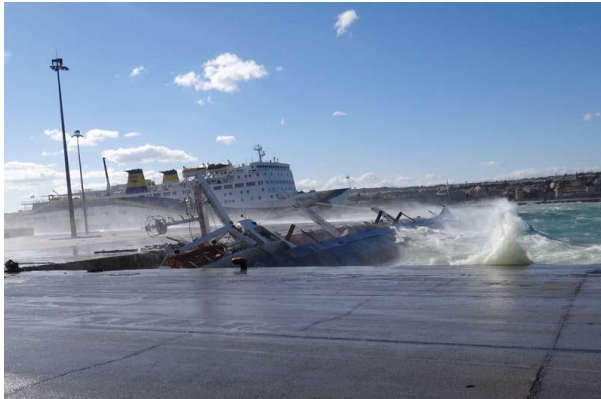
Figure 15. Nour M sinking (source local press).

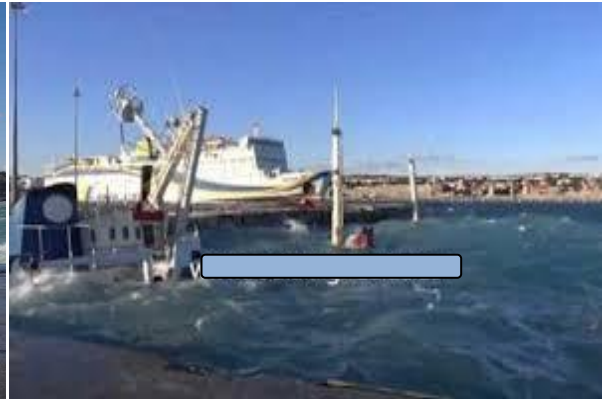
Figure 16. Nour M sank at “Dorieas” dock wall (source local press).
