HELLENIC BUREAU FOR MARINE CASUALTIES INVESTIGATION

**MARINE CASUALTY SAFETY INVESTIGATION REPORT
13/2013**

**Grounding and foundering of General Cargo Stella
18 nm W of Karpathos Island - Greece**

November 2016

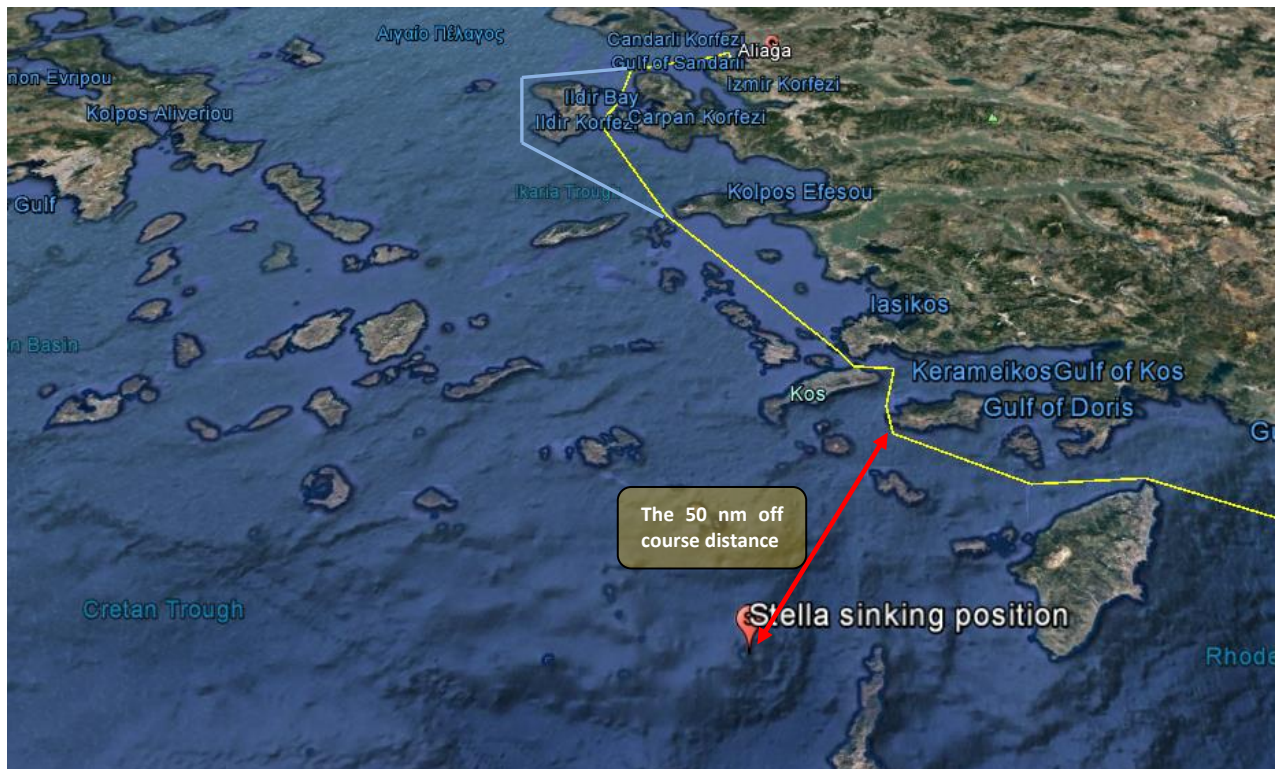
A quick check on the drafted courses that had to be navigated in relation to Stella sinking position evinces that Stella was navigating more than 50nm southwesterly of the appropriate passage she had to navigate.

More specifically, instead of following courses projected between the Turkish coastline and the Greek Islands as depicted below in figure 4, Stella was evident that on the day of the marine casualty was navigating with southerly course towards the sea area west of Karpathos Island without any apparent reasoning, as it was emerged through the crew interview process.

Figure 4. Stella indicated and appropriate passage planning in yellow line from Aliaga Gulf, Turkey towards Cyprus. The blue line represents the reported courses that were actually followed. Sinking position also demonstrates the distance off the appropriate passage she had to follow.

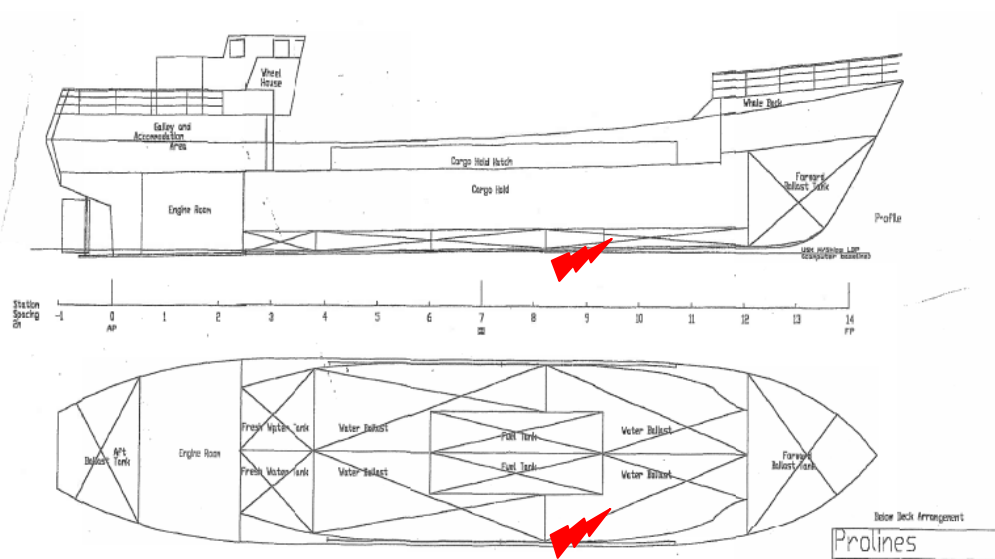
The Chief Mate rushed his way on deck and reported that a crack was spotted on the bottom of the cargo hold starboard section of approximately 1 m of length.

More specifically, it was observed that the bottom was holed and the double bottom tanks were penetrated causing a crack to the cargo hold plating as indicatively shown in following figure 5 & 6.

Figure 5. Stella drawing indicatively showing the damaged bottom section as reported

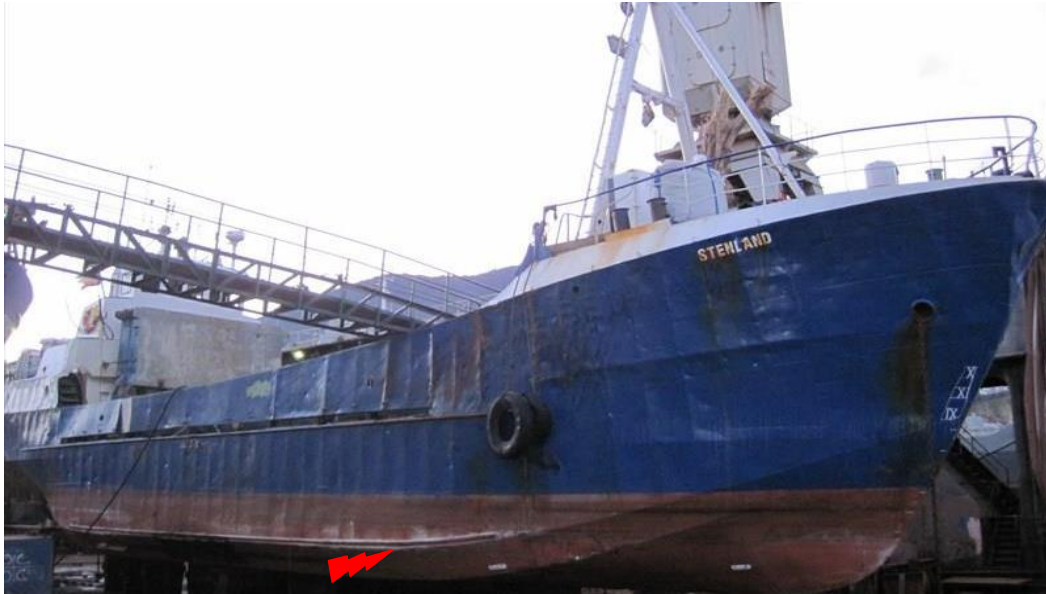
Figure 6. Stella in dry dock, located in the Adriatic Sea. The starboard bottom section that was reported to have been damaged and holed (photo source marine traffic taken on 08-03-2012).
