**HELLENIC REPUBLIC
HELLENIC BUREAU FOR MARINE CASUALTIES INVESTIGATION**

**MARINE CASUALTY SAFETY INVESTIGATION REPORT
14/2013**

**Death of 3rd Engineer of
M/V CAPTAIN PETROS H.**

July 2017

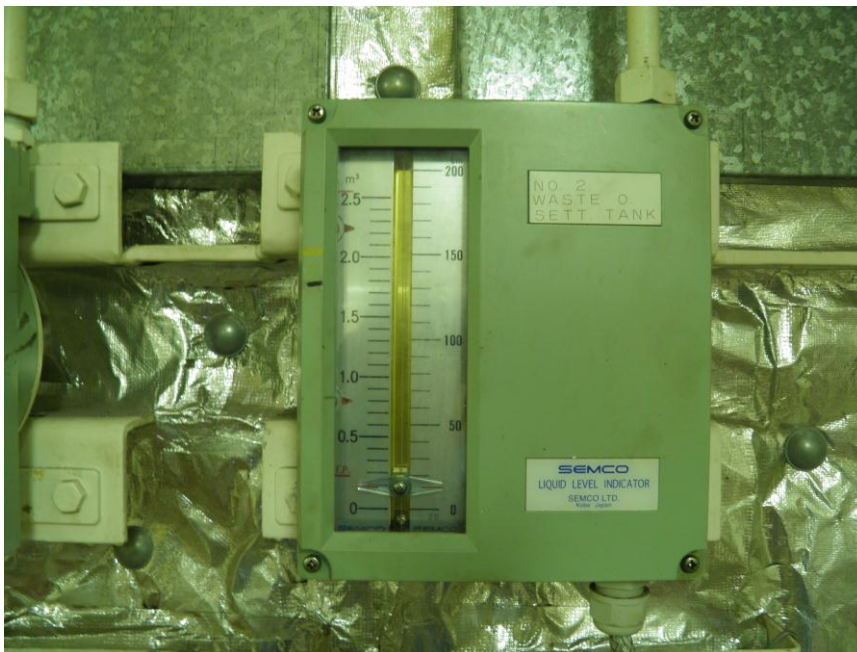
However after the transfer it was observed that the local level gauge of the No 2 W.O.S. tank was not indicating the correct quantity. The 2nd Engineer confirmed the transferred

quantity by sounding the B.S.O. tank and it was concluded that the level gauge was not working properly.

Figure 3: The level gauge of No 2 Waste Oil Settling tank.

On the above grounds it derives that the jamming of the level gauge float and the clogging of the drain valves was caused by the accumulated oil sludge mud to the bottom of the No 2 W.O.S. tank.

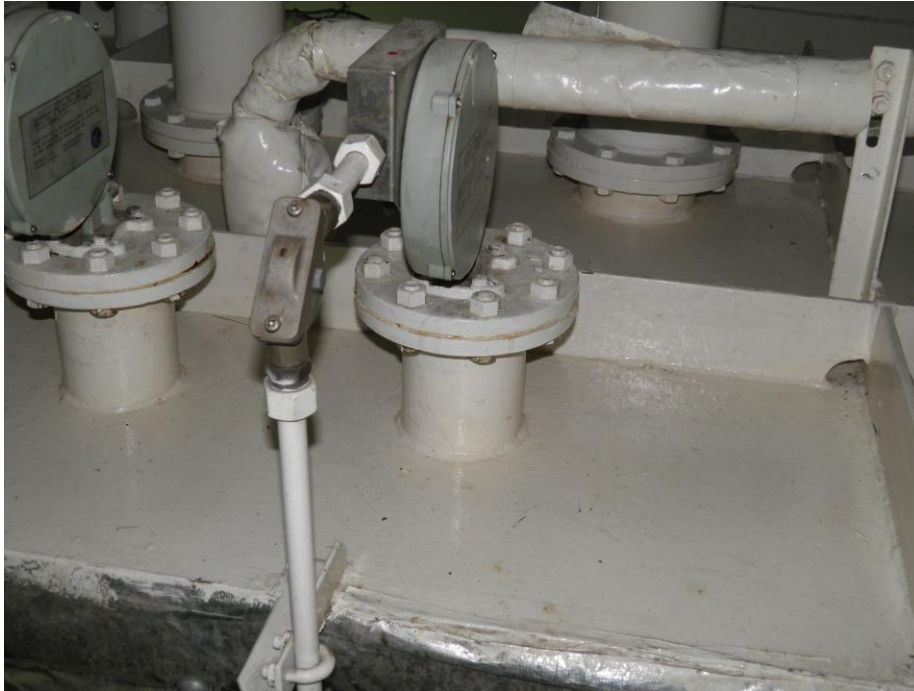
It was reported that when they got at the tank the 3rd Engineer climbed on the top of the tank to check manually the mechanism of the level gauge and reported to the 2nd

Engineer that it was working. The exact indication of the level gauge at that time could not be established however it was reported to be more than 300 ltrs.

Figure 4: The mechanism of the level gauge on top of No 2 Waste Oil Settling tank.

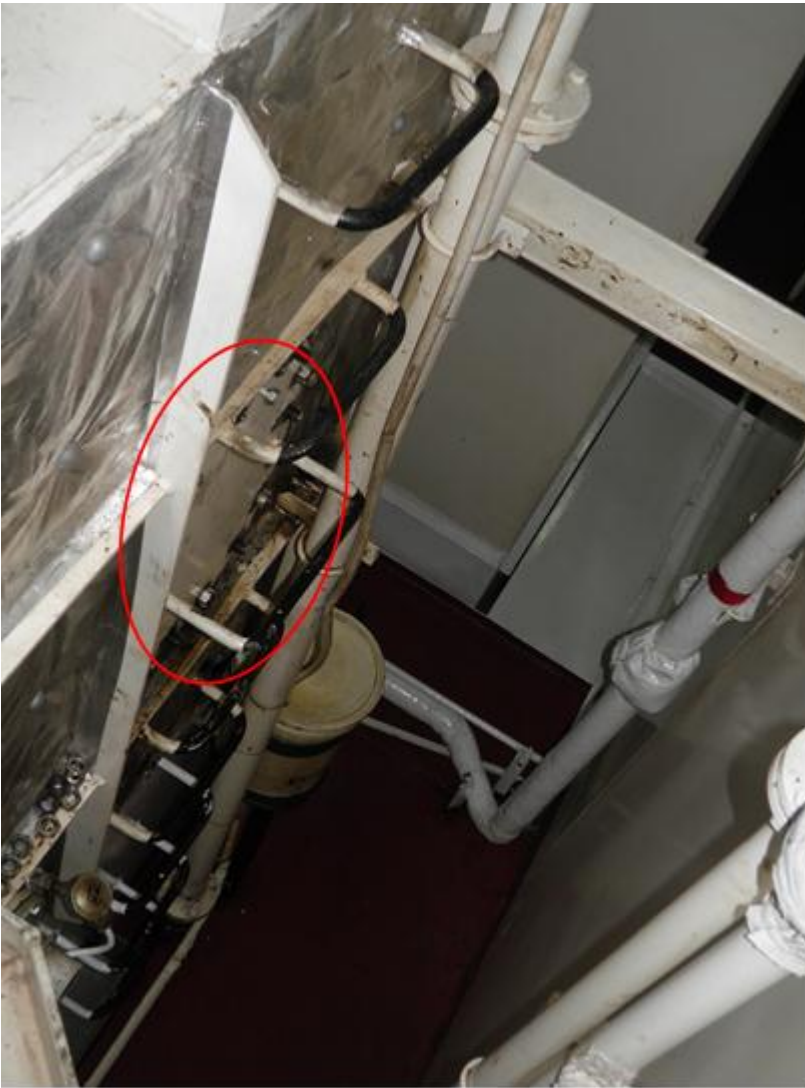
The manhole was situated almost two meters higher from the floor on the aft side of the tank which was close to a bulkhead. The distance of the tank from the bulkhead was approximately one meter. The 3rd Engineer used a small aluminum folding ladder to reach to the manhole height and started loosening the manhole cover nuts using an air impact wrench.

Figure 5: The manhole at the aft side of the tank almost one meter from the bulkhead and two meters from the floor.

The 3rd Engineer removed most of the nuts of the manhole and left four of them. He then loosened the four nuts by half turn. As the 3rd Engineer didn't observe any oil leakage from the manhole's seat he started loosening the nuts more rounds. Then, without removing the nuts he pulled the manhole cover which detached from the tank and hot oil started splashing from the manhole's bottom side onto the 3rd Engineer who was standing on the folding ladder.

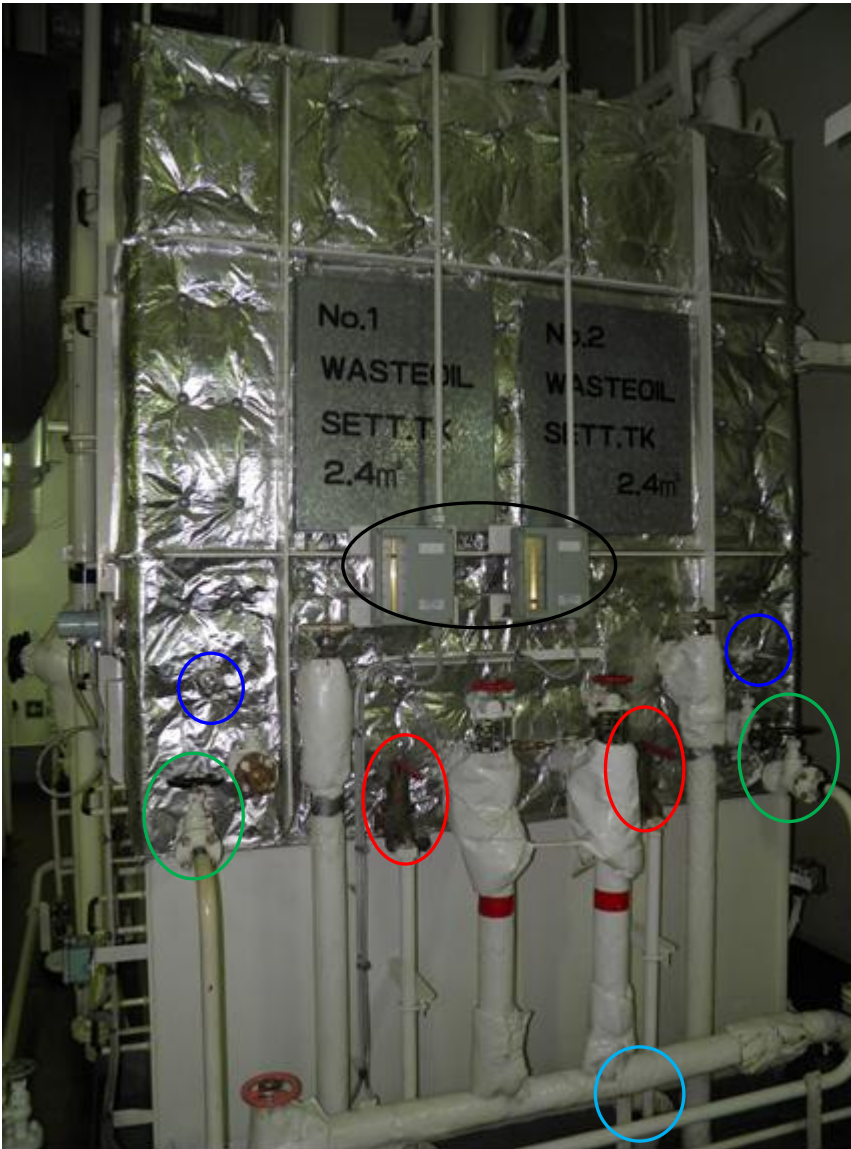
Each tank was fitted with a floating type level gauge, a thermometer and a manhole the center of which was approximately 2m above the floor. In addition they were fitted with a drain pipe that was draining the tank to the Bilge Separator Oil Tank through a manually operated valve as well as with a self-closing valve for draining the water quantities that accumulated at the tank lower levels. The piping of the self-closing valves was leading to an open scupper fitted at the tank floor for the visual check of the water drainage (Figures 6,7).

It is noted that the level gauge was the only available means for perceiving the remaining quantity in the tanks as they were not fitted with sounding pipes at the top of the tanks.

Figure 6: Depiction of the two Waste Oil Settling Tanks.

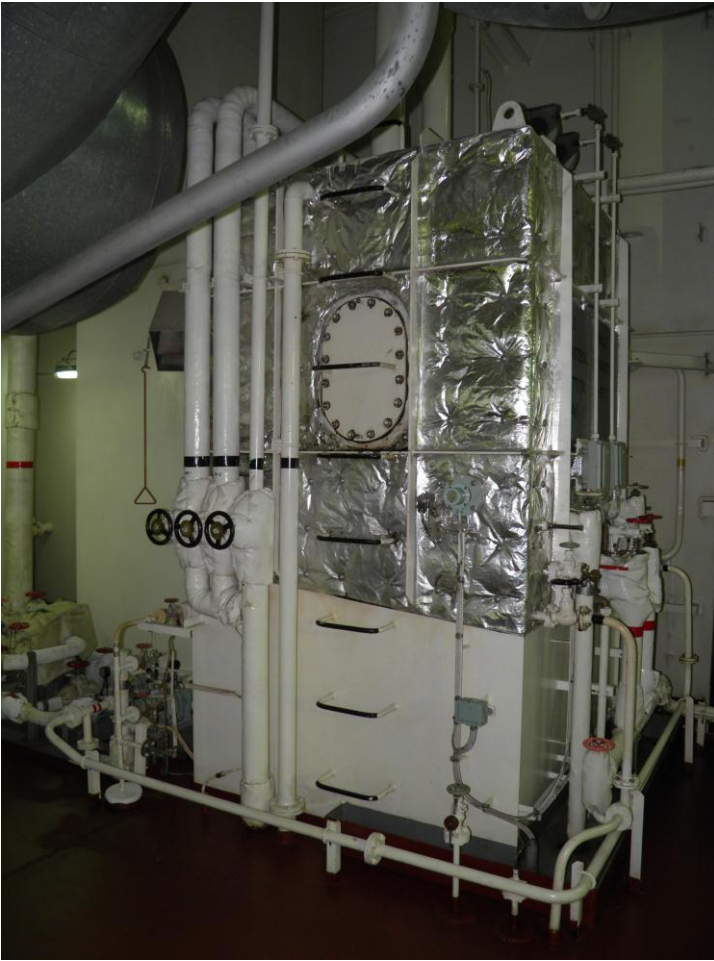
Figure 7: The manhole of No 1 W.O.S. Tank fitted at the fore side of the tank.

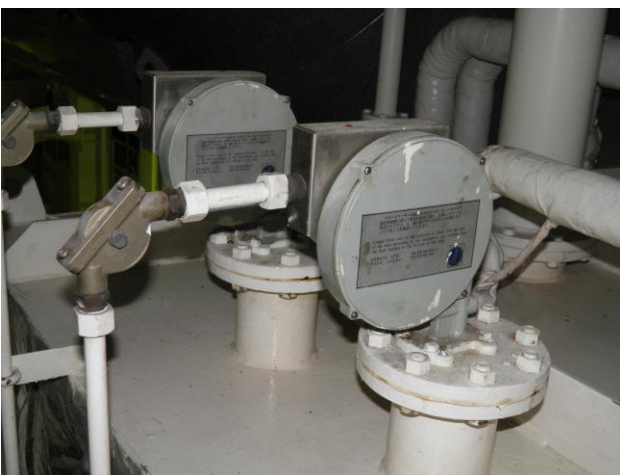
The level gauge system of the Waste Oil Settling Tanks was float type, operating with a floating device on the liquid surface. The float was fitted inside a guide pipe and it was connected to the level indicator by wire which was passing through an intermediate device for the scale reduction. The lower part of the float guide pipe was almost at the bottom of the tank.

Figure 8: The device for the wire scale reduction fitted on top of the tank.

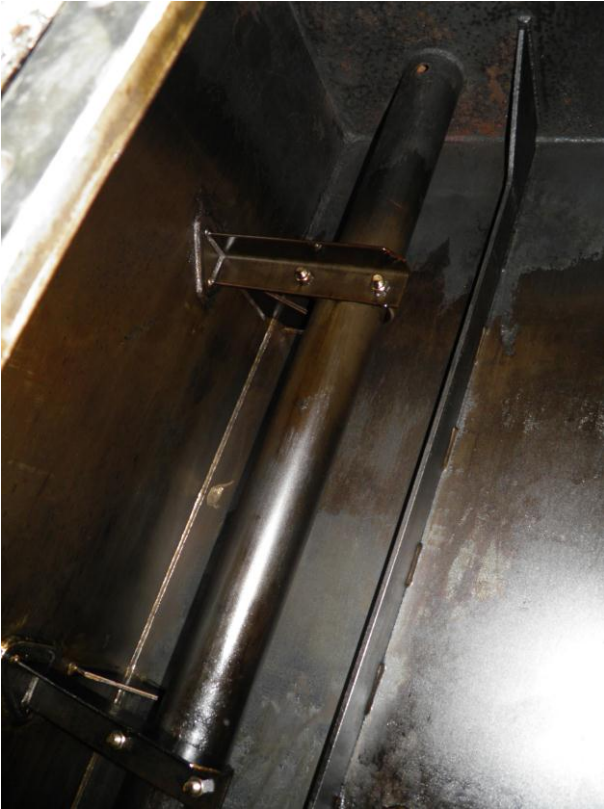
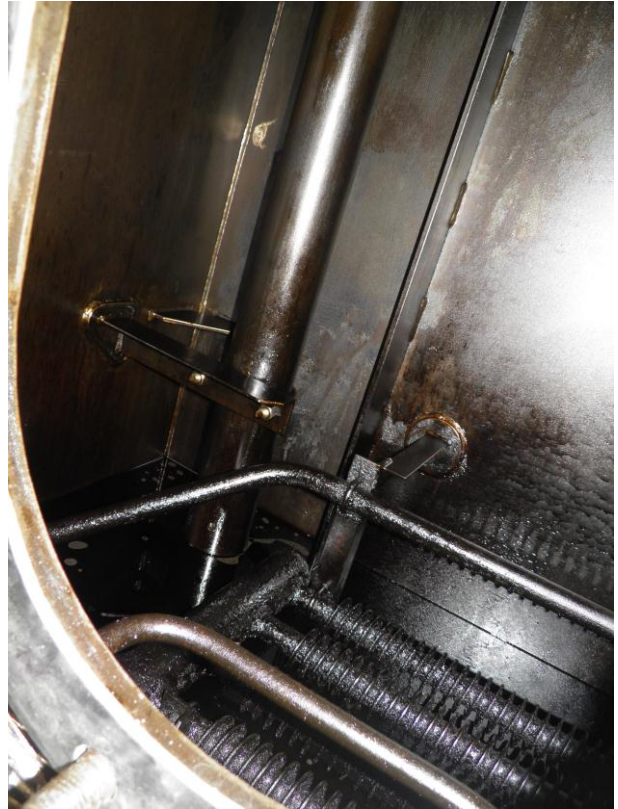
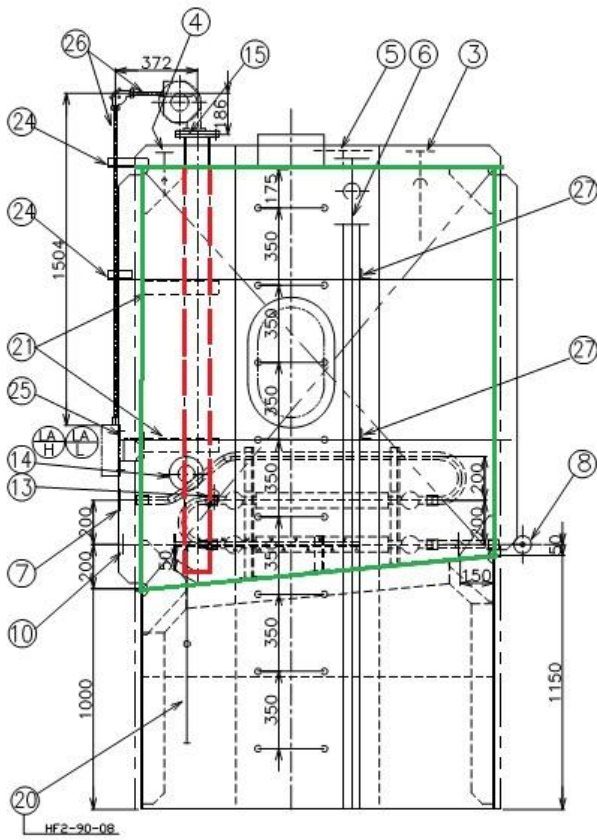
Figure 9: Drawing and photos of the float guide pipe fitted inside the tank.

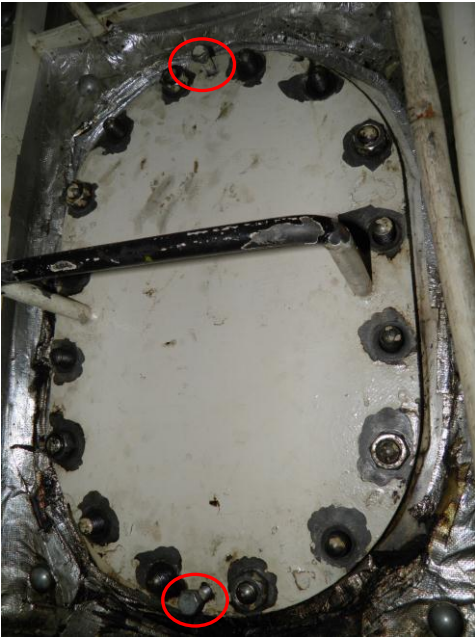
Considering the above in conjunction to the massive leakage and the splashing of oil onto the 3rd Engineer's body, it derives that the 3rd Engineer did not use the jackscrews to detach the cover from the manhole seat while the nuts were loosened by half a round. Instead he loosened the nuts more while the cover was still attached to the manhole seat and when he pulled the manhole cover the oil started splashing heavily from the bottom side of the manhole.

It is suggested that the false perception of the two Engineers that the tank had been drained and it was empty had contributed to the decision to skip the necessary step for the safe opening of the manhole, by using the jackscrews while four crosswise nuts were slightly loosened.

Figure 10: The manhole cover of No 2 Waste Oil Settling Tank and the two jackscrews fitted on the top and bottom side.

- remove all nuts except four crosswise (top-bottom, left-right),
- slightly loosen the four nuts not more than half a turn,
- tighten the jackscrews to detach the cover from the manhole seat. If leakage is observed the cover may easily be secured back to the manhole by loosening the jackscrews and tightening the four nuts,
- if no leakage is observed, loosen another half round the four nuts,
- tighten again the jackscrews and
- if no leakage is observed continue to loosen the four nuts and remove the cover.

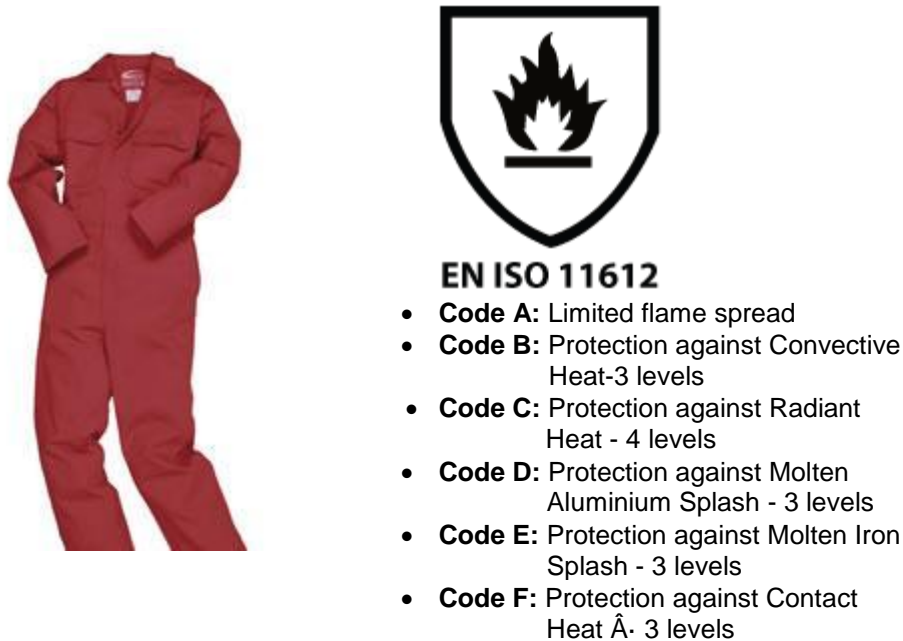
Figure 23: Indicative protective overall against heat and flame ISO 11612:2015 (source web)

In light of the above it is suggested that existing protective clothing do not provide full protection against steam and hot liquid. However the use of a heat/flame protective clothing complying with ISO 11612 could have provided better protection to the 3rd Engineer's body than the common cotton type overall he was wearing at the time of the casualty.

| 84/2013 | Consider providing the crew with heat/flame protective clothing (overalls) complying with the respective standards, for use at works or operations with burn injury hazards. |
