**Marine casualty
Safety Investigation**

Serious marine casualty

August 2019

«ROPAX EL. VENIZELOS»

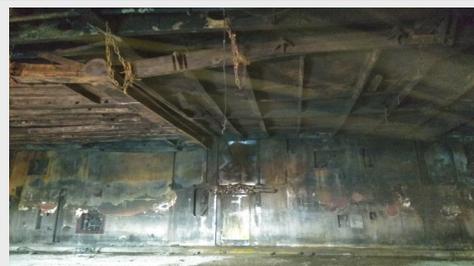
The fire extinguishing operation as well as the trucks removal undertaking from «EL. VENIZELOS» garage spaces lasted for a long time, mainly due to the fact that the extremely high thermal load developed in the main garage area of Deck No.3 (approximately 500°C) created hazardous and extremely fuzzy atmosphere for the fire fighting personnel involved as well as due to the restricted access in the loaded garage spaces. More specifically the trucks and vehicles had been stowed at a close distance between them causing difficulties on firemen access into the garage, while the release of dense smoke due to the various cargo being carried by the trucks (flammable materials, plastics, wood products etc.) that were fuelling the fire, was periodically covering the garage space with heavy smoke that was creating extremely reduced visibility.

An inspection was carried out at the fore port area of garage deck No. 3, where the fire was initially spotted and in particular on the electrical installation and equipment of the vessels that was supplying the refrigerated trucks with electrical power (electrical panels, sockets, electrical fuses) as well as in specific refrigerated trucks located at that area. According to data collected so far, the investigation analyses is focusing on a short-circuit that occurred on a refrigerator truck's cooling equipment, that was in operation during the voyage, as it was supplied with electrical power through the ship's electrical power supply system. Due to the short-circuit and the generated spark the fire broke out and was rapidly expanded to the near by parked refrigerator trucks and general cargo tracks, namely due to the fact that the parking distance between them was limited; the tractors' covers and refrigerator tractors were not fire retardant or resistant; general cargo (wood products, plastic goods, etc.) was fueling the fire.

Image 2: The garage deck No.3 following the fire
