Hellenic Bureau for
Marine Casualties
Investigation

M/T EPHEOS

F/V POLAT BEY 1

Marine Accident Synopsis

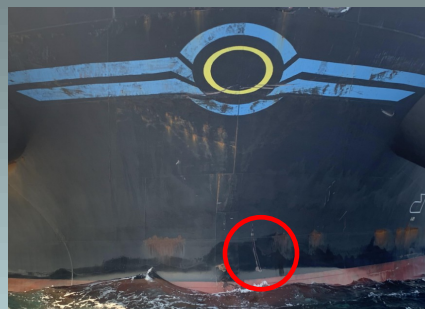
Figure 1: The paint scratches on the stem of EPHESOS

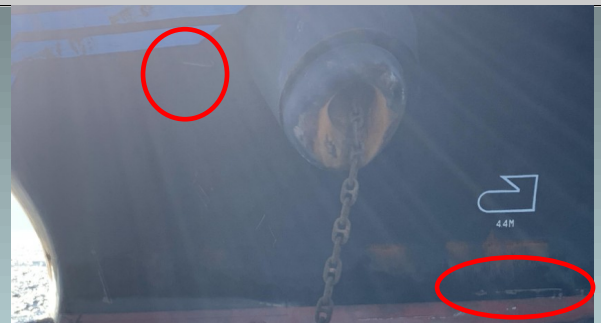
Figure 2: The paint scratches on the port bow of EPHESOS

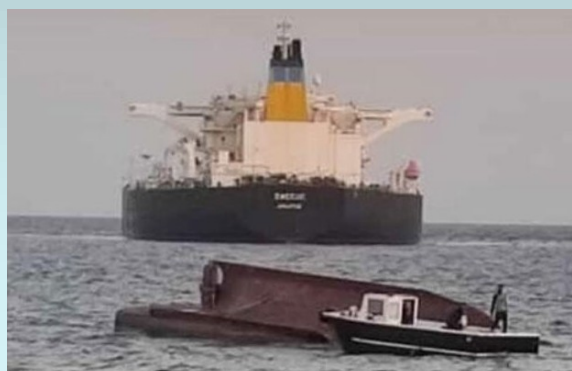
Figure 3: The trawler POLAT BEY 1 capsized after the collision.
