**Marine casualty  
Safety Investigation**

**Very serious marine casualty**

**August 2021**

**«B/C FANEROMENI»**

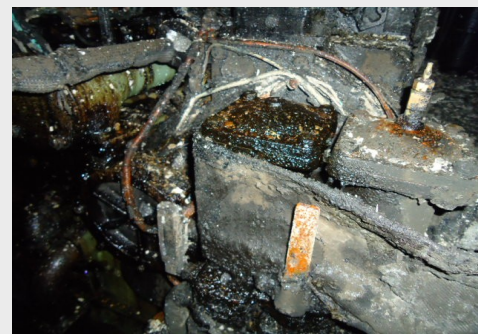
**Origin of the fire:** The safety investigation analysis is focusing on a fuel leakage in No. 3 Auxiliary Diesel Generator, originating from the fuel filter's inlet air vent (Figure 2). It is presumed that due to the leakage diesel fuel was sprayed on the hot surfaces of the generator causing the fire ignition that was spread rapidly to the adjacent area and nearby to components and equipment. The maintenance of the generator's fuel system is under thorough examination to identify the causes of the fuel leakage.

Figure 2: Fuel filters of No.3 Generator
