**HELLENIC REPUBLIC
HELLENIC BUREAU FOR MARINE CASUALTIES INVESTIGATION**

Impact of MSC Magnifica on Piraeus Port entrance breakwater

August 2015

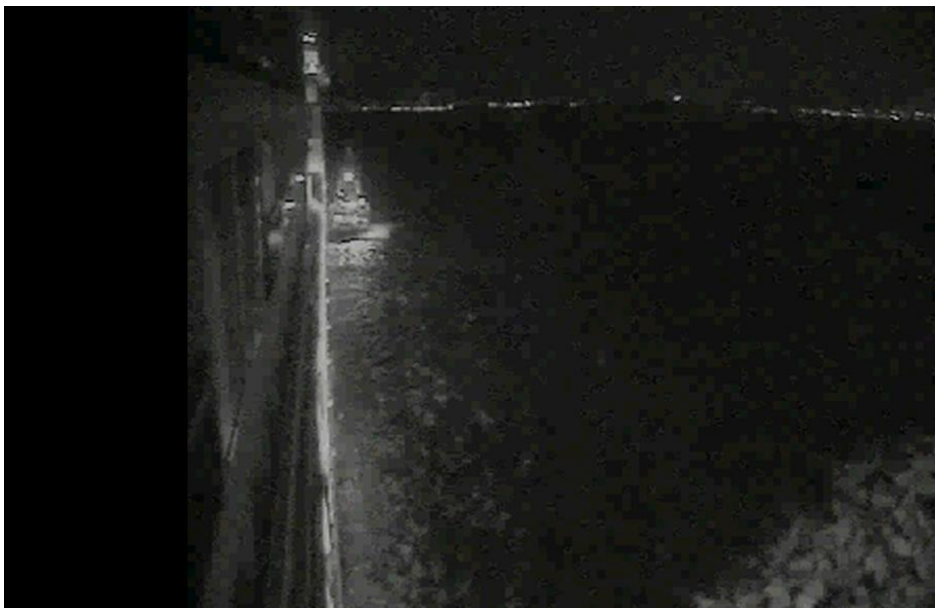
The pilot immediately contacted the Captain of port tug Alexander III and instructed him to proceed to the vessel's port aft quarter in order to push her off the breakwater, if possible. However, although the Captain of Alexander III maneuvered towards the port aft quarter of the cruise ship, it was not feasible to assist her as she was underway exceeding the speed of 5 knots and continuously drifting to port, approaching perilously the port breakwater and the imminent danger of impact was inescapable (figure 21).

Figure 21. MSC Magnifica by the time impacting on the head of the breakwater. Tug Alexander III is shown standing down from the effort to push Magnifica's stern section. Breakwater section appears on the right down part of image view.

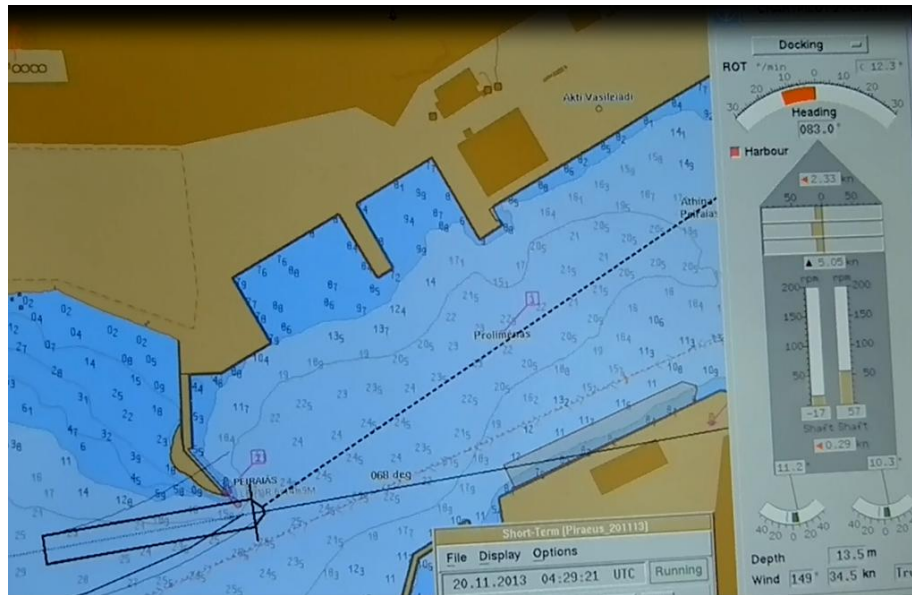
At 06:29:21 the huge cruise ship's port bow impacted the top side structure of breakwater's head. By that time the wind was recorded at 34.5 knots Southeast (figure 22 & table 5 figure e.1).

Figure 22. MSC Magnifica by the time her port bow impacted on the port breakwater head.

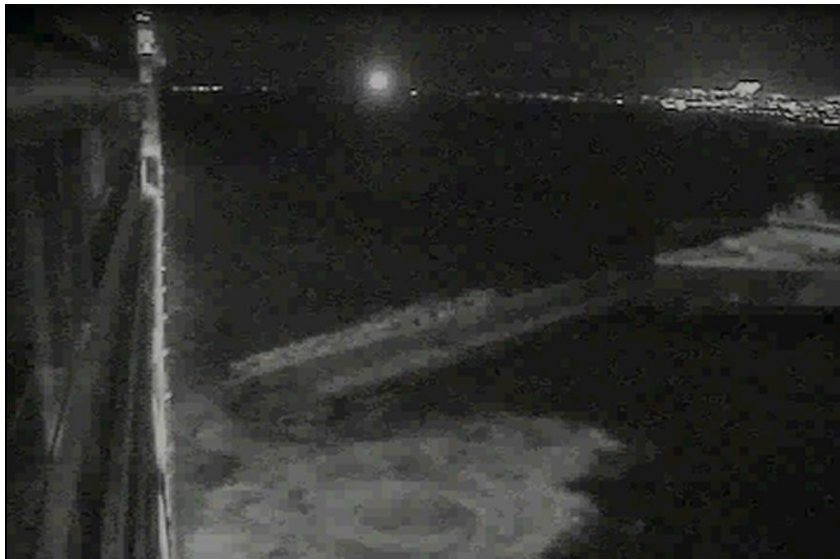
The impact of the 90,000 GT cruise ship with the head of the breakwater forced the concrete round-hut red light to come down that was subsequently detached and collapsed into the sea (figures 23, 24, 25 & 26).

Figure 23. MSC Magnifica by the time her hull substructure was contacting with the port breakwater structure under the sea. The red light has already collapsed into the sea.

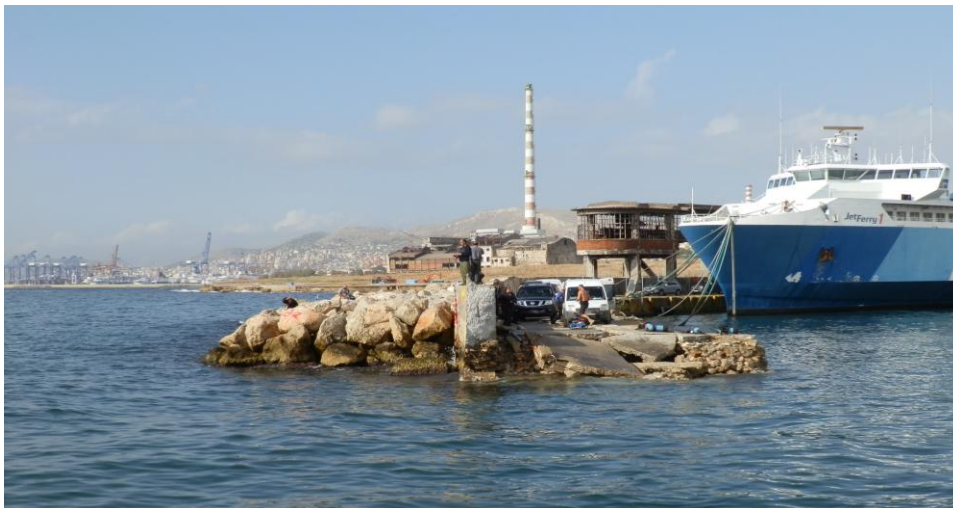
Figure 24. The damaged head of the breakwater. Abeam view.

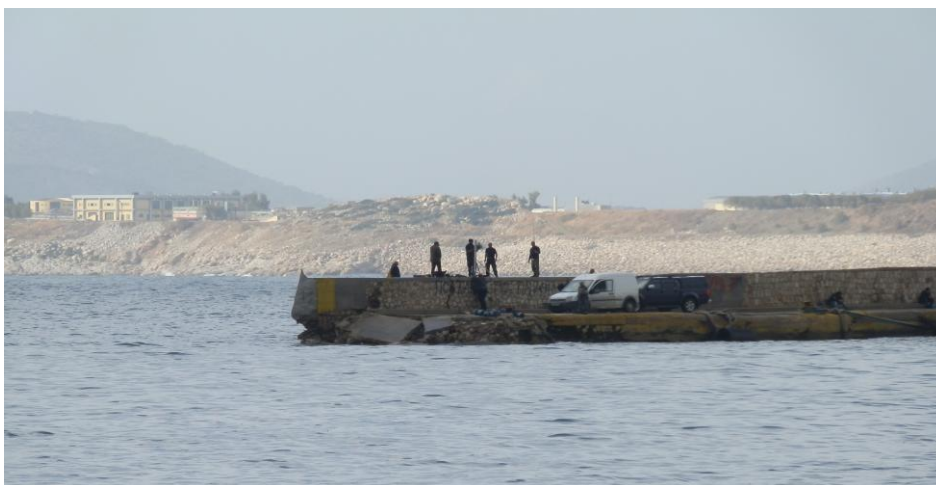
Figure 25. The damaged head of the breakwater. View from Prolimenas section.

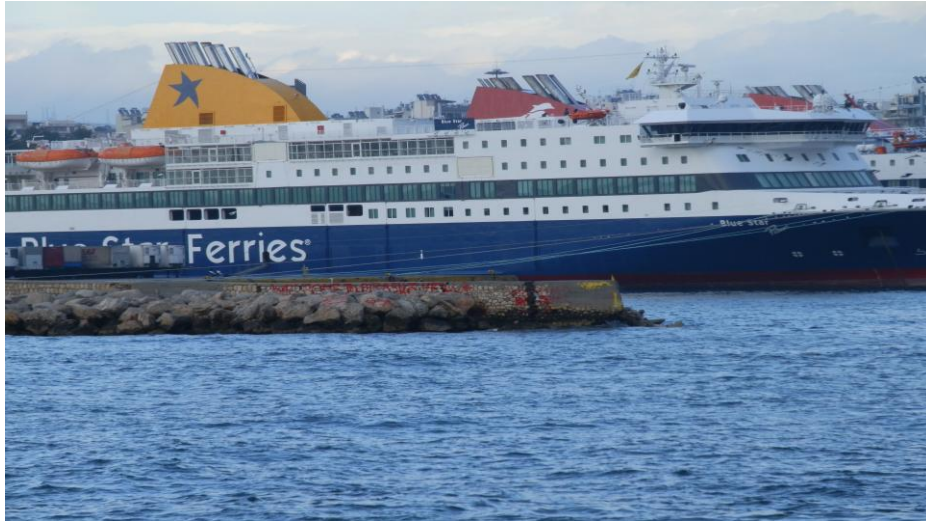
Figure 26. The damaged head of the breakwater. View from outer port section.

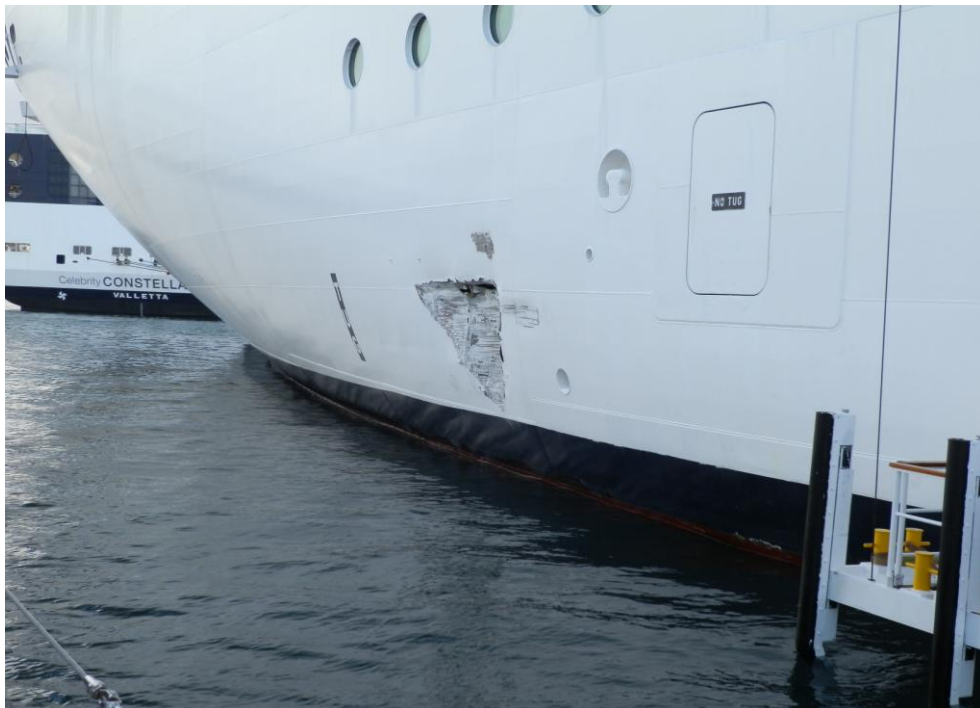
Consequences (to individuals, environment , property)	<ul style="list-style-type: none"> • 1m x 0.40 m crack on port bow section close to 4m over the waterline and deformation on shell plating on port side • 4 m indent at port aft section close to stern post • deformations and scratches on port side hull plating lengthwise under the waterline • No injuries • No pollution
----------------------------------------------------------------	------------------------------------------------------------------------------------------------------------------------------------------------------------------------------------------------------------------------------------------------------------------------------------------------------------------------------------------------------------------------------------

Figure 27. The damaged port bow section of MSC Magnifica.

The required repairs were carried out by an authorized marine repairing contractor. Following the inspection by her class MSC Magnifica departed the port of Piraeus at morning hours on the 21 November 2013.

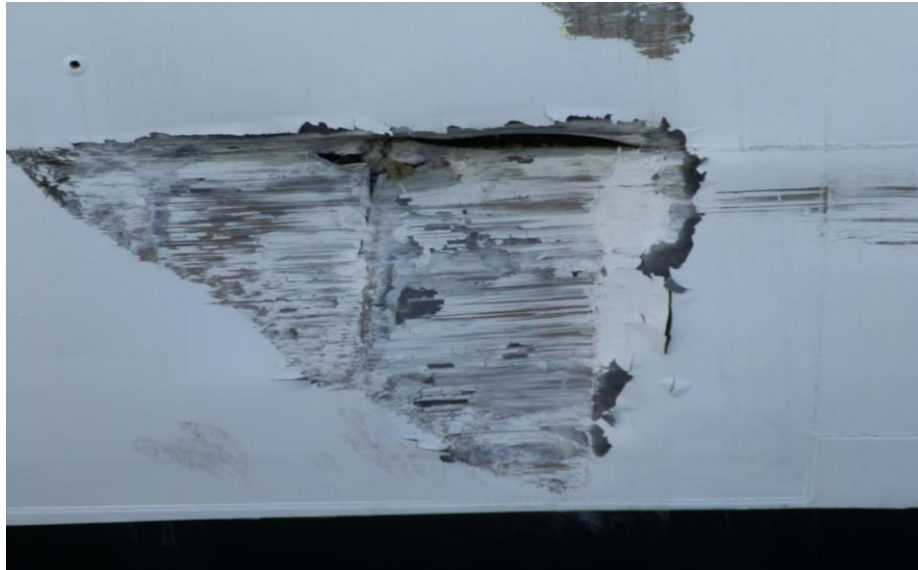
Following an inspection by her Class and Port State Control Officers of Piraeus Coast Guard Authority she was found to have suffered structural damages on her port side and more specifically a crack was reported over the waterline on her port bow while scratches and hull deformations and indents were sustained lengthwise on her port side under her waterline. No water ingress was reported to have occurred.

Figure 28. The sustained deformation and crack to hull caused by the impact on the head of the breakwater

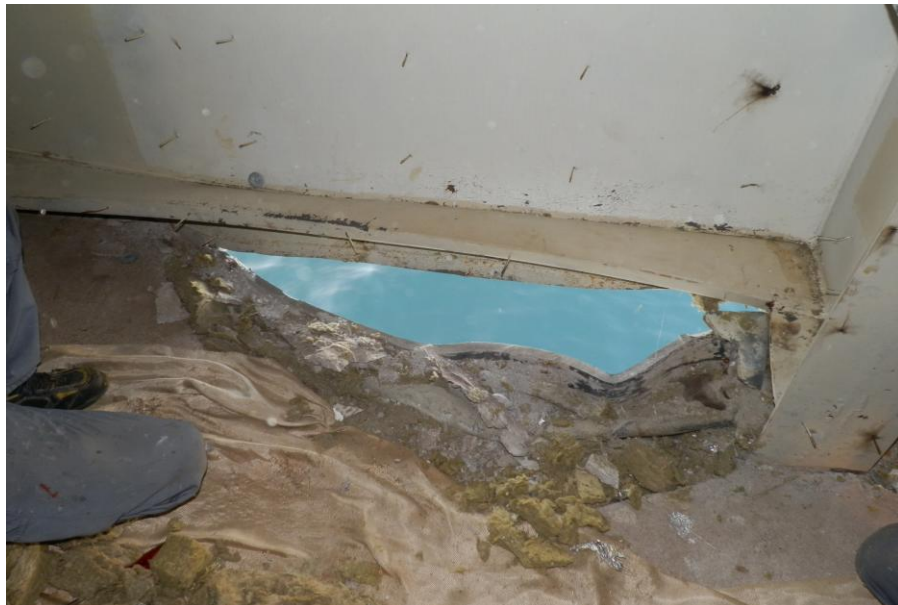
Figure 29. The sustained crack from inner view caused by the impact on the head of the breakwater.

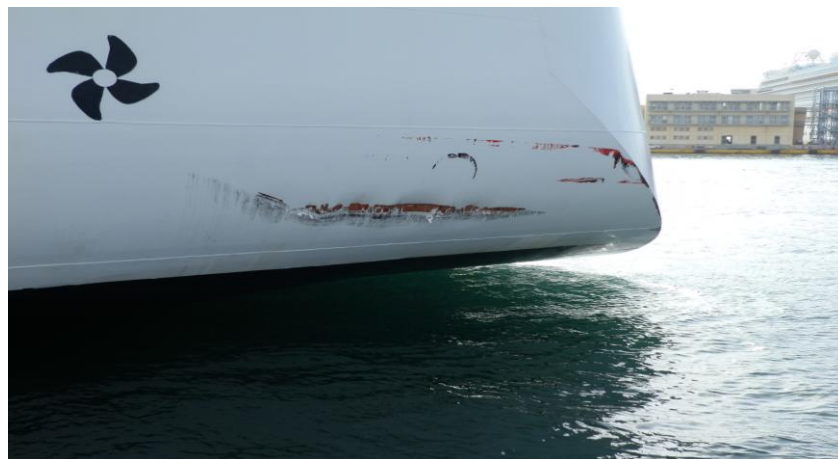
Figure 30. The sustained indent of port stern section caused by Tug Alexander III on the effort to push the stern section.

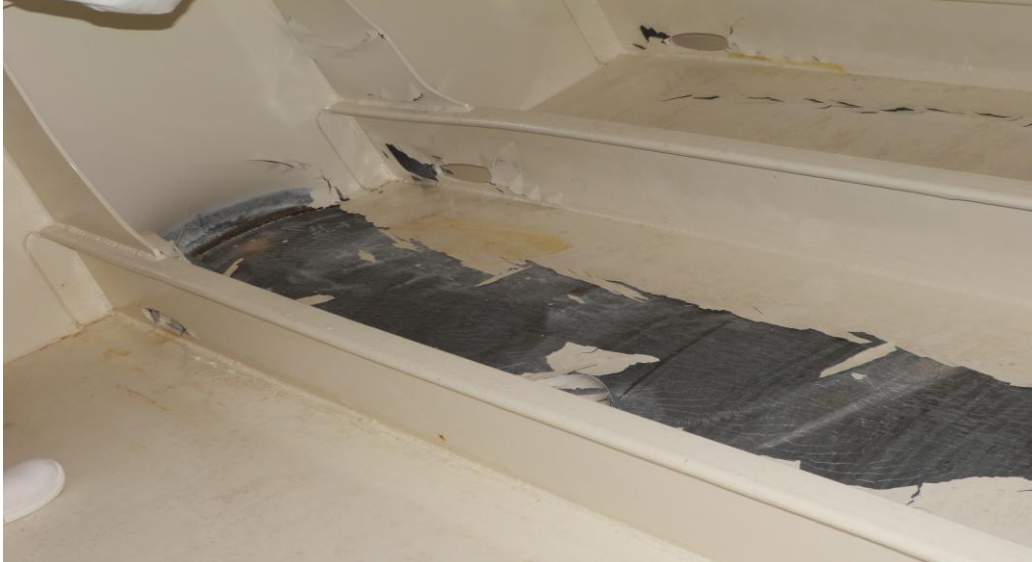
The initial inspection conducted by the crew showed that MSC Magnifica had sustained structural deformations lengthwise of her port hull under the waterline (figures 31, 32) however there was not water ingress. One crack was found at the port bow section almost 4m above waterline due to the impact on the head of the breakwater (figures 27, 28 & 29). An intend was also found at her port aft section, close to the stern post of approximately 1.5m of length due to the contact of the escorting tug (figure 30). No injuries to passengers or to crew were reported.

Figure 31. The deformations sustained on the hull plating under the waterline caused by the contact on the breakwater substructure.

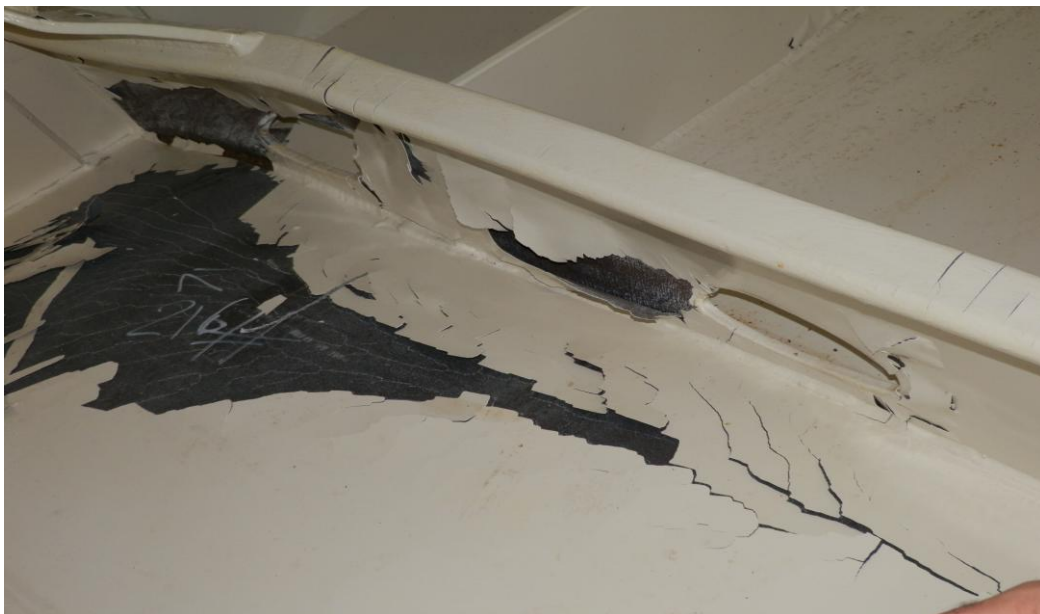
Figure 32. The indents sustained on the hull plating under the waterline caused by the contact on the breakwater substructure.
