**HELLENIC REPUBLIC
HELLENIC BUREAU FOR MARINE CASUALTIES' INVESTIGATION**

**MARINE CASUALTY SAFETY INVESTIGATION REPORT
10/2014**

FIRE ON BOARD RO-PAX IERAPETRA L (29-11-2014)

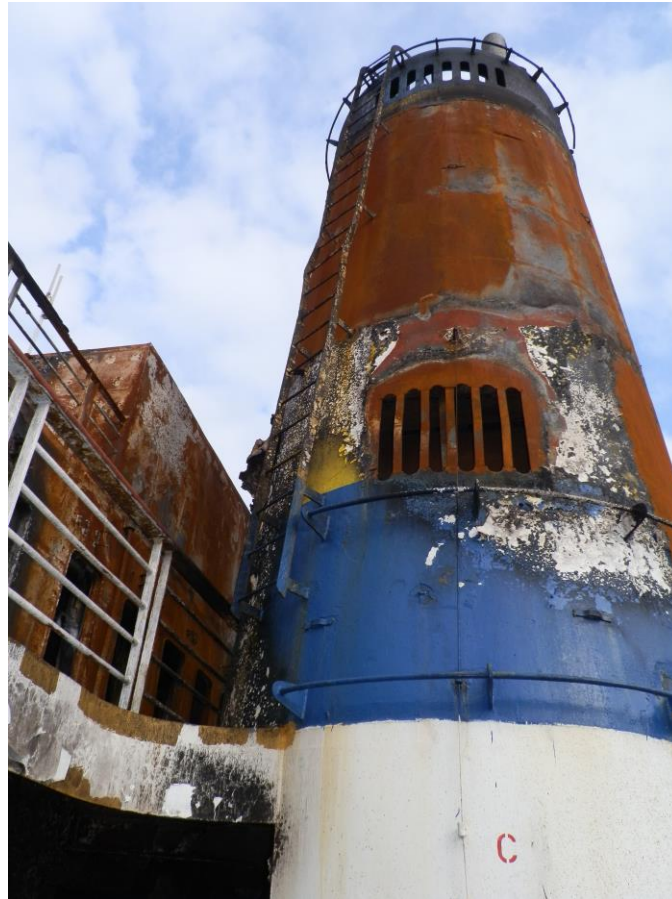
The fire caused extended damages to the inner side of the port side funnel and also to the adjacent accommodation areas on decks No 7 and 8. The engine room was also affected by the oil leakage and mostly by the firefighting materials and residues. No pollution and no injuries were reported.

Figure 4: Capture of the aft side of the port side funnel duct with evident results of the fire

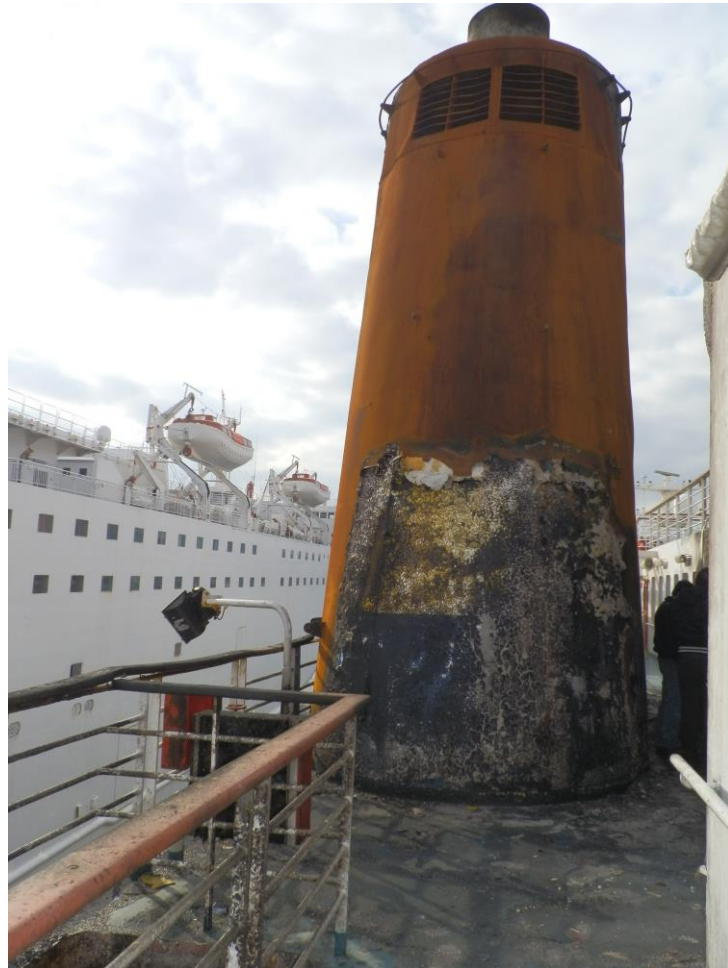
Figure 5: Capture of the fore side of the port funnel duct

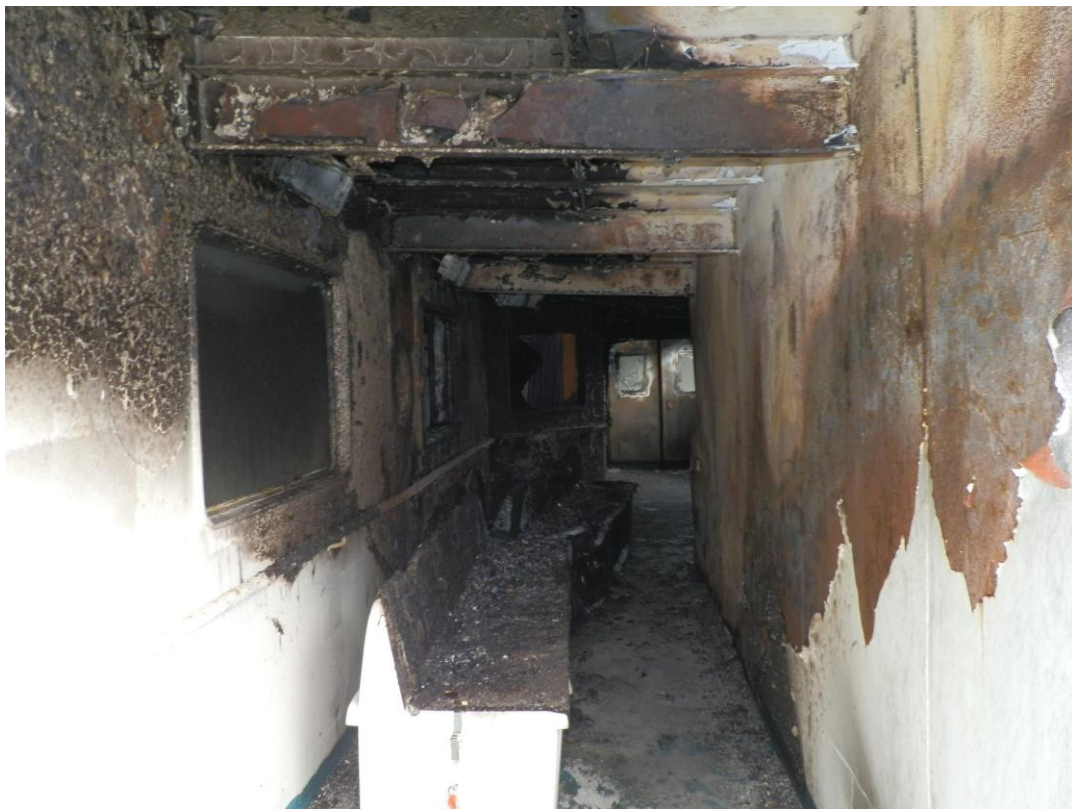
Figure 6: Capture from the external accommodation spaces at the port side of the vessel (deck 8)

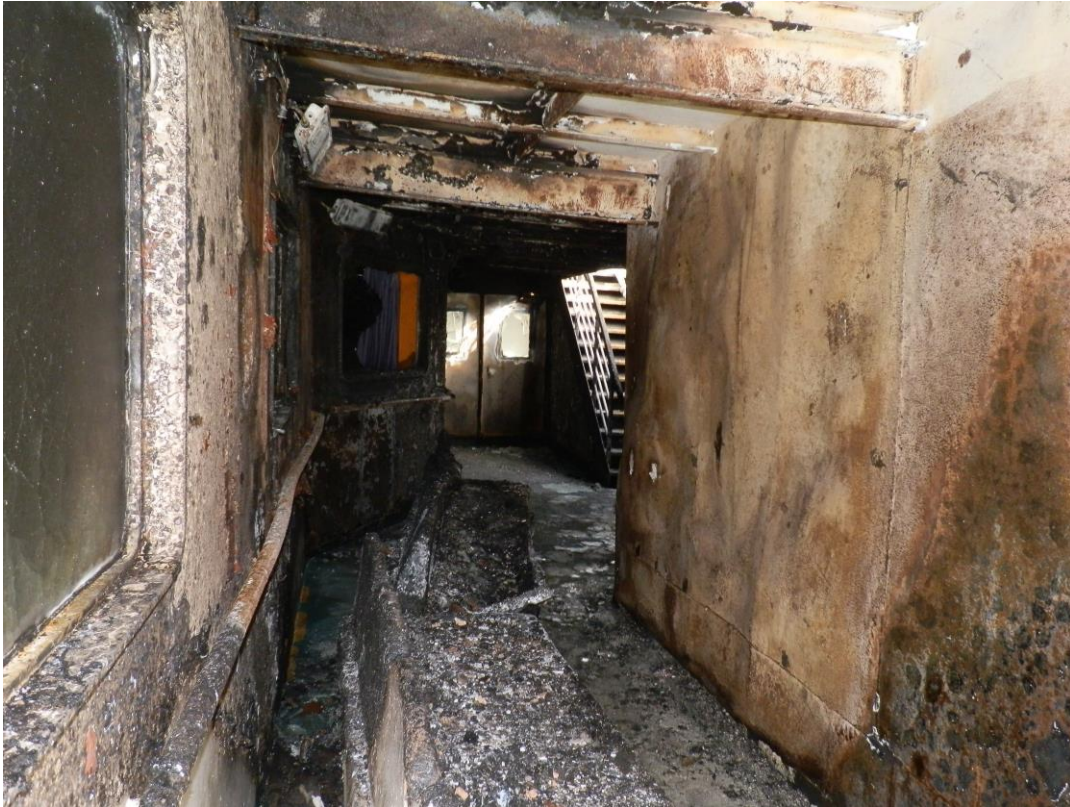
Figure 7: Capture of the external accommodation spaces at the port side of the vessel (deck 7)

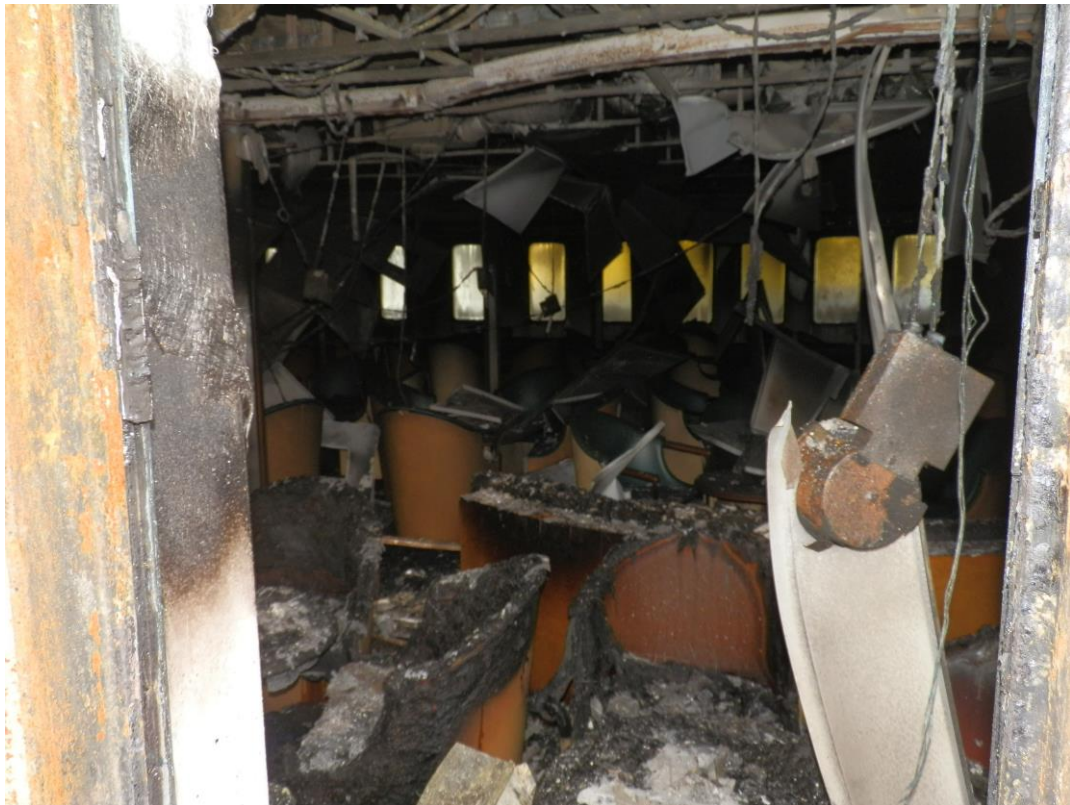
Figure 8: Capture of the port side accommodation lounge (deck 7)

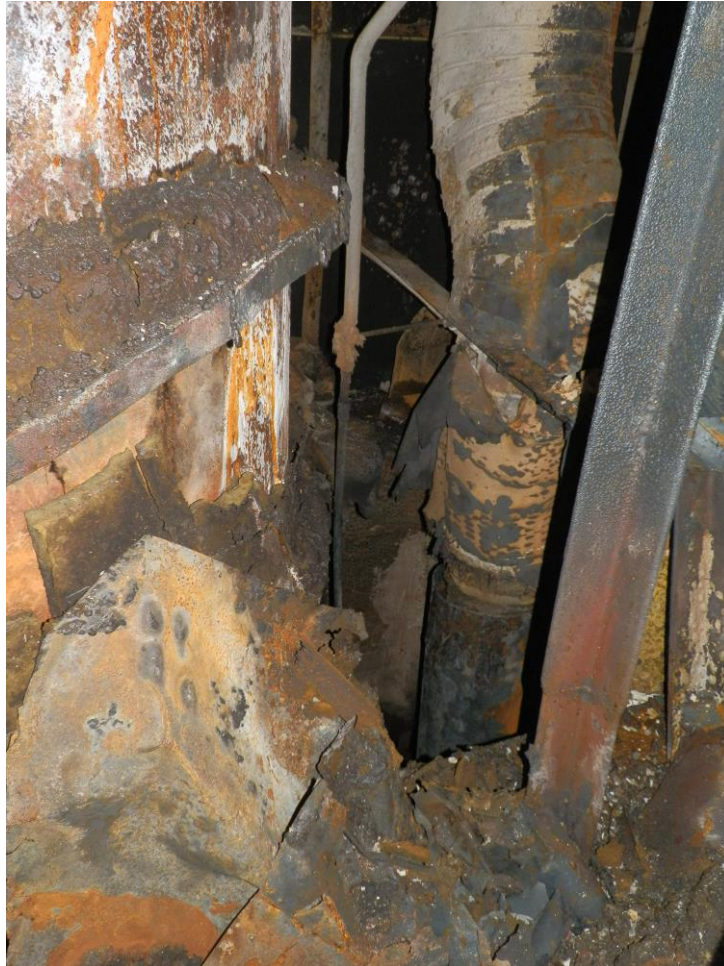
Figure 9: Capture of the inside of the port funnel duct

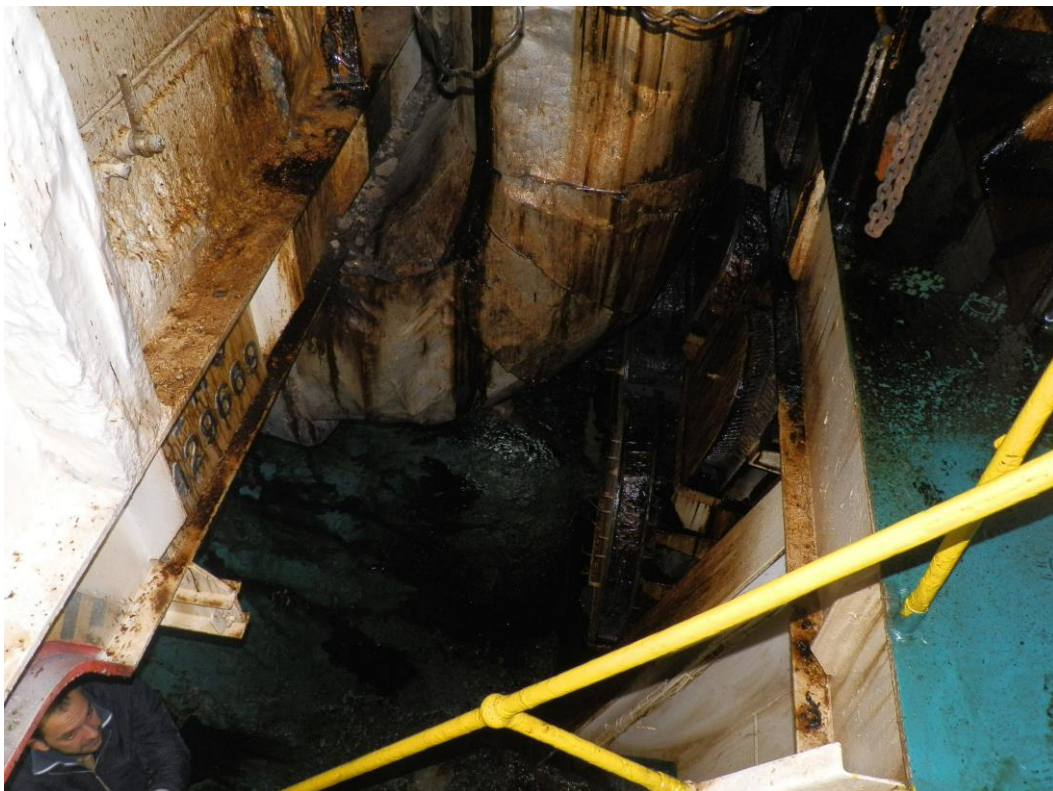
Figure 10: Capture of the floor of the engine room, right below the port funnel, with evident residues from the extinguishing process

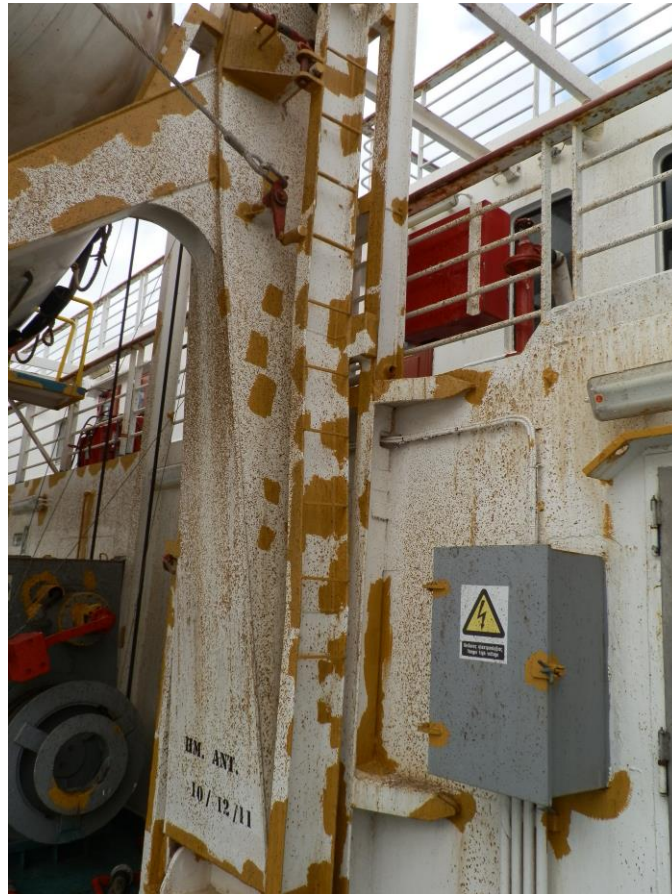
Figure 11: the area around the port funnel. Traces of the oily mixture spray are quite evident on the bulkheads (deck 7, port side)

The investigators took a sample of these oil markings, using wads. The samples were analyzed by the National General Chemical Service and the results, showed that it was Heavy Fuel Oil with water and particles from the wads. The results also noted that this type of oily substance did not contain any used mineral oils (lubricant oils), or other type of oil, such as marine gas oil (used in the vessel's generators).

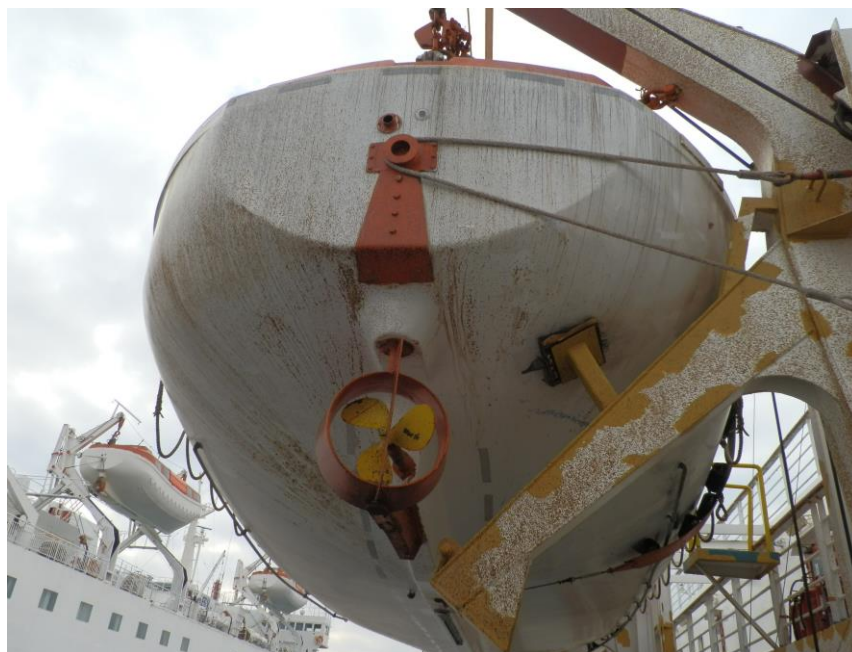
Figure 12: the same spray appears also on the life boat and its crane, which were nearby the port funnel (deck 8 port side)

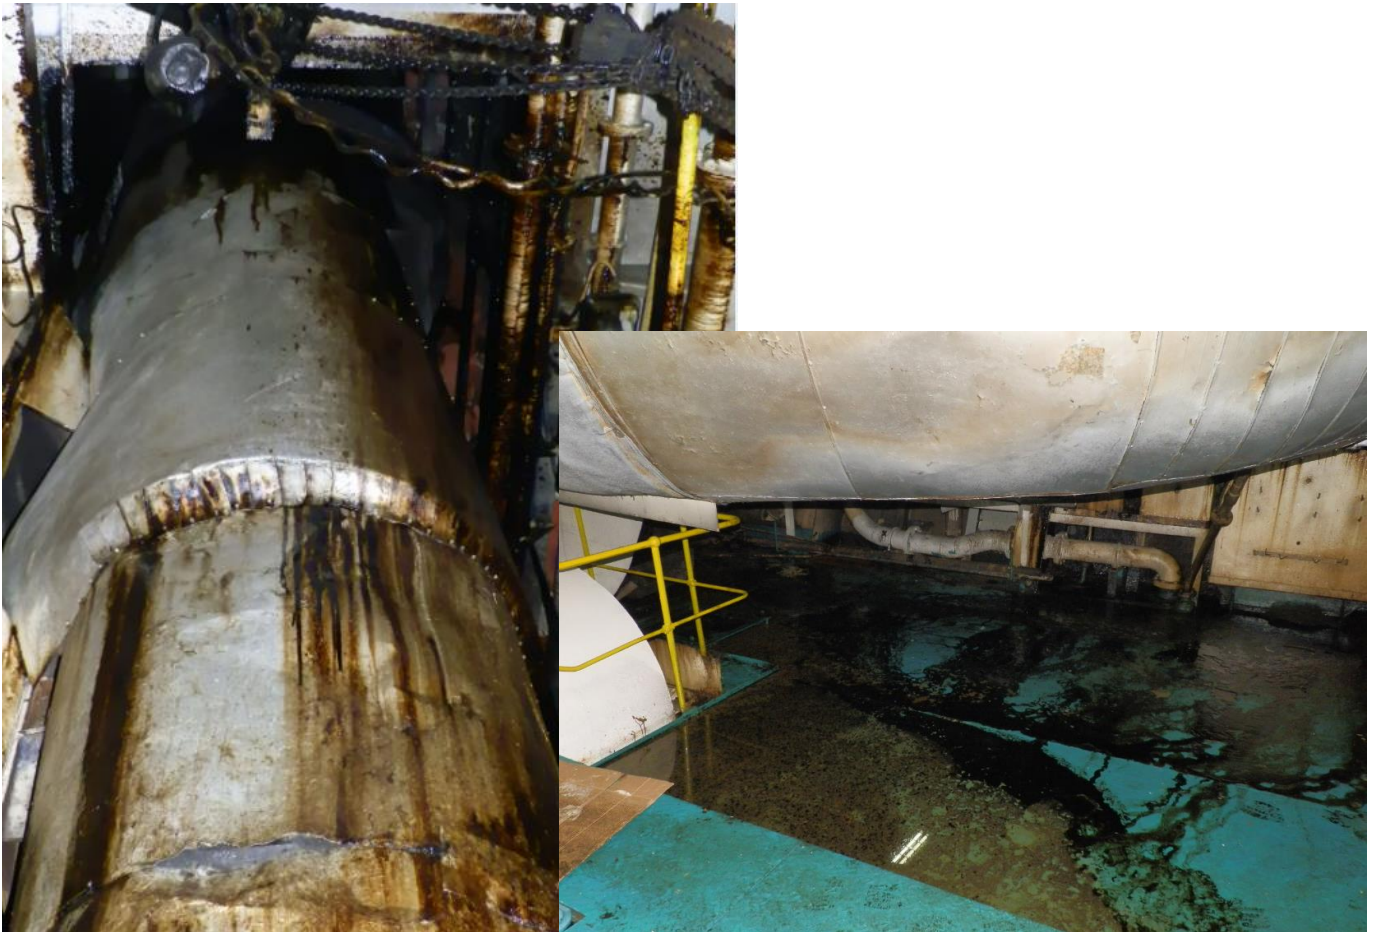
Figure 13: visible oil traces on the surface of the exhaust pipe and the port side main engine room

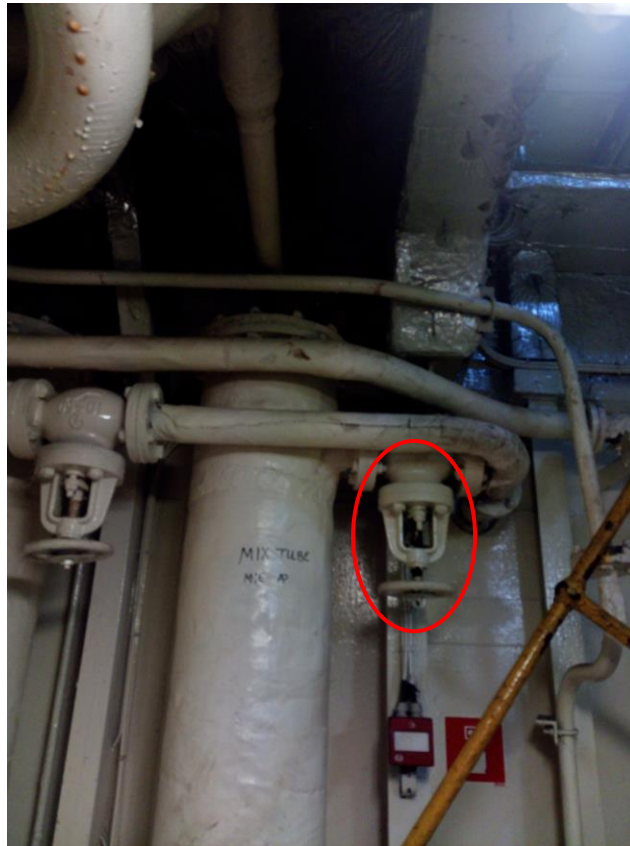
As mentioned, during the evaluation of the cause of the fire in Piraeus, it was found that the valve from the "Return Chamber to the fuel supply pipe", which is fitted within the oil fuel supply system of the main engines, was damaged and closed which in turn have caused the fuel oil to overflow inside the return chamber and thereafter through its air extractor pipe. The air extractor pipe unlike most of the air-vent pipes of the tanks containing fuels which end up on deck 5 (garage deck), was fitted at the upper edge of the duct funnel in a small space that was air vented through a natural ventilation opening. Said space had a remotely operated fire damper for fire protection purposes.

Figure 14: the valve from the Return Chamber to the fuel supply pipe, which was found damaged (photo captured after ship's repairs)

The most possible time for the valve from the return chamber to the supply pipe, to have been damaged was during the maintenance works which were conducted in the engine room in Brindisi. Consequently the valve remained in the closed position, unnoticed by the engine crew until finally it was too late.

- 6.3** The valve from the Return Chamber to the fuel supply system of the vessel was found damaged, at closed position most possible (without being recorded) during maintenance (§4.3.1)

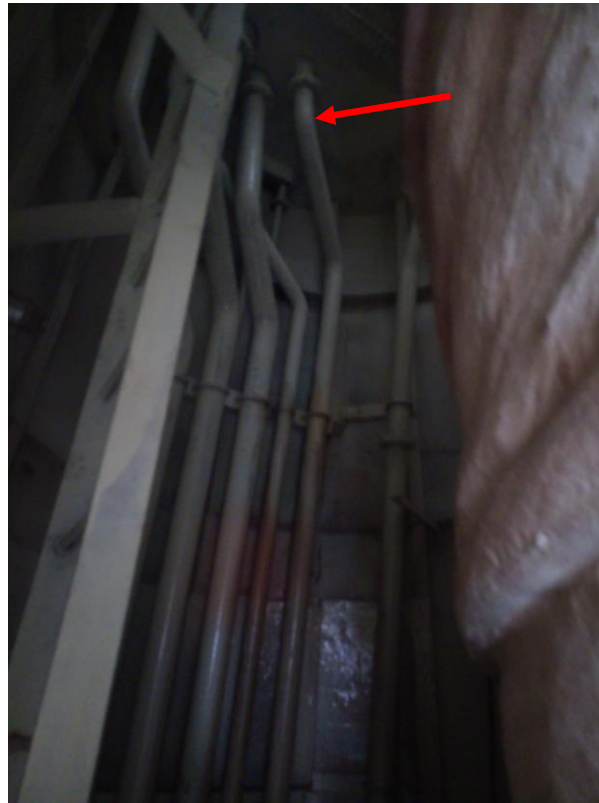
Moreover, in the piping system of the air extractor pipe there was no safety arrangement which would either activate an alarm in case of overflow or ensure that fuel in the case of overflow would not be led towards the funnel through the air extractor pipe, which was a totally free-flow pipe. The return chamber itself had no level indicator, so the level of fuel contained in it could not be monitored.

Figure 15: The air extractor pipe within the port funnel duct; capture is from underneath the panel where the air extractor pipe ends up (see indicator arrow and next figure). On the right side of the figure the main exhaust pipe is visible (photo captured after the repairs)

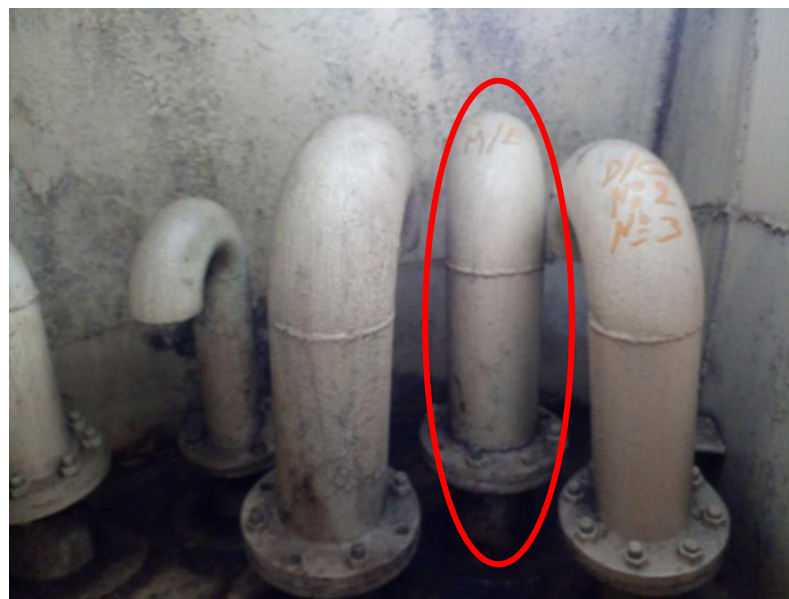
Figure 16: The air extractor pipe's ending (indicated) over the panel within the port funnel duct (photo captured after the repairs)

- 6.5** The fire was caused by the overflow of fuel oil from the port main engine's Return Chamber which was led through the air extractor pipe within the port funnel duct where it came in

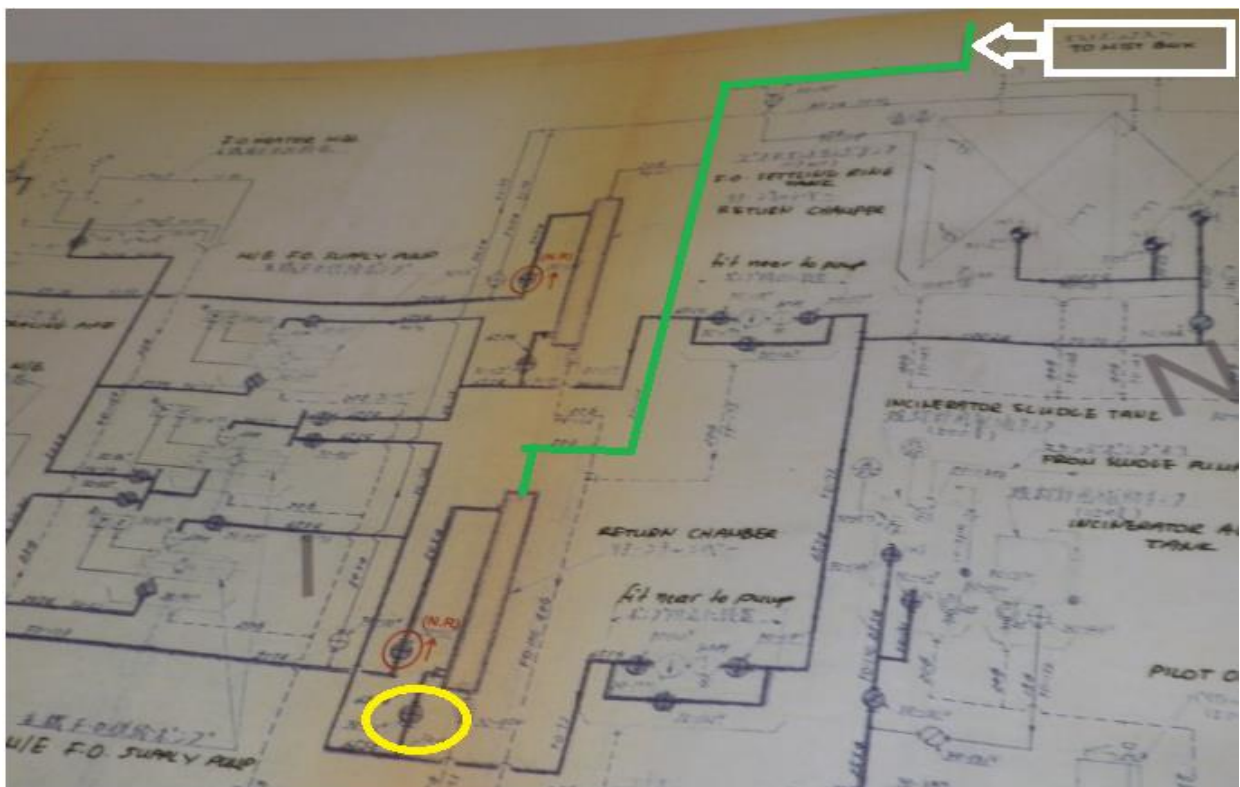
From the examination of the vessel's drawings it was found that the relevant drawing concerning the fuel oil piping system for the main engines, showed no indication that the air extractor pipe's ending of the return chamber, was leading up inside the port funnel duct as is evident in the figure below. Additionally the relative drawing of the port side funnel duct showed no indication of the existence of the air ventilation pipe inside that space. Finally the mist box as shown in the figure below was missing in the actual piping arrangement.

Figure 17: Capture of the fuel oil piping diagram showing that the air extractor pipe (indicated with green) of the return chamber, ends up to the mist box (indicated with white square). Additionally the damaged valve to the fuel supply (yellow circle) is shown which caused the overflow of the return chamber.

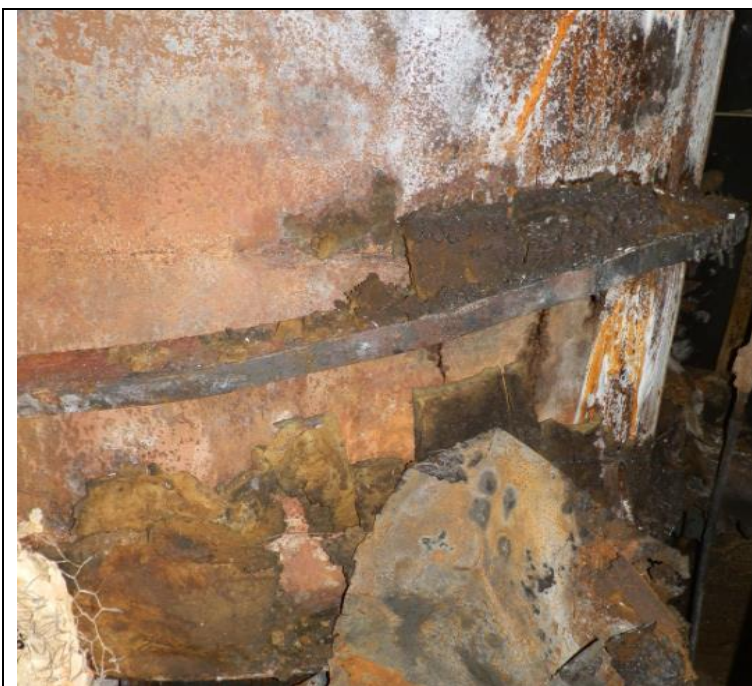
During the visit of the investigation team on board IERASPETRA L, the port side engine exhaust inside the funnel duct was checked to investigate any exposed parts that could come in contact with the fuel oil, in order to verify the ignition source. Unfortunately the intensity of the fire inside the port funnel destroyed large sections of the exhaust's pipe insulation, so no specific conclusions could be reached.

Figure 19: Part of the exhaust pipe inside the port funnel duct. The damaged insulation is visible in the lower part of the picture.
