INTERIM REPORT

MARINE ACCIDENT SAFETY INVESTIGATION

Fire on board "OLYMPIC CHAMPION" IMO No. 9216028

SEPTEMBER 2020

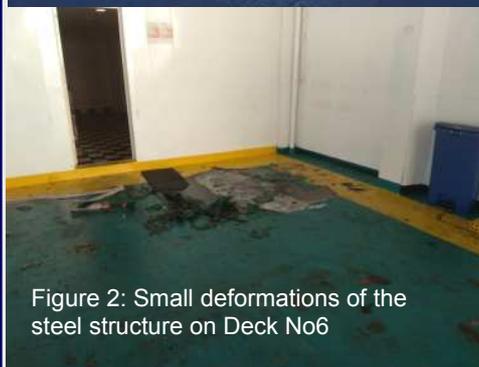
Date & time	28/09/2019 at 07:40 LT
Type of marine casualty	serious marine casualty
Weather & environmental conditions	GOOD VISIBILITY, NNW WIND DIRECTION 3-4 bf ,DAY TIME
Location of casualty	Near the dock of Igoumenitsa port, NW Greece
Damages to ship	Deformations of the steel structure at the fore starboard section of Deck No 6
Fatalities / injuries / pollution	none/two (02) passengers/none

Figure 2: Small deformations of the steel structure on Deck No6

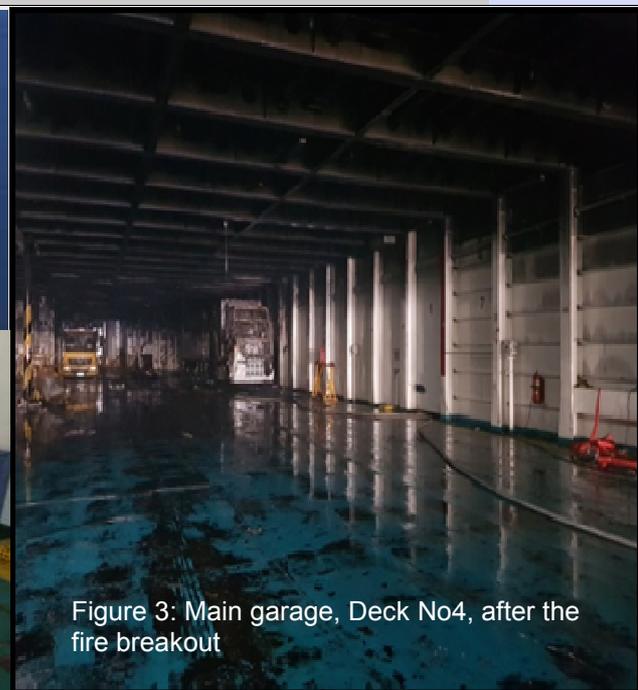
An inspection was carried out at the fore starboard area of the main garage, deck No. 4, where the fire was initially spotted and in particular on the electrical installation and equipment of the vessel that was supplying the refrigerated trucks with electrical power (electrical panels, sockets, electrical fuses), as well as in specific refrigerated trucks located at that area. According to data collected so far, the investigation analyses is focusing on a possible short-circuit that occurred on the front left part of a tractor, located at the fire breakout area.

Due to the short-circuit and the generated spark, the fire broke out and was rapidly expanded to the other parts of the mentioned tractor and subsequently to the near by parked refrigerator trucks and general cargo tracks, stowed in the main garage, namely due to the fact that the cargo (plastic goods, etc.) loaded was fueling the fire.

Figure 3: Main garage, Deck No4, after the fire breakout
