## Bundesstelle für Seeunfalluntersuchung Federal Bureau of Maritime Casualty Investigation

**HANLA LEVEL CO., LTD. HFO-Flow-Sensors: Danger of Earth Fault**

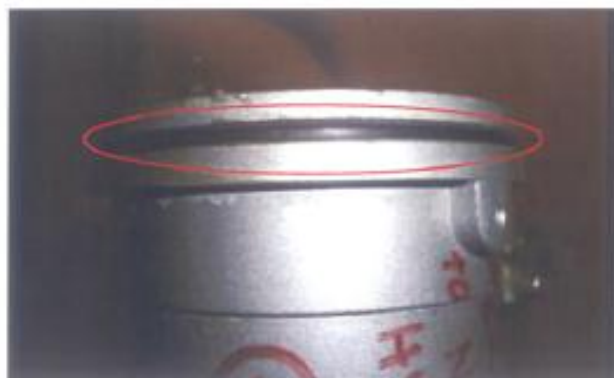
Picture 1

During a damage investigation some sensors from the maker "HANLA LEVEL CO. LTD" were found suspicious. They are designed in a way that a earth fault can occur very easy.

According to our actual knowledge only the sensor type "LIDEC-L91B" is affected. The sensors are installed in the HFO overflow pipe and used as flow-sensor.

The failure occurs when the O-ring for sealing the sensor between the housing and the cover is not installed (picture 1). In this case the cover can touch a jumper on the board of the sensor (picture 2) which leads to an earth fault (-24 V DC).

The thread of the affected sensor covers should be shortened by at least 10 mm. When this counter-measure is done the cover can not touch the jumper even if the O-ring is not installed. Please note that the O-ring should be installed anyway!

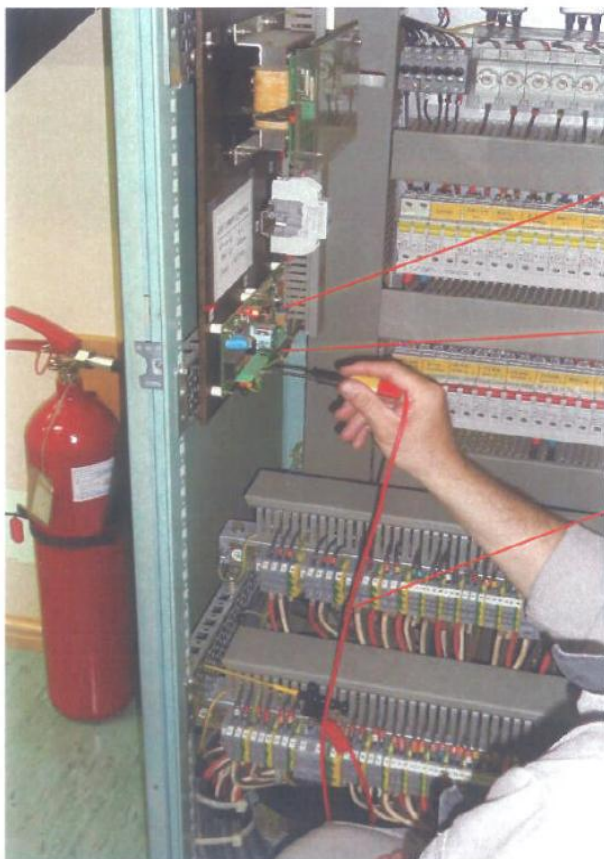
Cabinet: DC 24 V UPS FOR AMS & BMS

Board for earth fault detection

Ground wire (yellow/green, connected to the board)

Manual bridge between ground connection of board and ground of cabinet

If you find a sensor box without O-ring and with slight touching marks on the jumper, please also check if the earth fault detection module of the 24 V system is working correct (picture 3) before fixing the problem at the cover. Therefore connect the earth-port of the module to the ground of the cabinet by using a short line. If then the red LED of the detection module starts to shine, then the original earth line of the detection module is interrupted.
