**Bundesstelle für Seeunfalluntersuchung**  
**Federal Bureau of Maritime Casualty Investigation**  
Federal Higher Authority subordinated to the Ministry of Transport  
and Digital Infrastructure

**Investigation Report 43/16**

**Very Serious Marine Casualty**

**Fatal line accident on board  
the CMV MAERSK KURE  
in the port of Bremerhaven  
on 6 February 2016**

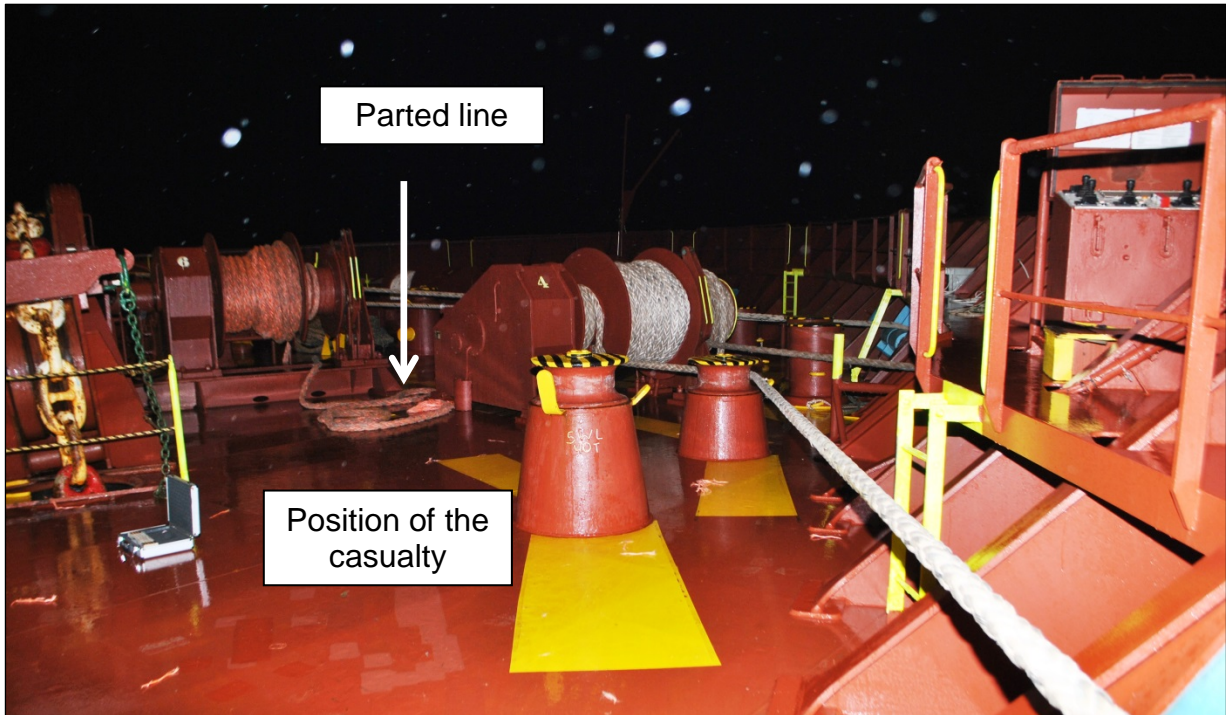
Figure 5: View toward the parted line

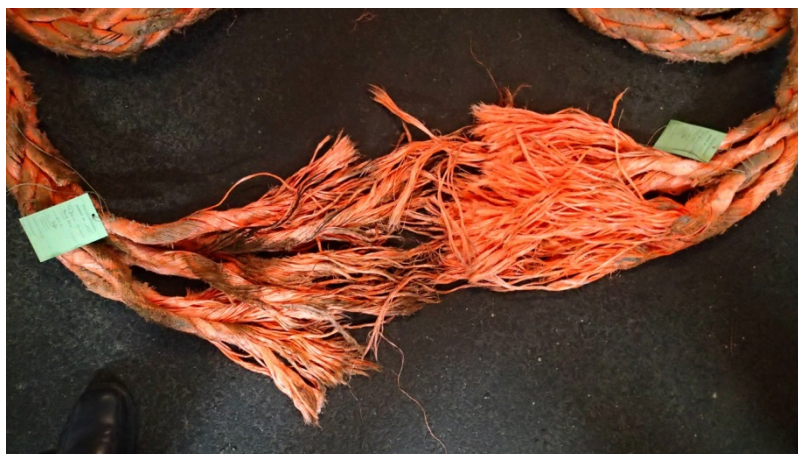
Figure 6: Line's point of failure

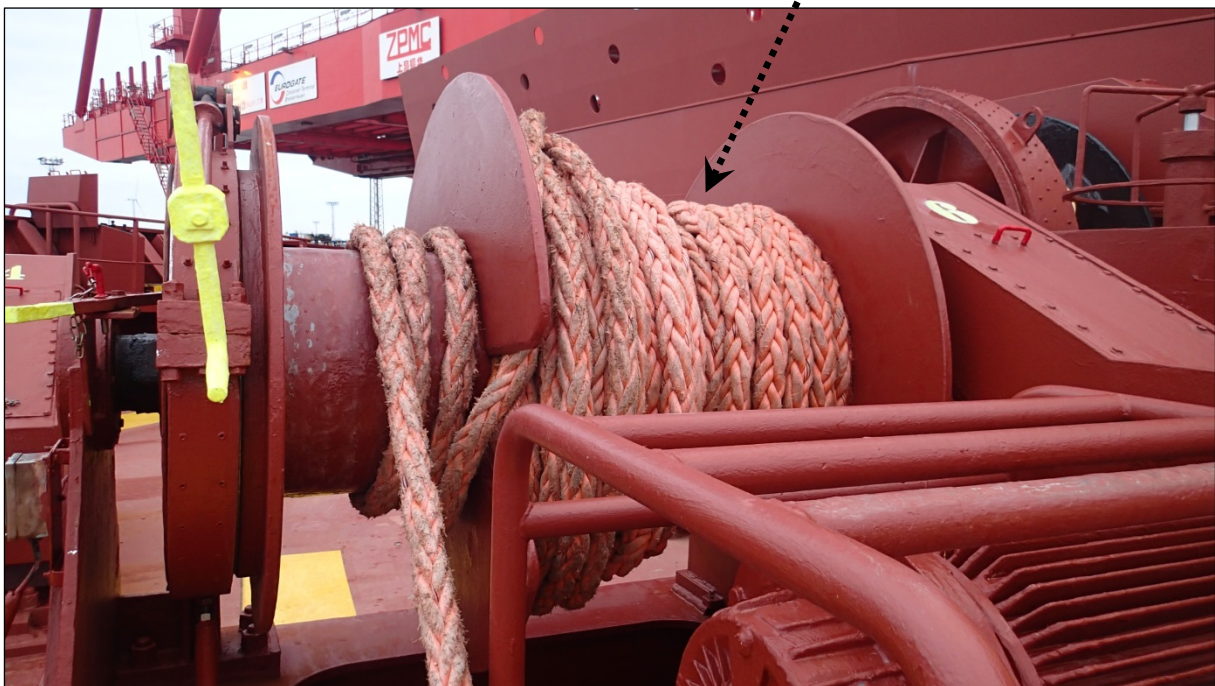
Figure 8: Winch holding the parted line

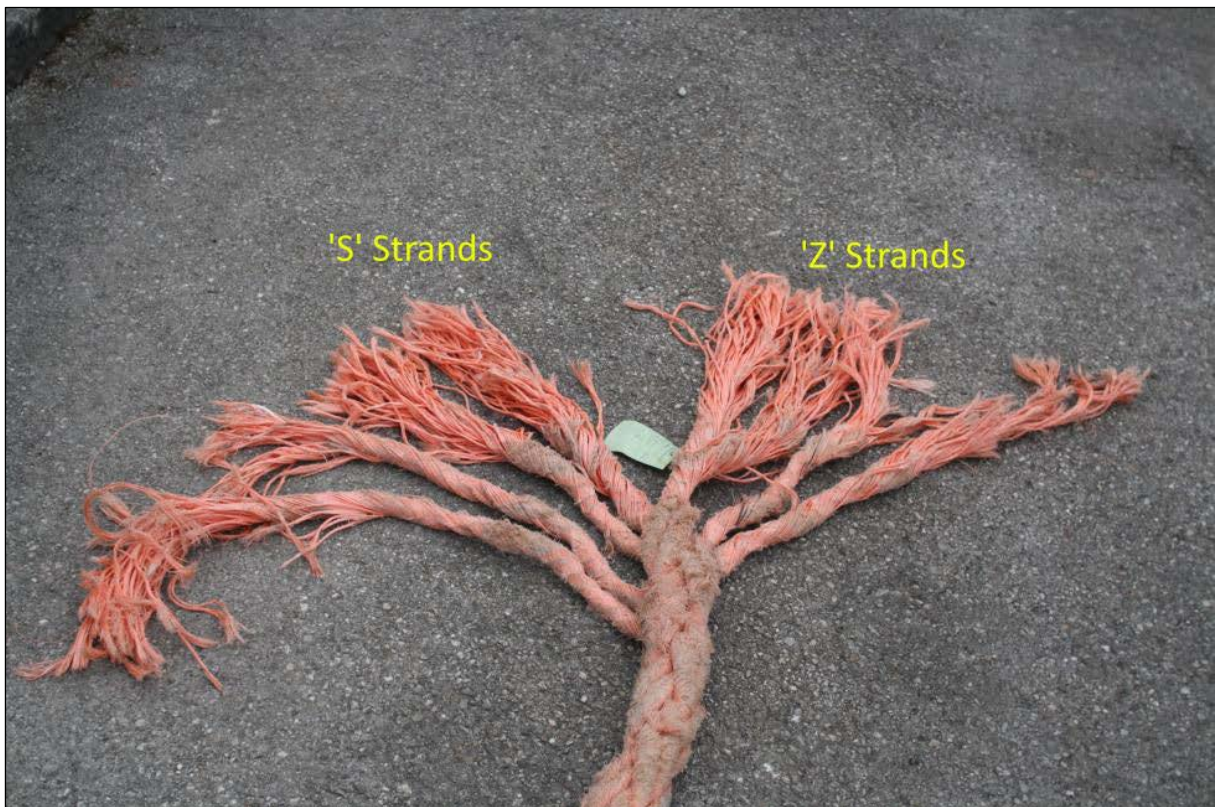
Figure 9: Failed secondary stand arranged as per its direction of lay

When a strong bend places a load on such line, one half of the secondary strand tightens while the other half loosens. The elongated secondary strand will fail first.

This is indicated by short compressed ends. The hitherto loose secondary strands will fail only after that and then produce elongated ends.

In the present case, all the secondary strands exhibit a similar failure pattern. Consequently, it is reasonable to assume that a bending load was not responsible for the failure of the line.

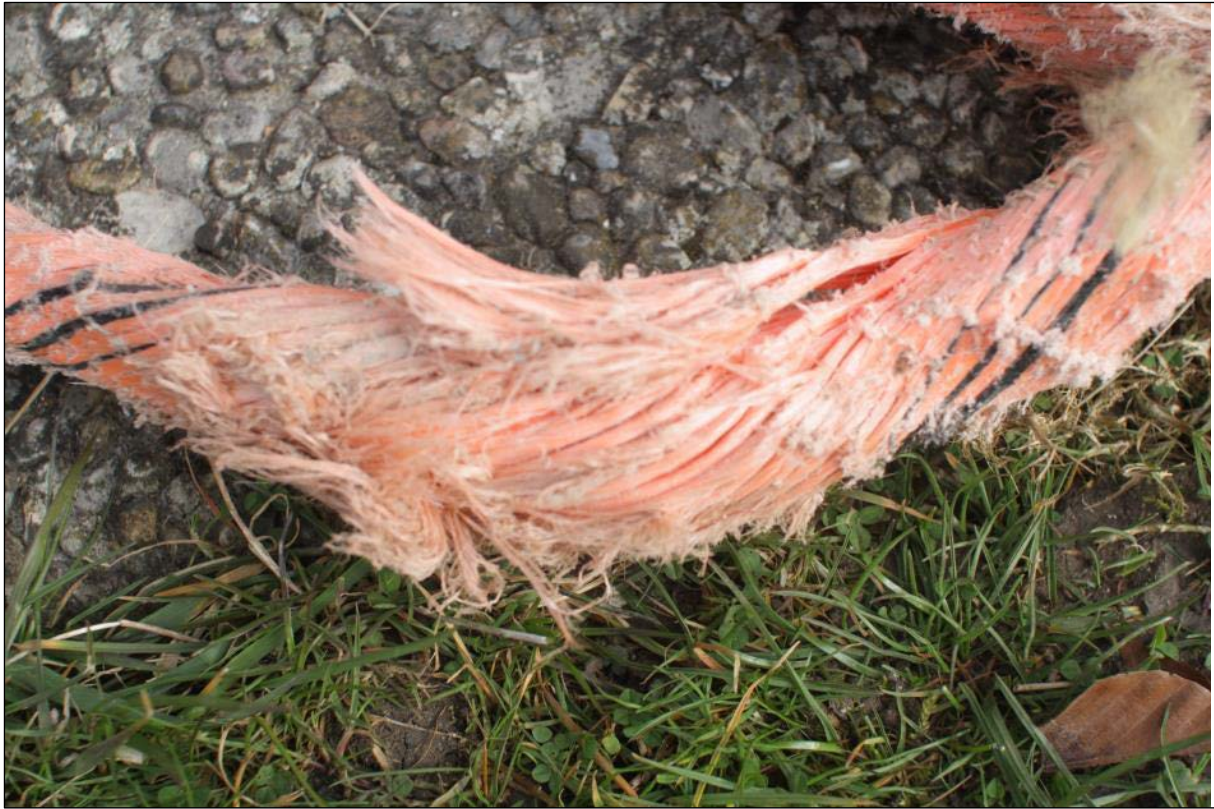
The line generally exhibited significant external damage, as shown in Figure 11. Its wear was also extremely advanced in certain places, as shown in Figures 12 and 13.

Figure 13: Heavy strand damage

In summary, a mooring line in this worn condition should be replaced immediately.

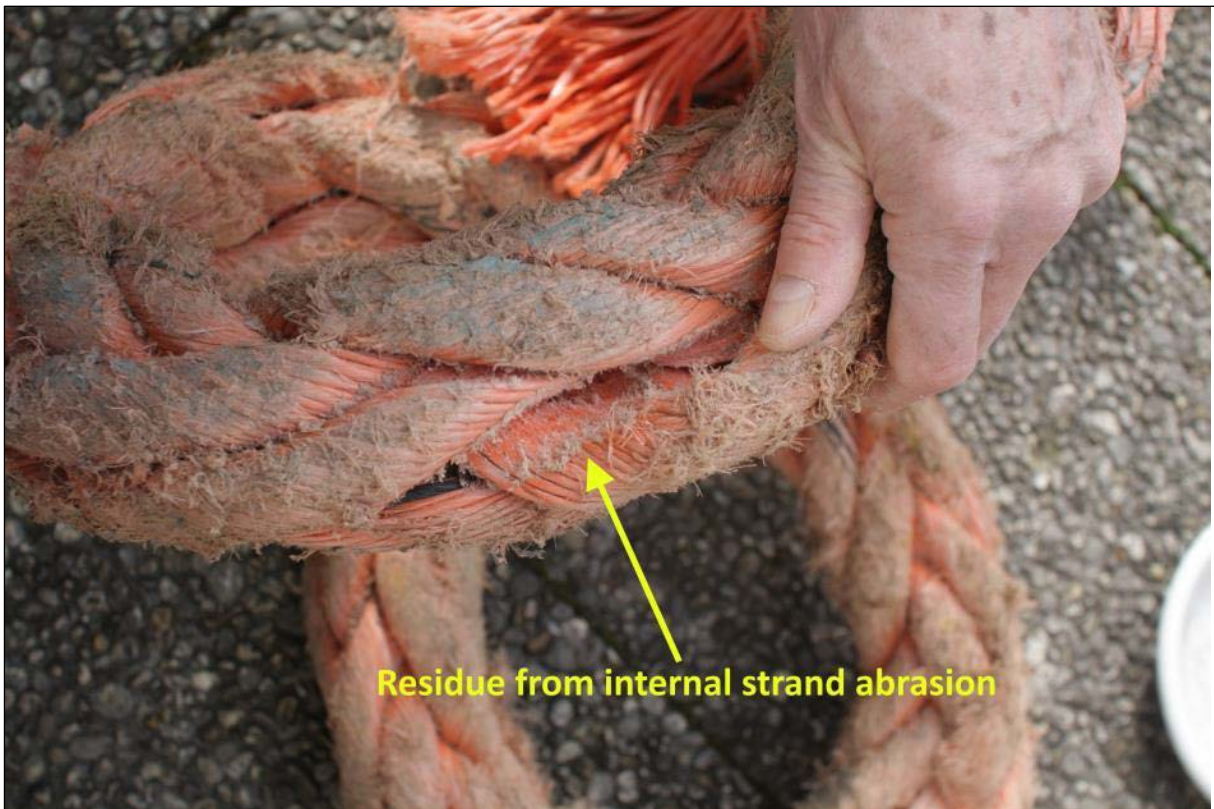
Figure 14: Abrasion on inner strand due to regular wear

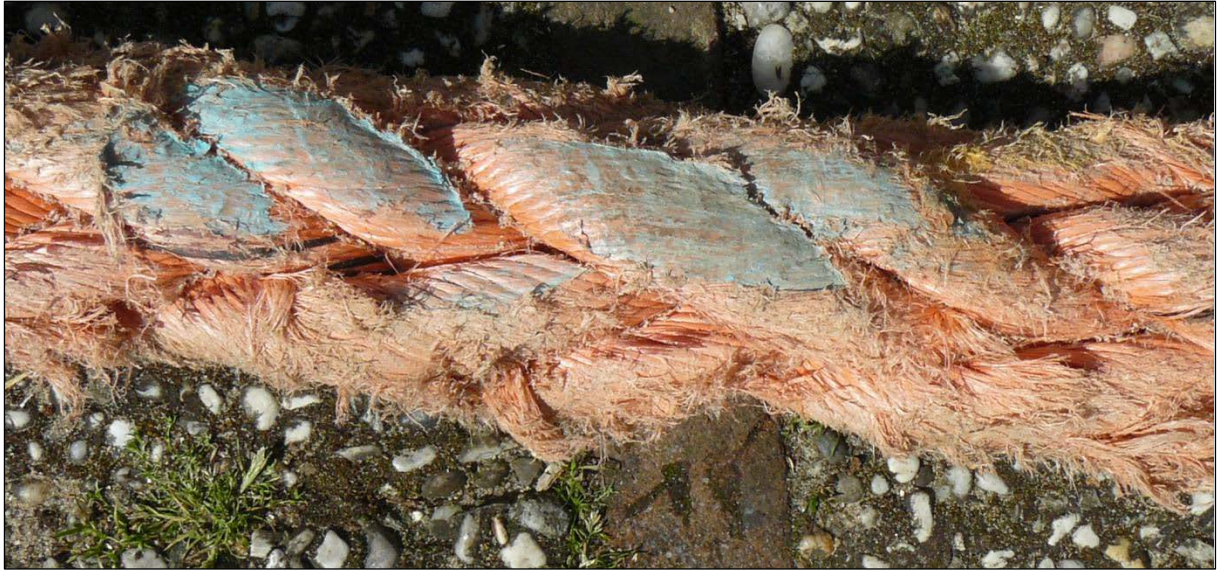
Figure 15: Paint abrasion from a fairlead

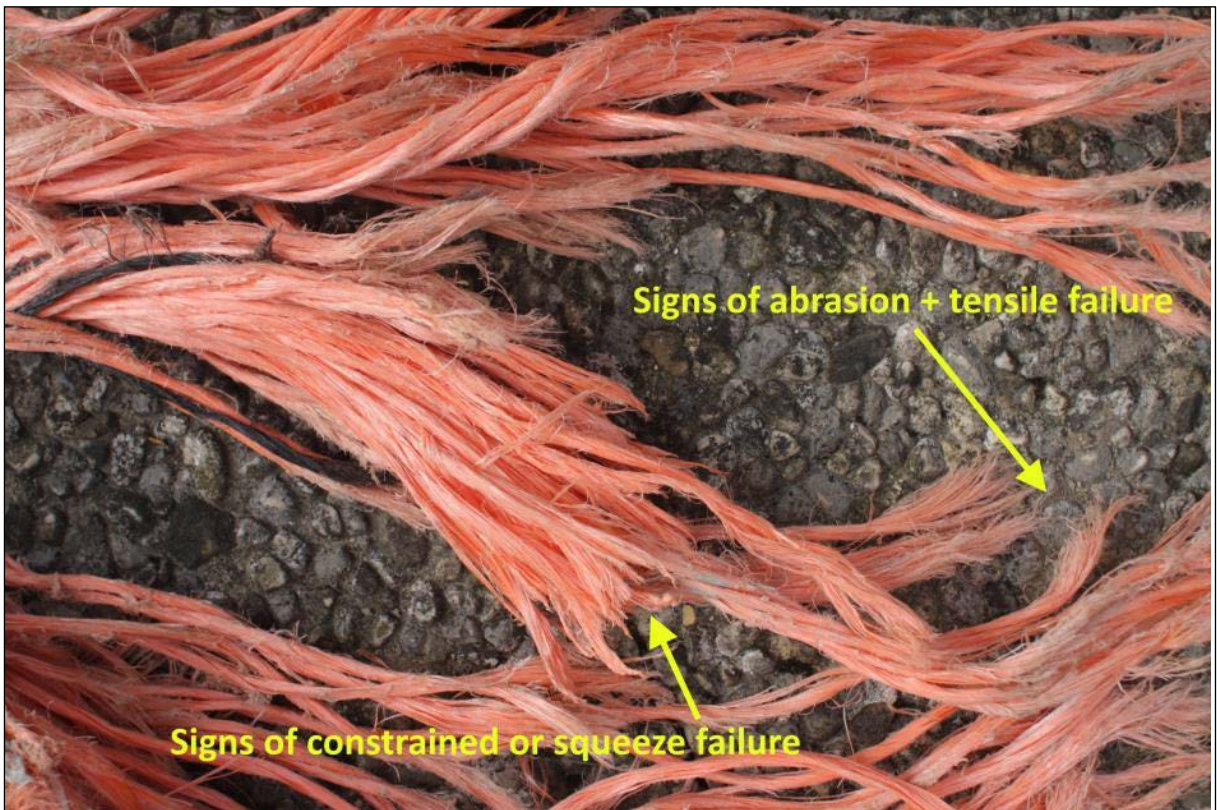
Figure 16: Close-up of the failure
