**HELLENIC REPUBLIC
HELLENIC BUREAU FOR MARINE CASUALTIES INVESTIGATION**

**MARINE CASUALTY SAFETY INVESTIGATION REPORT
02/2016**

**Fatal injury of a truck driver onboard
Ro/Ro EUROCARGO TRIESTE**

December 2024

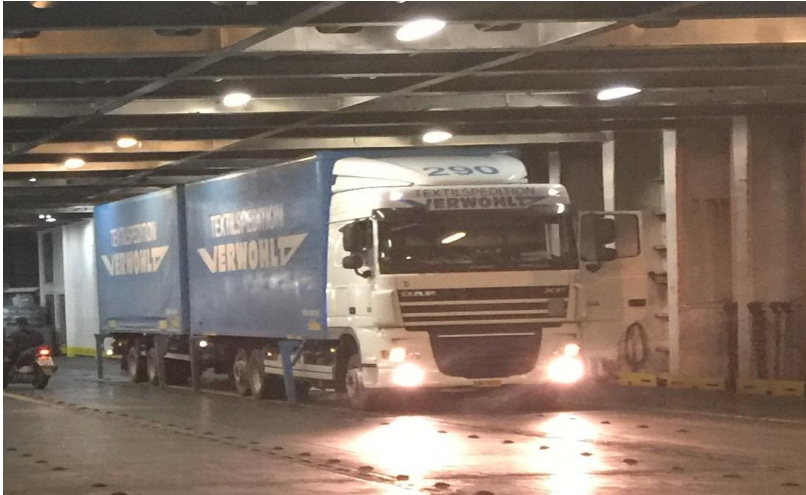
The first vehicle to enter Eurocargo Trieste was the one involved in the casualty. It was a rigid truck with drawbar trailer²(figure 3).

Figure 3: The rigid truck with drawbar trailer involved in the marine casualty. All supporting legs of the right trailer's side are lowered. Photo taken during the reconstruction of the accident.

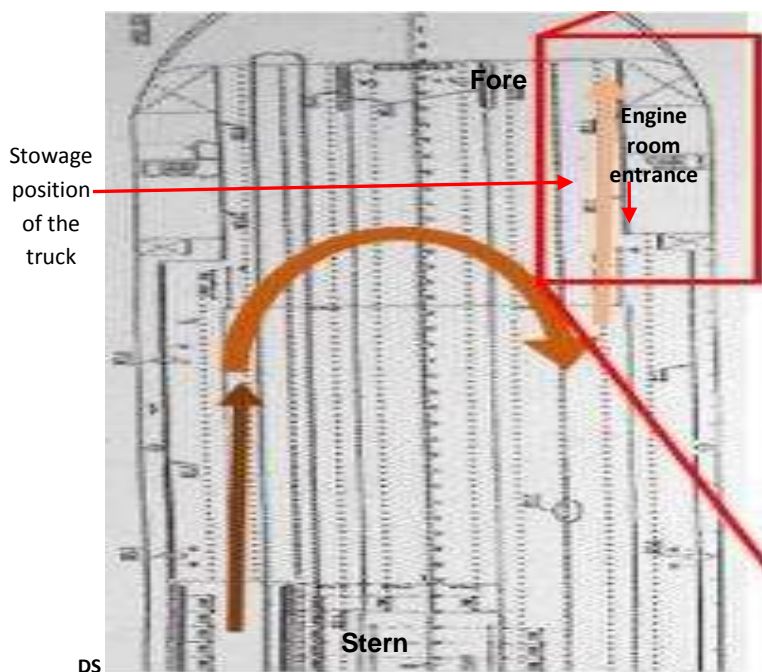
The stowage position was located at the starboard forward end of garage deck number 3 and was indicated by the Ordinary Seaman (O/S) who arrived at the location. At approximately 12:30 the driver maneuvered and aligned the rigid truck within no. 2 parking lane; reversed it towards the vessel's fore and parked it alongside the starboard garage bulkhead of the engine room entrance (figures 4 & 5).

Figure 4: Sketch of the truck manoeuvring to stowage position on garage deck no. 3.

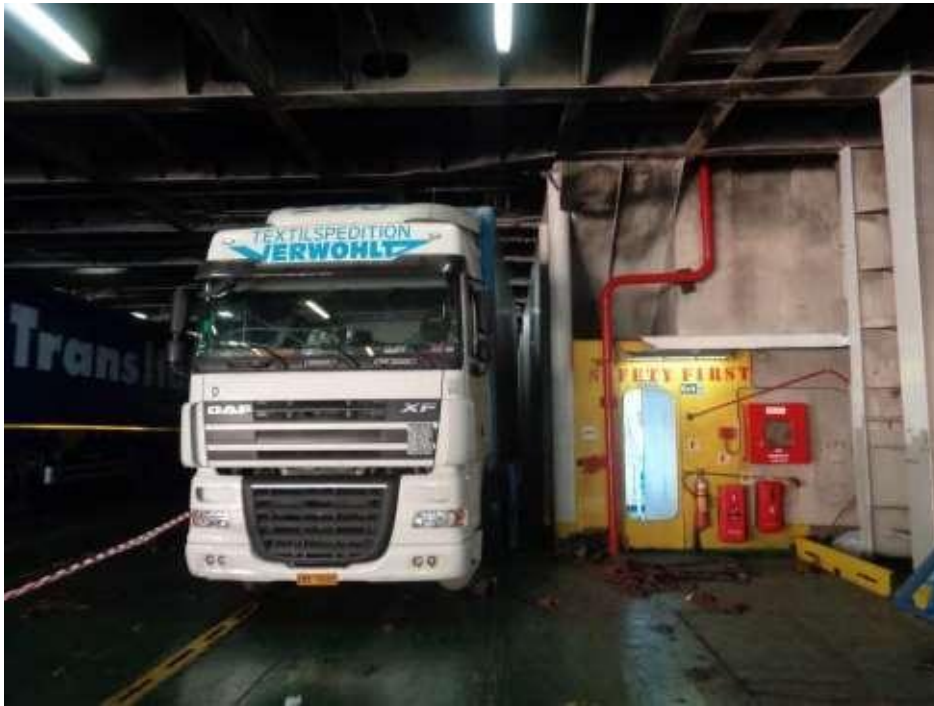
Figure 5: The rigid truck parked next to the engine room entrance bulkhead after the accident.

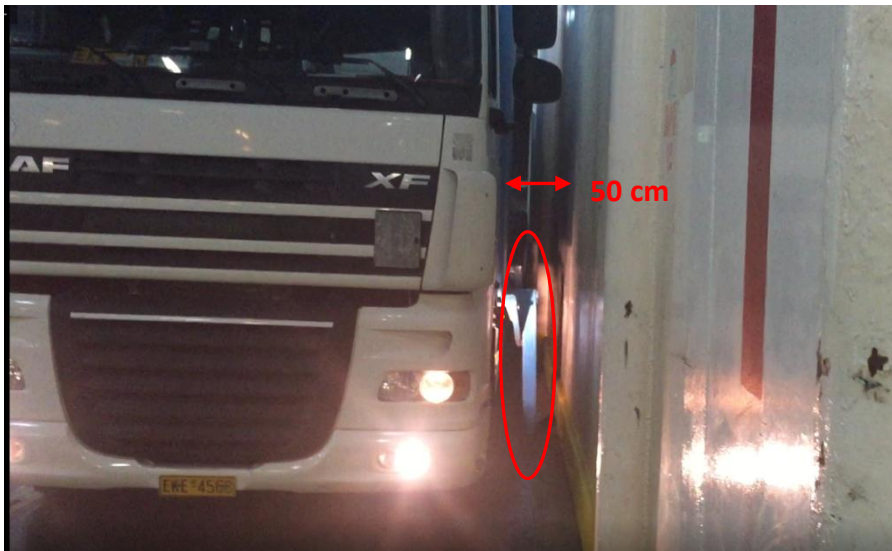
For setting the supporting legs on the left side of the trailers he had to move within the limited space of about 50cm of width, formed between the trailers' side and the bulkhead (figure 7).

Figure 7: The space formed between the truck trailers and the engine room entrance bulkhead. Photo taken during the reconstruction of the accident.

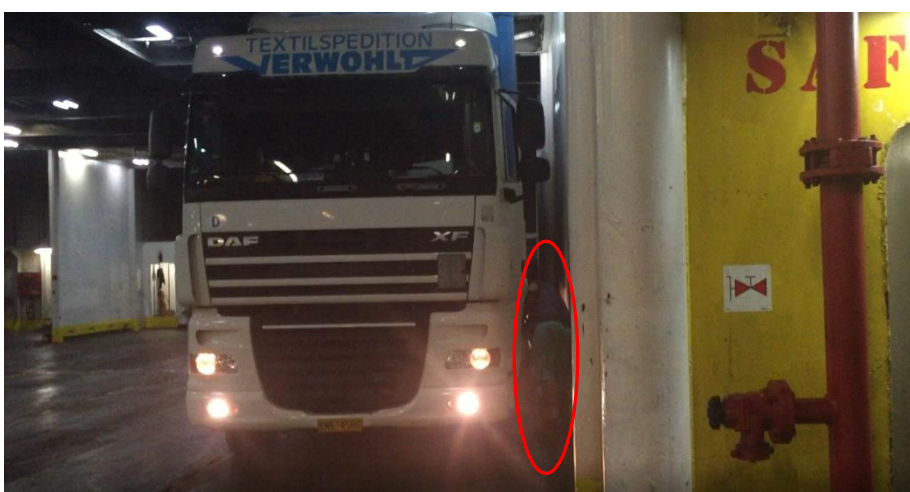
At that time, the rigged truck started unexpectedly moving forward and towards the bulkhead as the tractor's wheels were slightly turned to the left and the parking brake had not been engaged before the driver stepped off the tractor's cabin. It was also reported during the investigation process that the driver's door was closed and the tractor's engine was off.

As the driver was still standing close to the forward supporting leg, it pushed and forced him against the bulkhead. Consequently, he got trapped between the left supporting leg of the landing gear and the bulkhead (Figure 8).

Figure 8: Estimated position of the driver trapped between the trailer and the bulkhead. Photo taken during the reconstruction of the accident.

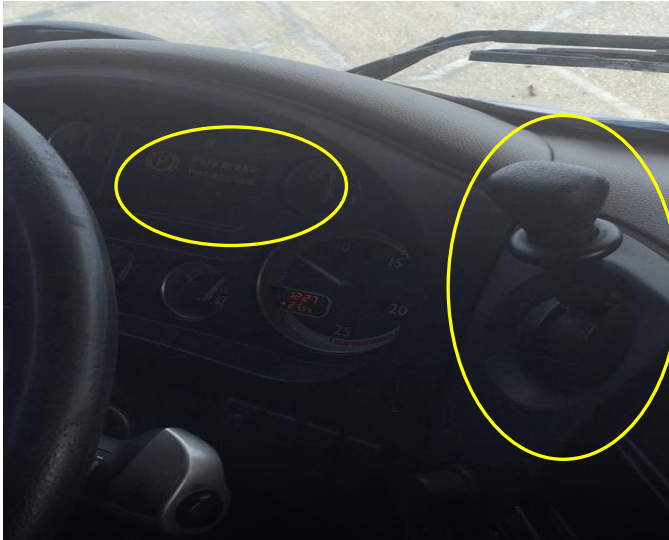
parking brake system was not engaged a visual indication as well as an audible alarm was activated (figure 9). On this ground, it is considered possible that when the truck driver stepped off the cabin without engaging the parking brake he either did not notice the visual indication and did not hear the audible alarm, probably due to the noise of the garage, or he acted purposely.

Figure 9: The parking brake lever and the visual indication on tractor cockpit.

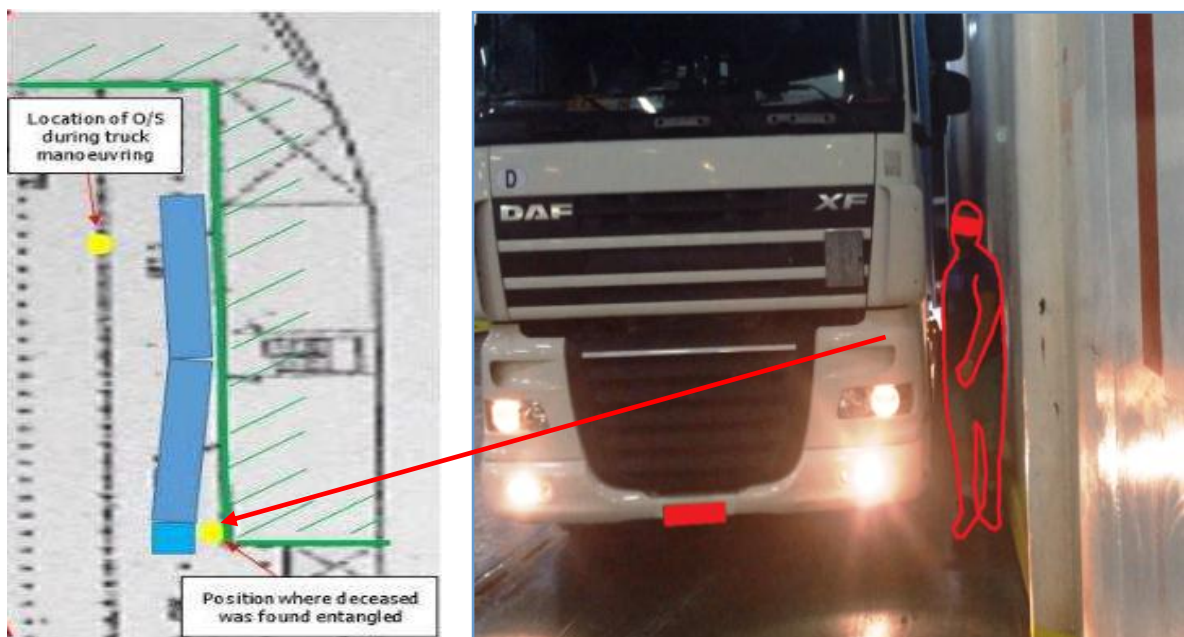
When the truck started moving and trapped the driver between the bulkhead and the left supporting leg of the landing gear, the O/S that guided the truck to the stowage position, was standing at the outer side of the rear trailer and was preparing the lashing equipment for securing the cargo units (Figure 10).

Figure 10: Location of O/S and the driver at the moment of the marine casualty

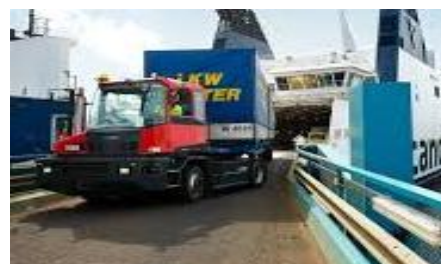
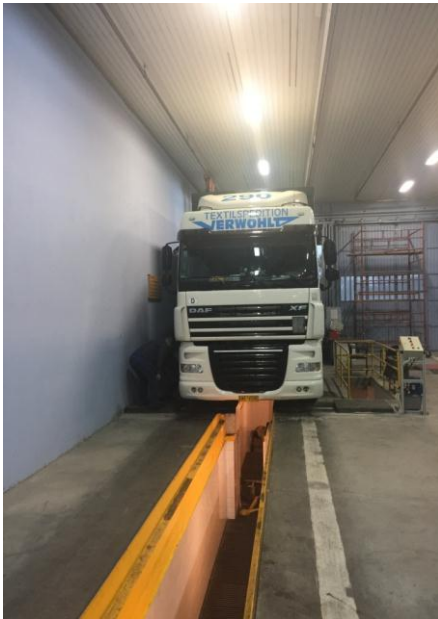
Figure 11: Truck on Vehicle Technical Inspection & Control Centre

According to the results of the inspection, the tractor and the trailer were found to have serious issues on their braking systems. More specifically, the tractor's parking braking ratio was found less than the minimum dedicated performance ratio⁶. Moreover, the tires of the truck were found in worn condition. A test was also carried out on the truck's parking brake, including its audible alarm, without any issue.

As a result of the aforementioned findings, the road worthiness certificate of the truck was withdrawn and the owner was required to rectify the issues within 2 months and proceed for re-inspection.

Nonetheless, taking into consideration the evolution of events leading to the occurrence, the condition of the truck is not considered as a contributing factor to the marine casualty, as it was concluded that the parking brake was not engaged.

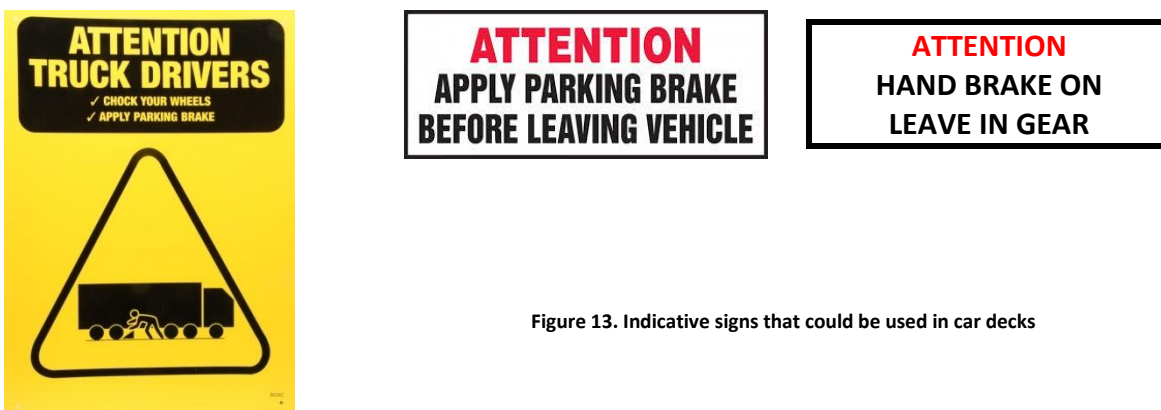
As it was emerged during the visit of the investigation team on the vessel, there were no signs on Eurocargo Trieste's garage spaces to draw the attention of the drivers for the engagement of the parking brake when stepping off the vehicle.

Figure 13. Indicative signs that could be used in car decks

On above grounds it is considered that parking procedure should be additionally supervised and reminded to the truck drivers by the deck crew. Therefore, many Operators of Ro/Ro ships have taken measures in order to draw the attention to drivers to apply the parking brake and engage gear once parked on a vehicle deck, by placing relevant signs and labels in visible positions or using hand-held by crew instruction boards. Such methods are indicatively shown in figure 13. It is noted that this type of signs reflects also the safety procedures of the vessel operator and could encourage the crew to motivate the drivers for the engagement of the parking brake.

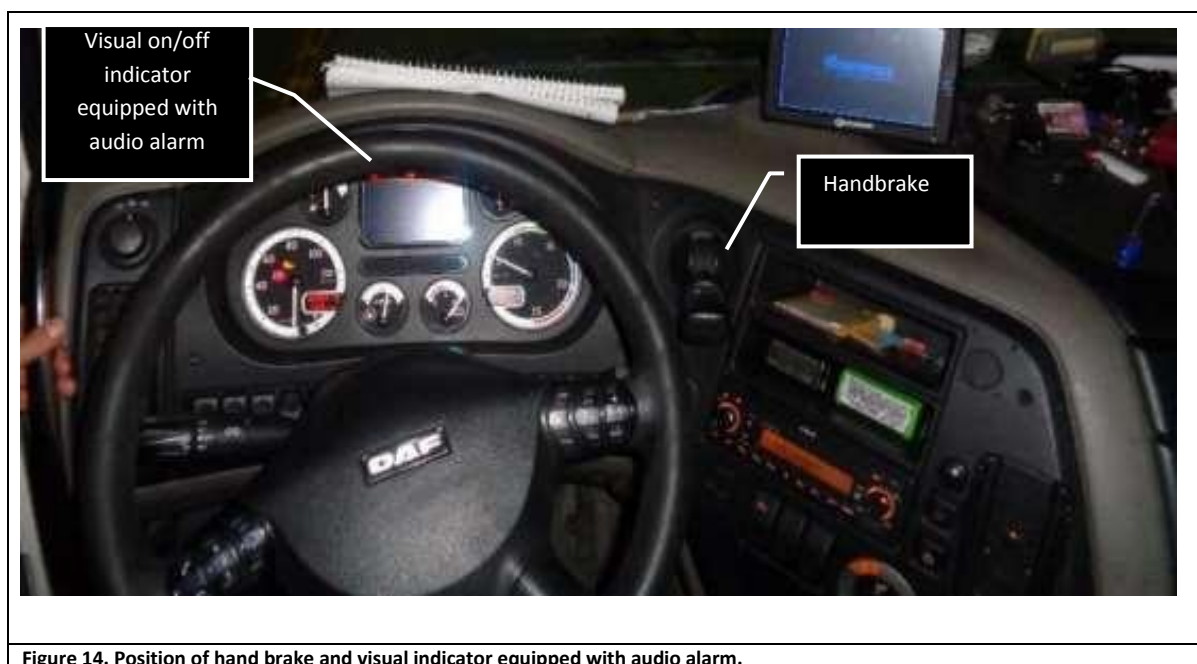
Based on the collection evidence during the investigation, it was concluded that the parking brake was not applied by the driver before exiting the cabin. Moreover, it is highly possible that the driver could not hear clearly the audible alarm, which was activated, since the parking brake was not engaged, due to the noise coming from the entrance of the engine room, located next to the truck’s parking position (Figure 8).

Figure 14. Position of hand brake and visual indicator equipped with audio alarm.

Consequently, since the vessel had a small trim, 0.5m by the stern, his truck shifted forward and entrapped him between the suspended container's forward left supporting leg, and one of the garages' starboard side plating pillars.
