**HELLENIC REPUBLIC  
HELLENIC BUREAU FOR MARINE CASUALTIES' INVESTIGATION**

**MARINE CASUALTY SAFETY INVESTIGATION REPORT  
04/2018**

**GROUNDING AND FOUNDERING OF TUG BOAT VIKING**

**January 2021**

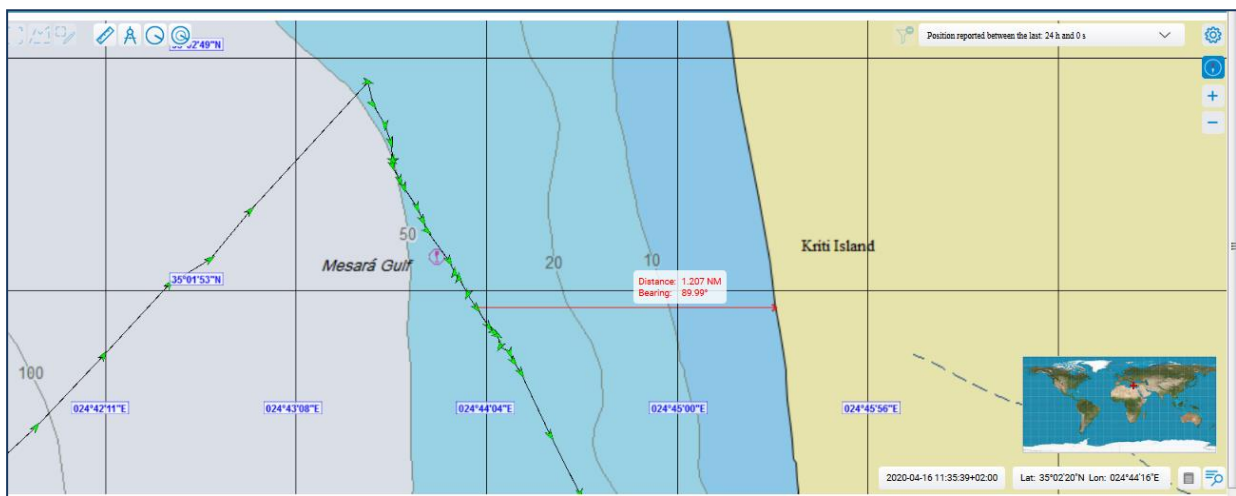
**Figure 4:** The position of the VIKING from the coast when the Master was summoned to take control.

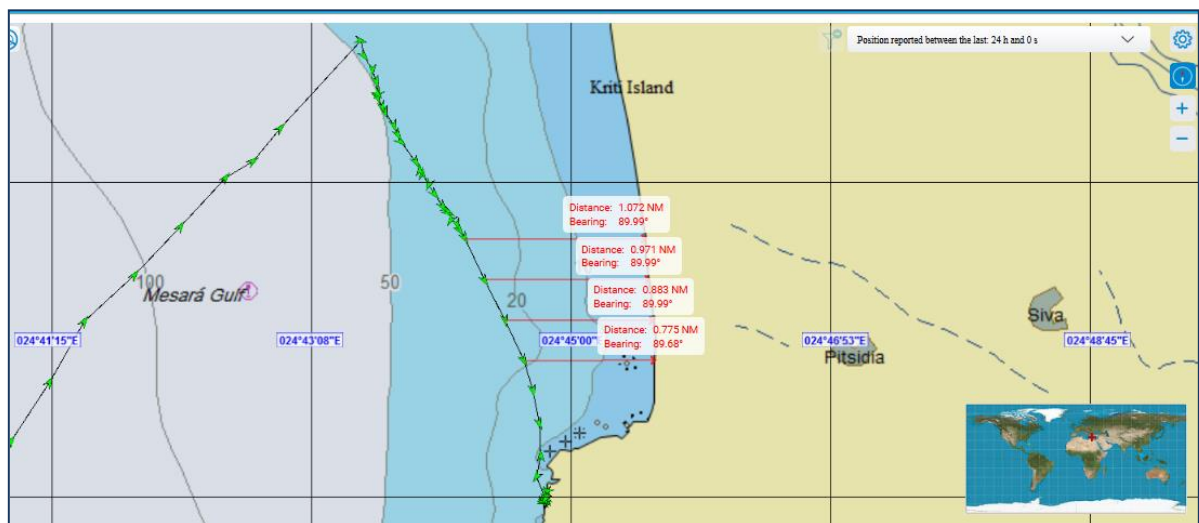
**Figure 5:** The continuous drifting of the convoy towards the coast. The four positions marked with their distance from the coast are within the time period from 04.10 to 04.38 (1 position every approx.10 minutes)

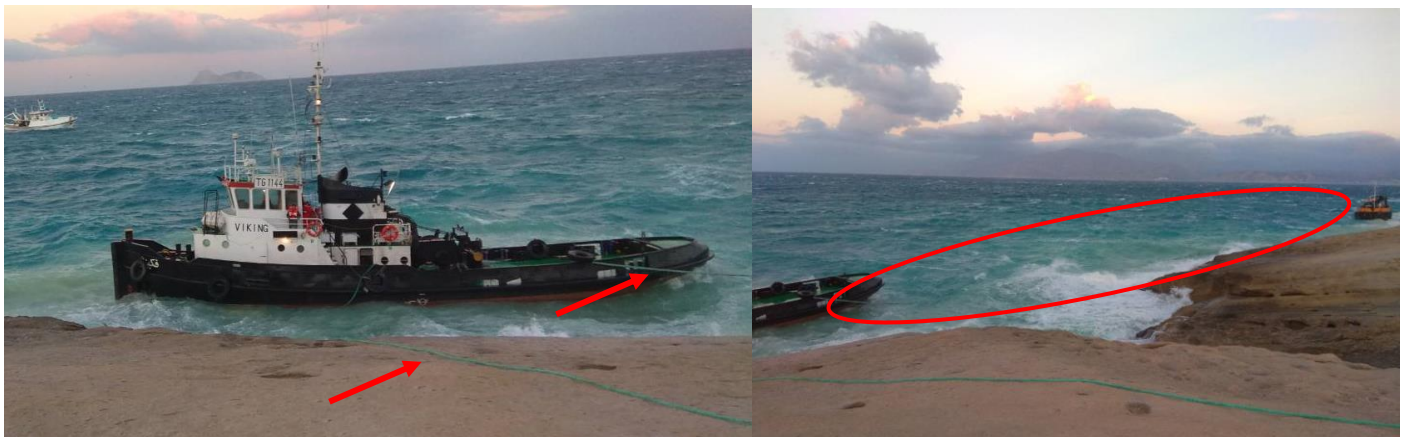
It should be noted here, that as visual evidence reveals, the tow line from the dredger remained attached to the tug boat, even after the grounding of the latter.

**Figure 6:** Captures during the grounding of VIKING; in the left image, the two lines indicated are the ones used for abandonment and the tow line, still attached to the dredger. In the right image the tow line is discerned floating (within red ellipse).

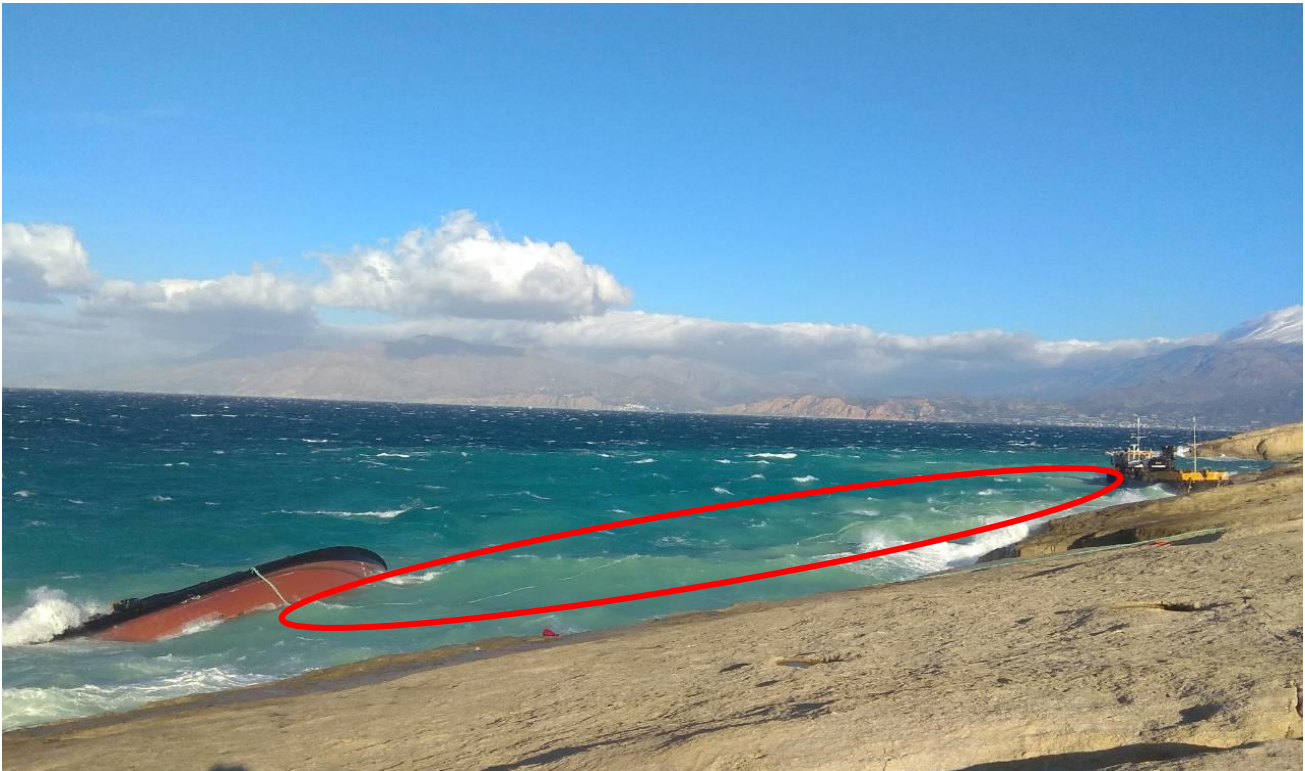
**Figure 7:** Capture after the sinking of VIKING. The tow line to the dredger is still floating, attached on VIKING (red ellipse).

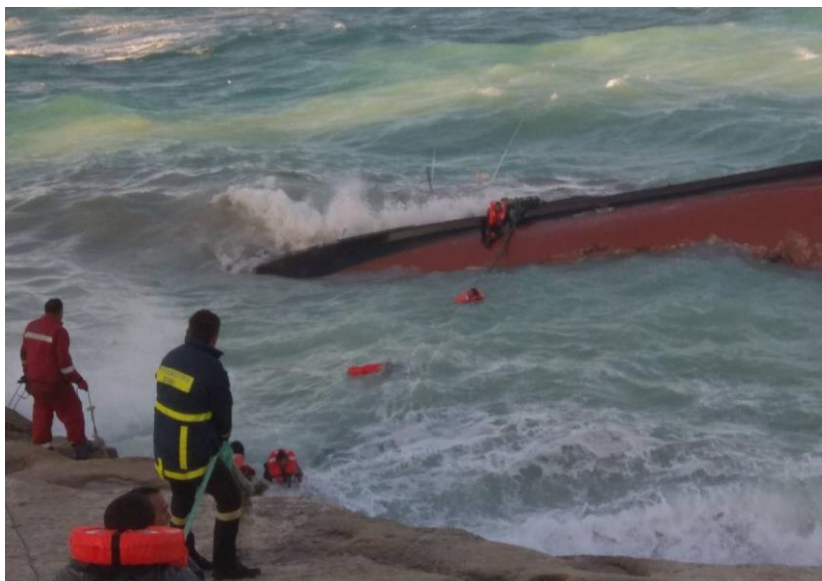
**Figure 8:** capture during the abandonment of VIKING.

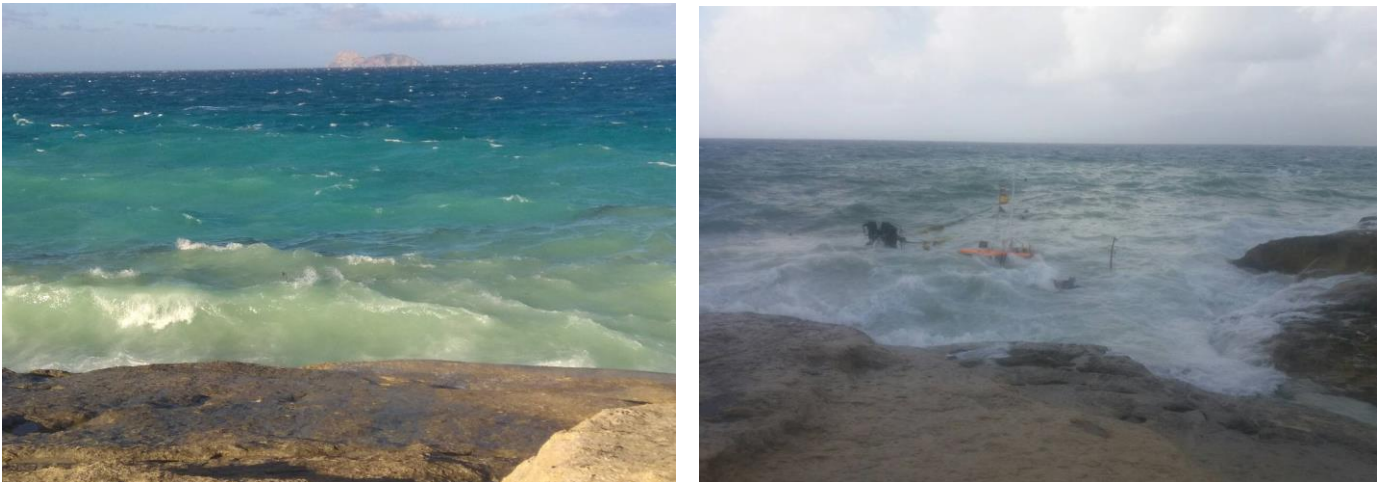
Within the next hours the VIKING foundered due to the water ingress and wave impact, while the dredger also foundered due to the same conditions.

**Figure 9:** Both VIKING (left capture) and NEPTUNE KHAN (right capture) foundered following their grounding on the rocky coast.

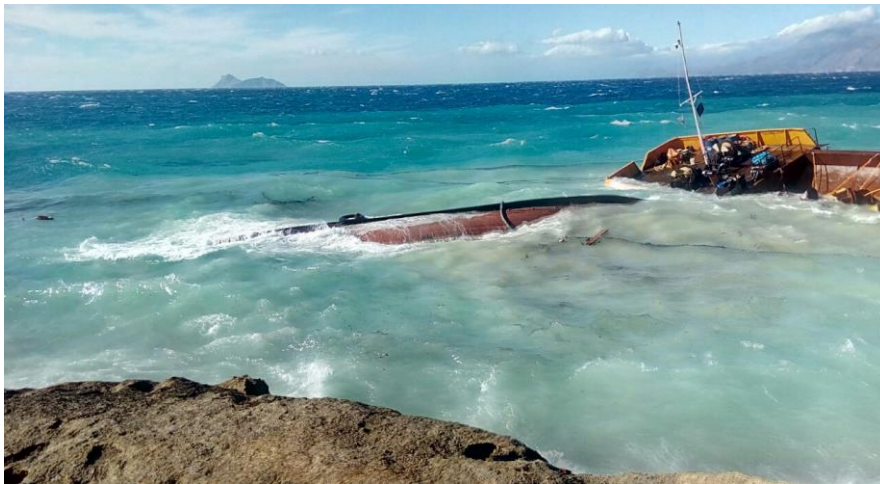
**Figure 10:** VIKING and NEPTUNE KHAN foundered; being still connected with the towing line they were drifting together under the waves' impact

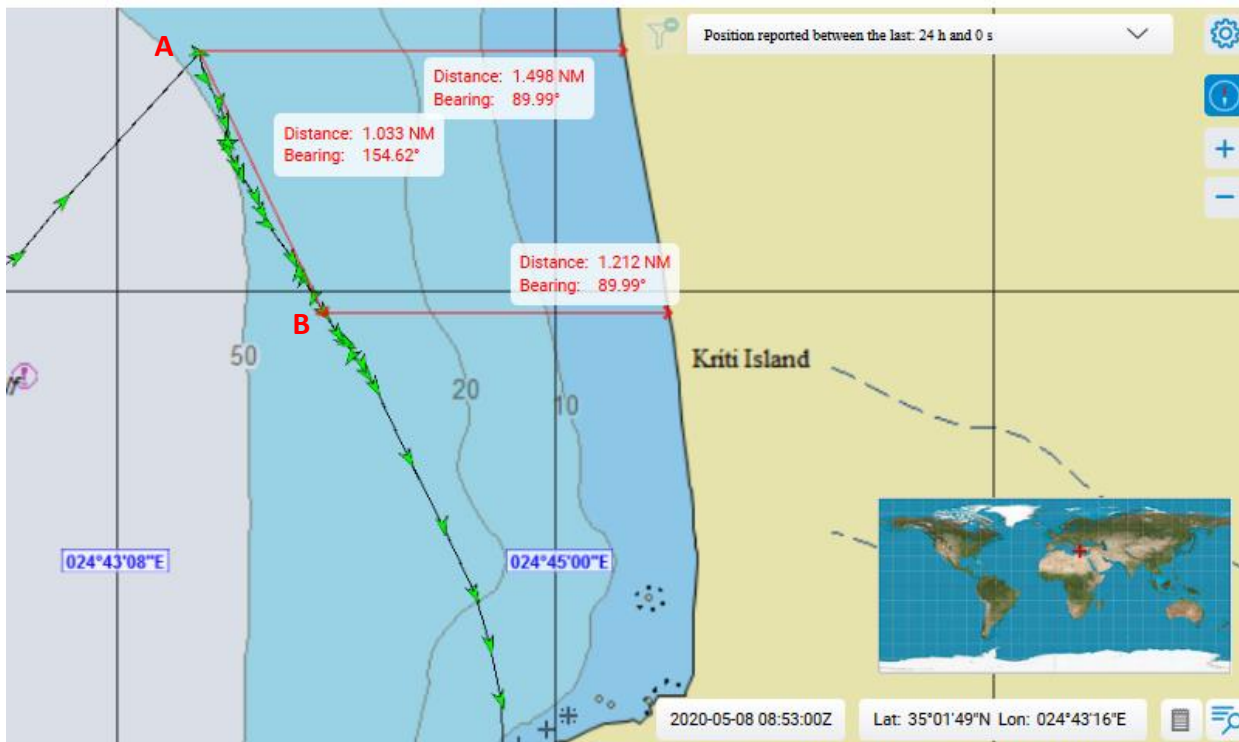
The Chief Officer who remained on watch notified the Master at approximately 03.00, when the convoy was at 1.2 nm from the coast, but had already drifted for more than 1 nm, under the waves' and wind's impact.

**Figure 13:** Depiction of the drifting of the VIKING from the time the Master handed over the watch (position A), to when he has summoned on the bridge by the C/O (position B)

The facts that took place from the anchoring position until the request for assistance by the Master reveal a case of inadequate risk assessment. The situation of the convoy as it appeared was not safe and secured before the handover of the watch to the Chief Officer, while the threshold of declaring the necessity of remedial actions and calling the Master at the bridge was not set at a reversible – for the developing situation – point, thus the Chief Officer called the Master after of more than 2 hours of continuous drift of the convoy and a drifting distance of more than 1 nm.

02/2018: Establish processes for ocean towage (based on the advisory provisions MSC/Circ.883) concerning contingencies due to bad weather and emergency handling with reference in particular to conditions of releasing the towed object, in order to support the decision making of Masters and Officers on board its vessels and ensure their safety.
