**HELLENIC REPUBLIC  
HELLENIC BUREAU FOR MARINE CASUALTIES INVESTIGATION**

**MARINE CASUALTY INVESTIGATION REPORT**

**07/2015**

**GROUNDING OF B/C GOODFAITH  
ON ANDROS ISLAND ON 11-02-2015**

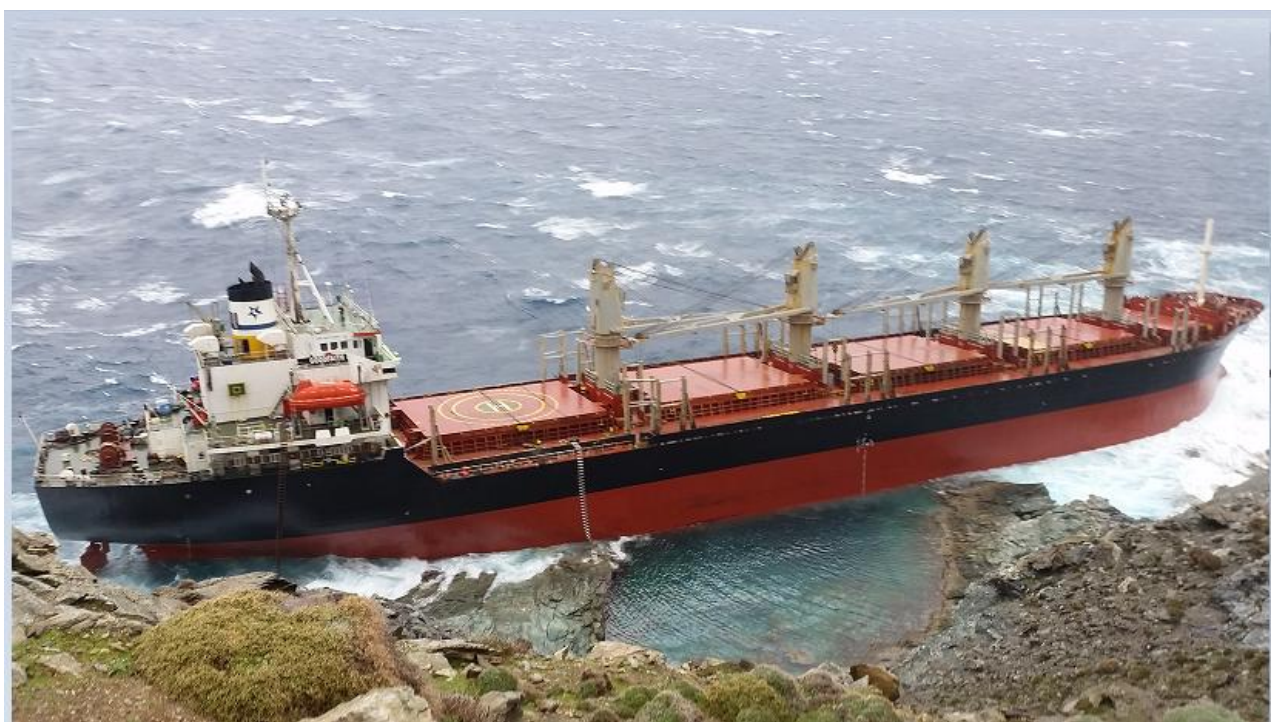
*Figure 1: Goodfaith grounded at Andros Island.*

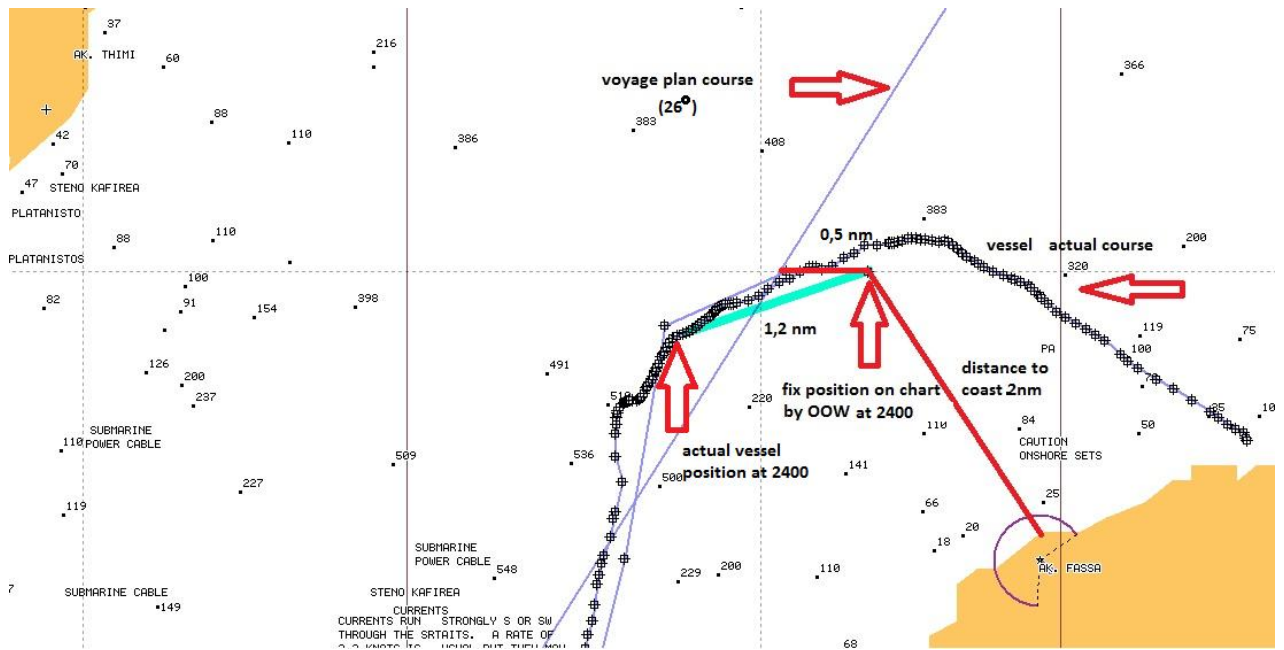
**Figure 7:** Goodfaith's last fixing position on chart at approximately 24:00 as marked on the chart by the OOW and actual vessel's position sailing through the exit of Steno Kafireas.

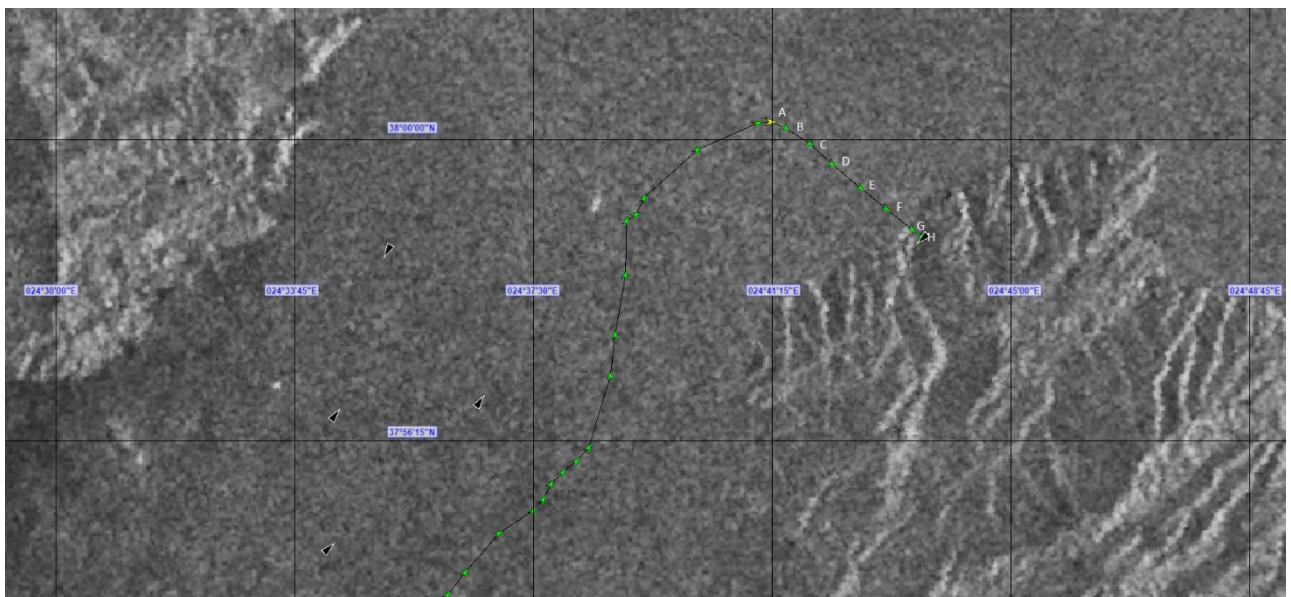
Figure 11 : Overview of Goodfaith passage to the grounding point as extracted by IMDatE

At 0105 in order the effects of the vessel's anticipated grounding to be minimized, the engine telegraph was set to Half Ahead followed by Slow Ahead at 0123. Vessel's SOG was reduced to 1 knot at approximately 0127. One minute later, at 0128 Goodfaith grounded on the rocky coastline at the Northwest seafront of Andros Island.

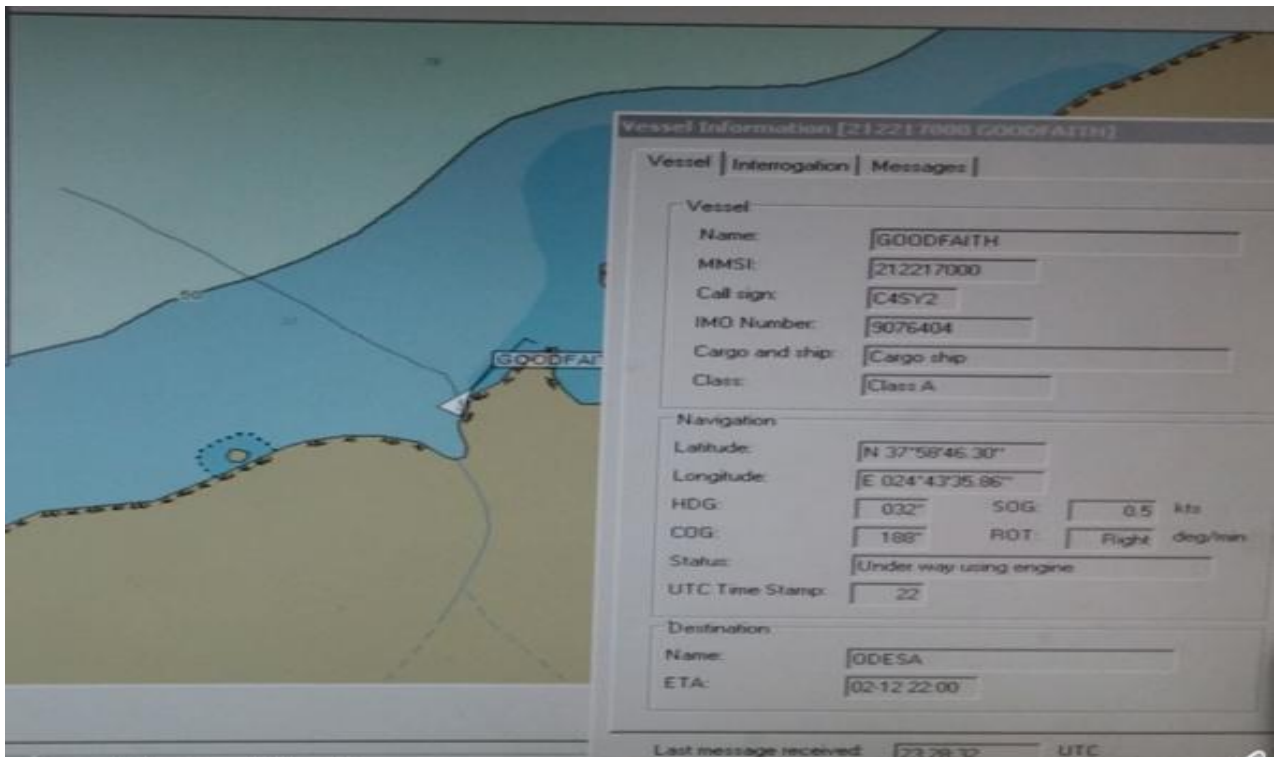
**Figure 12:** At 01:28' 32" Goodfaith grounded at position Lat.:37° 58' 46" N, Long.:24° 43' 36" E as recorded by HCG AIS system

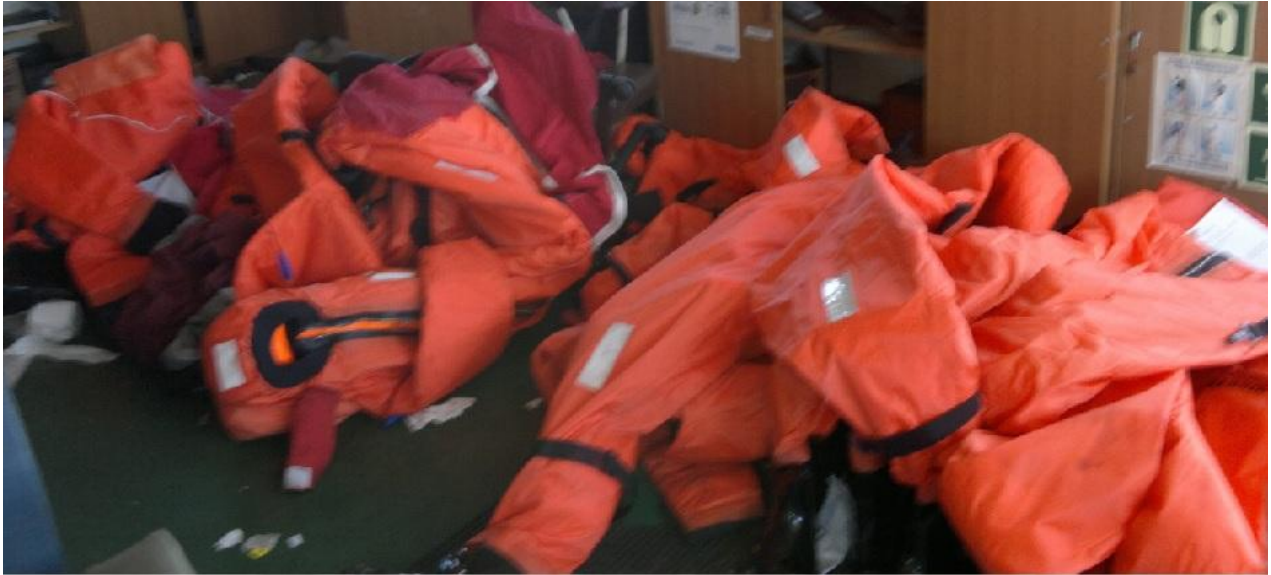
**Figure 13:** Immersion suits as were found after the crew's evacuation inside the bridge

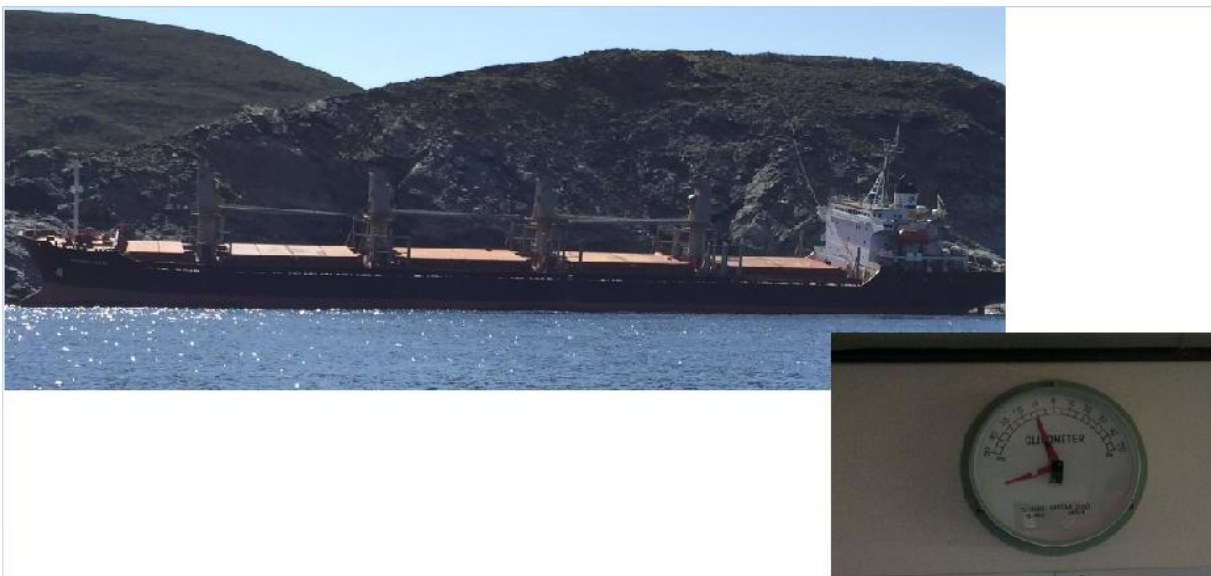
M/V Goodfaith was stranded lengthwise with her starboard side and wedged on a rocky slightly sloped flat reef, meters away from the coast's steep cliffs. Due to the strong impact and the fact that huge waves of 9-10 meters were unceasingly slamming her port side, covering her deck and causing striking violent rocking, the cargo hold water ingress alarm system was activated indicating that the hull was breached and cargo holds No.1 and No.2 were flooded. Consequently the vessel started listing about  $10^{\circ}$  to port. The Master urgently reported the ongoing situation to the Coastguard Authorities and requested again assistance for evacuating the vessel.

**Figure 14:** M/V Goodfaith grounding position and view from the clinometer inside the bridge indicating a list of  $10^{\circ}$  to port.

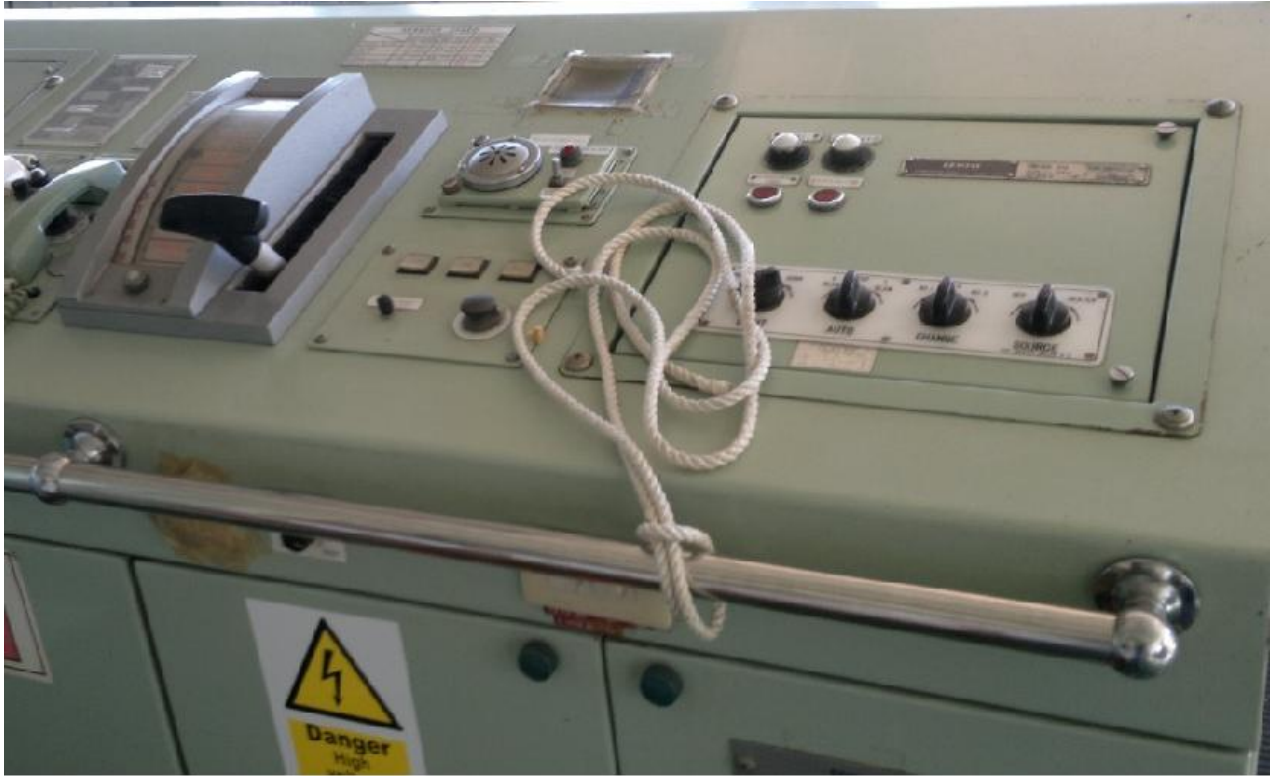
Figure 16: Ropes as were found after the evacuation process inside the bridge.

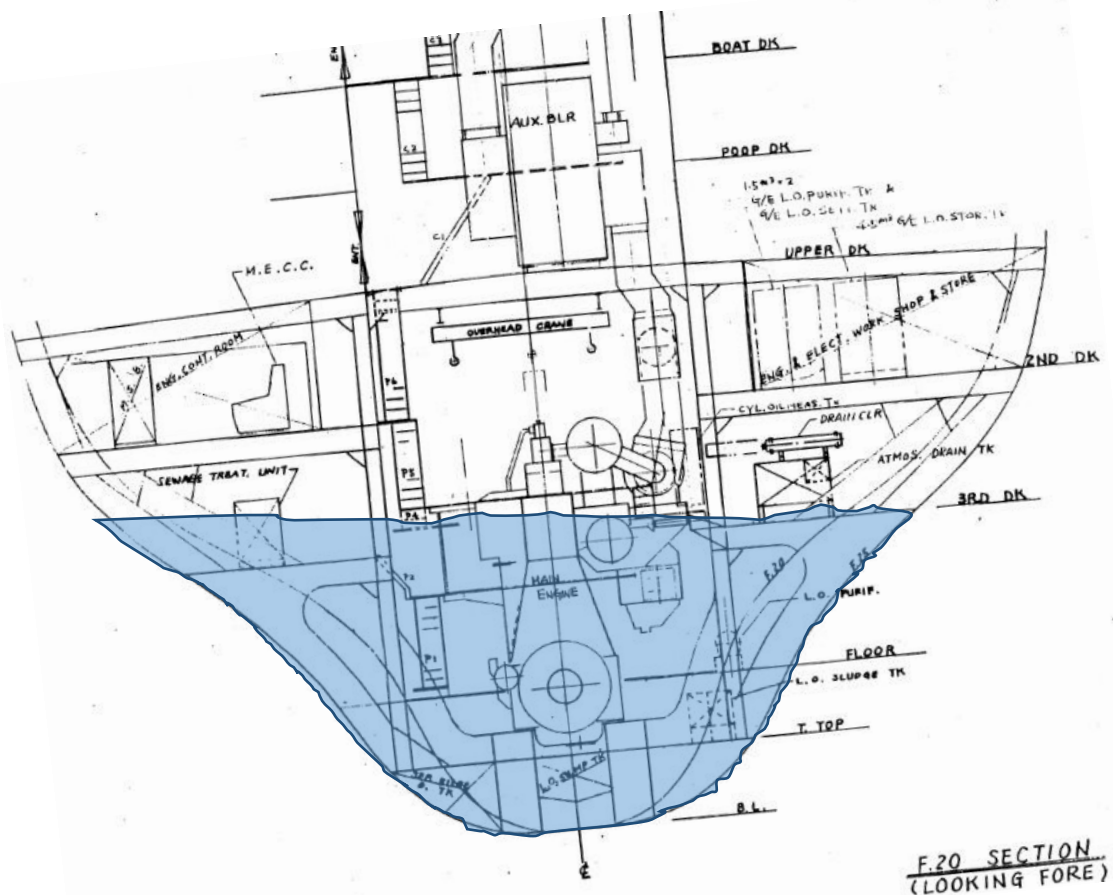
- Engine room was found flooded up to the 3<sup>rd</sup> deck level as shown in Figure 17 with oily water/sludges reaching the main engine scavenge space level on stbd side and purifiers room as well as main engine's emergency controls unit level on the port side. Moreover from the extent of the damages it was apparent that the engine room in whole and main engine in particular had been lifted upwards in various locations, as a result of the impact of the grounding. It appeared that the main engine had been rotated to port, with the port side displaced down and the starboard side displaced upwards. Consequently all machinery, electrical, automation and in general all equipment of the flooded compartment were considered completely damaged from the oily water contamination. Finally it was assumed that the double bottom tanks of the engine room had been heavily buckled/damaged in order such distortion at the top deck of the engine room and main engine braces to be evident.

**Figure17:** Depiction of engine room flooded and rotated to port for illustration purposes (source consultant company)

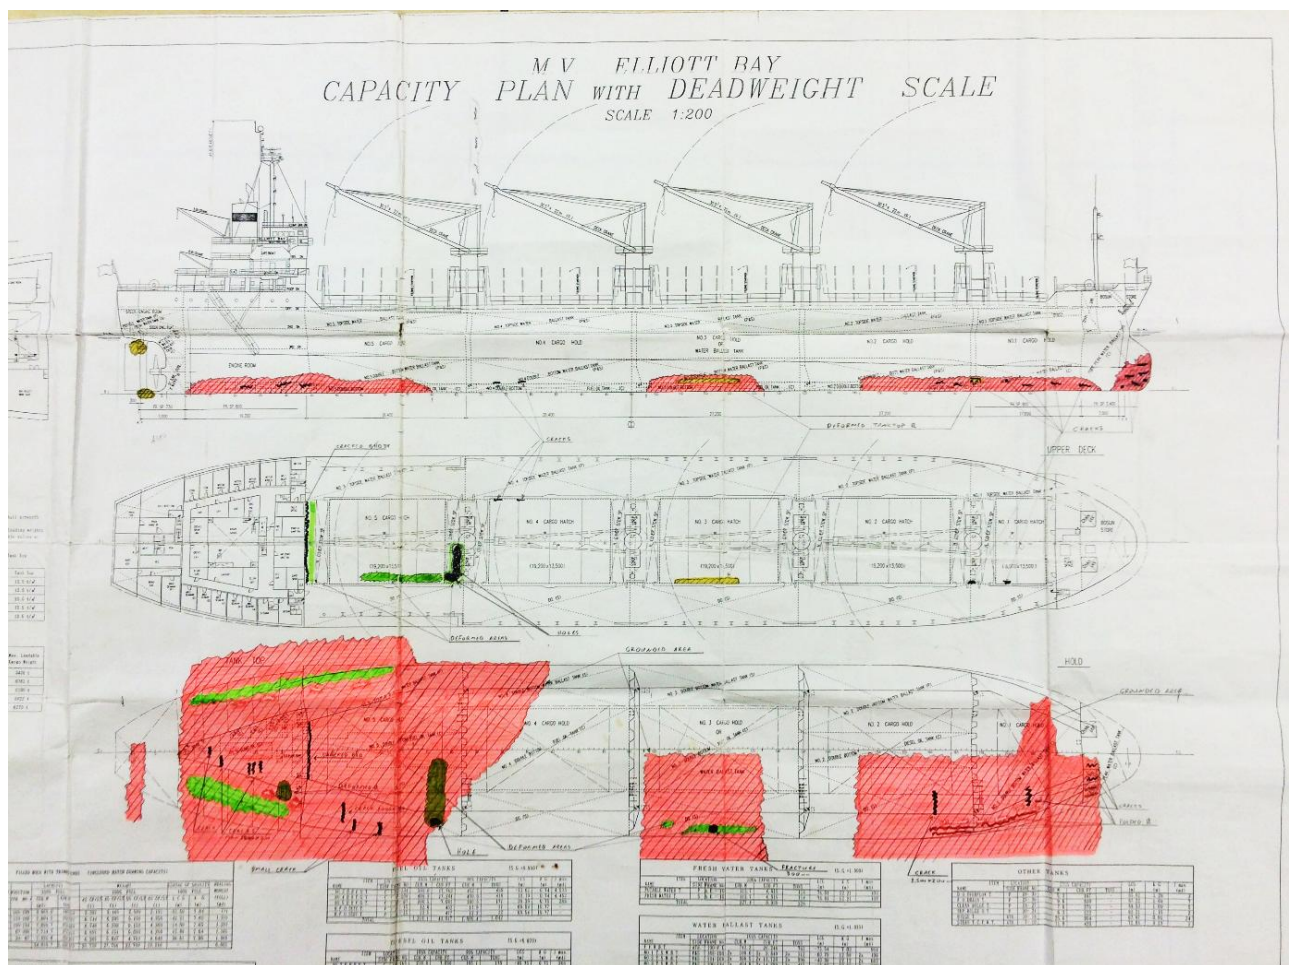
- Underwater hull damages ascertained by divers are summarized in the following Figure 18. Indicatively they included port side shell plating between frames 53 to 12, in way of Cargo hold No.5 and Engine room which were found heavily deformed/buckled. Starboard from forward to frame 190 (in way of the forepeak tank) side shell plating was heavily deformed with longitudinal fractures of various dimensions, extended over entire underwater area of bulbous bow. Additional areas were found heavily deformed with associated transverse and longitudinal cracks and holes where starboard side and bottom shell plating was touching the rocky seabed, in way of Cargo holds No.1, 2, 3, 5 and engine room as illustrated at figure 18.
- Finally it was estimated that the rudder system had suffered extensive damages from top to bottom including its foundation and surrounding structure.

**Figure 18:** Indicative depiction of damaged areas of Goodfaith as inspected by divers (green color indicates deformed areas, black color indicates cracks/holes/fractures, yellow color indicates deformed tank top, red color represent firmly grounded areas of the vessel (source consultant company).

The above description of underwater damages is not exhaustive since there was an extensive bottom damage that could not be inspected, particularly in way of double bottom tanks no.5 port, centre and starboard, and the engine room, as the vessel was sitting firmly on the rocky seabed all along the above areas. It appeared however that these cracks extended towards the centre line but full extend was unknown.

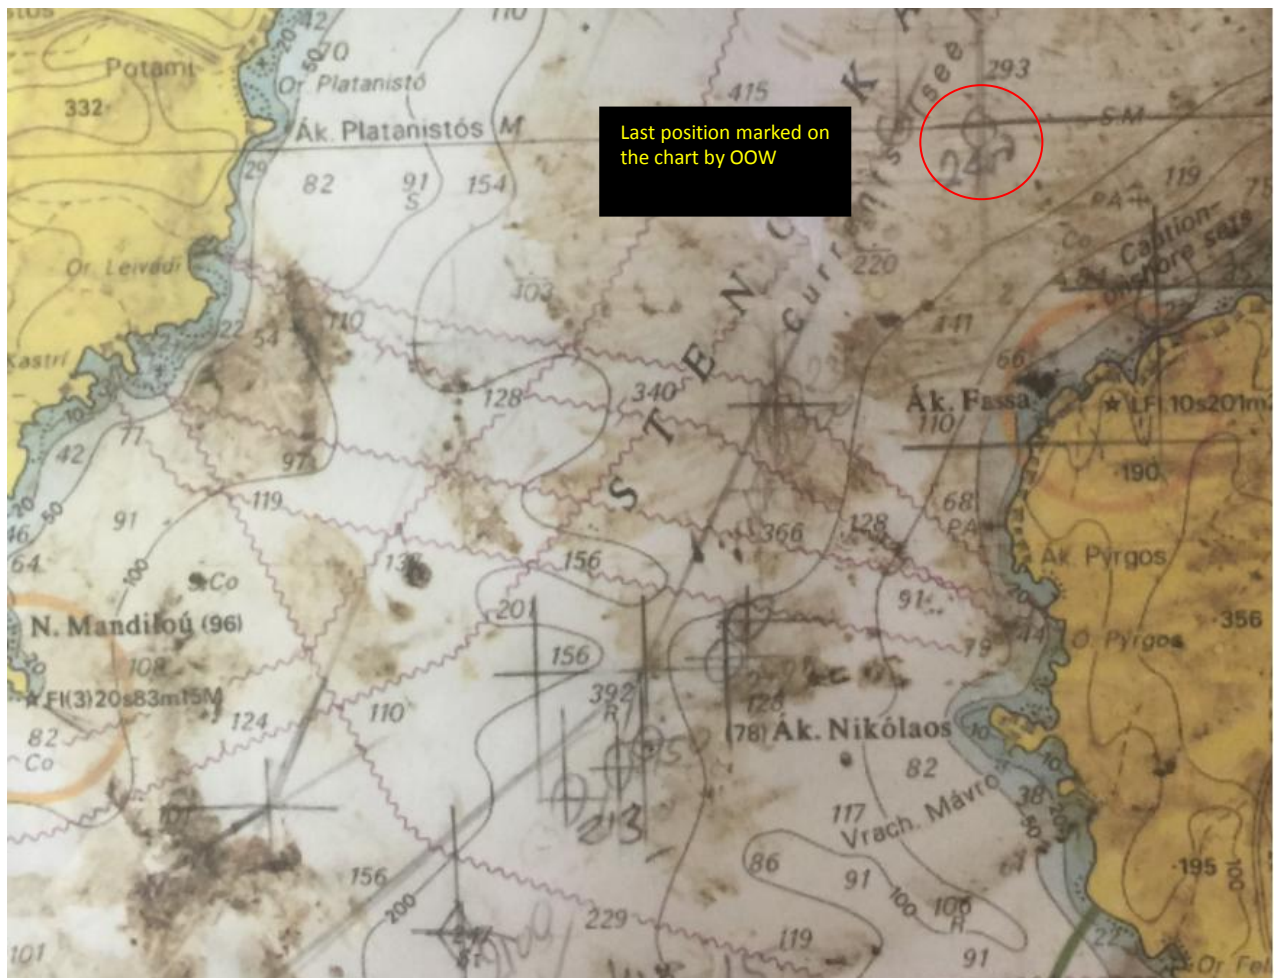
Additionally no safety contours were planned in order to alert the O(s)OW about the maximum allowable deviation from the planned course of the vessel. Considering the wrong position fixing of 2400, which indicated a drift of 0.5 nm east from the planned course, it is suggested that the utilizing of the safety contours would have alerted the OOW to monitor the vessel's COG and to take appropriate actions to follow the planned course by altering the heading to port. This would have provided different navigational conditions while exiting the Steno Kafireas and would have decreased the applied yawing forces due to the wind and waves to the vessel's bow that after a point overcame the turning force of the hard to port steering and the vessel could not restore her 30° course.

**Figure 28:** View of the used paper chart where frequent vessel's positions are shown at 2100, 2130, 2150, 2229 2300 and the last (wrongly) recorded position at 2400 respectively.

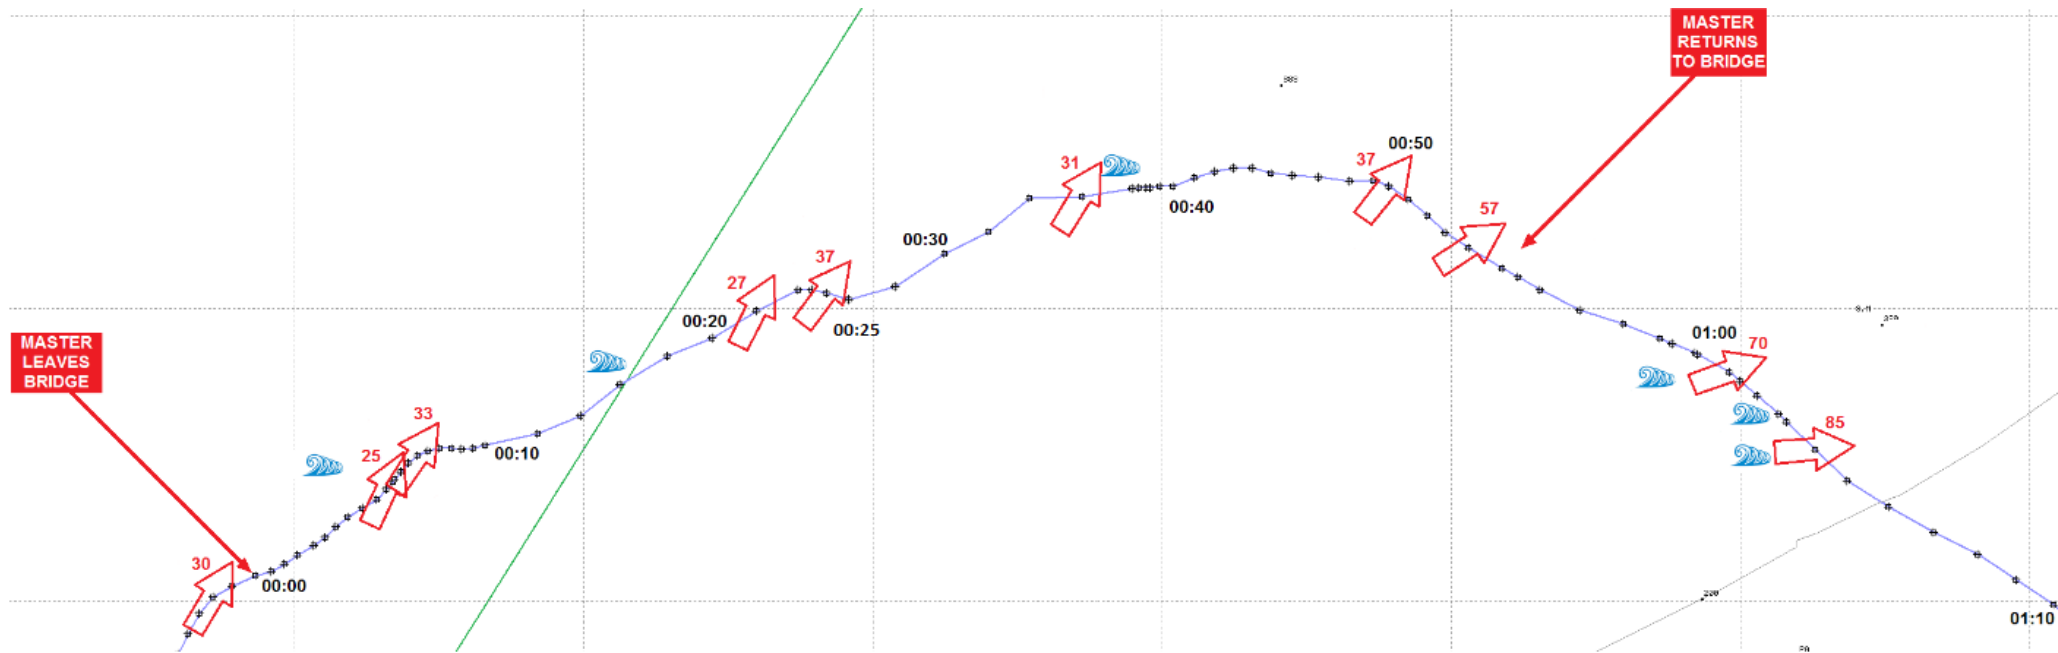
**Figure 29:** Goodfaith's voyage plan (green line) and actual course (blue line) as plotted on the electronic chart for the period when the Master was not on the bridge. The red arrows and numbers indicate the vessel's HDG. The effect of the strong waves and winds to the vessel's drifting is also indicated by the blue wave icons, as their effect can be heard causing intense vibrations in the bridge (sourceS-VDR data).

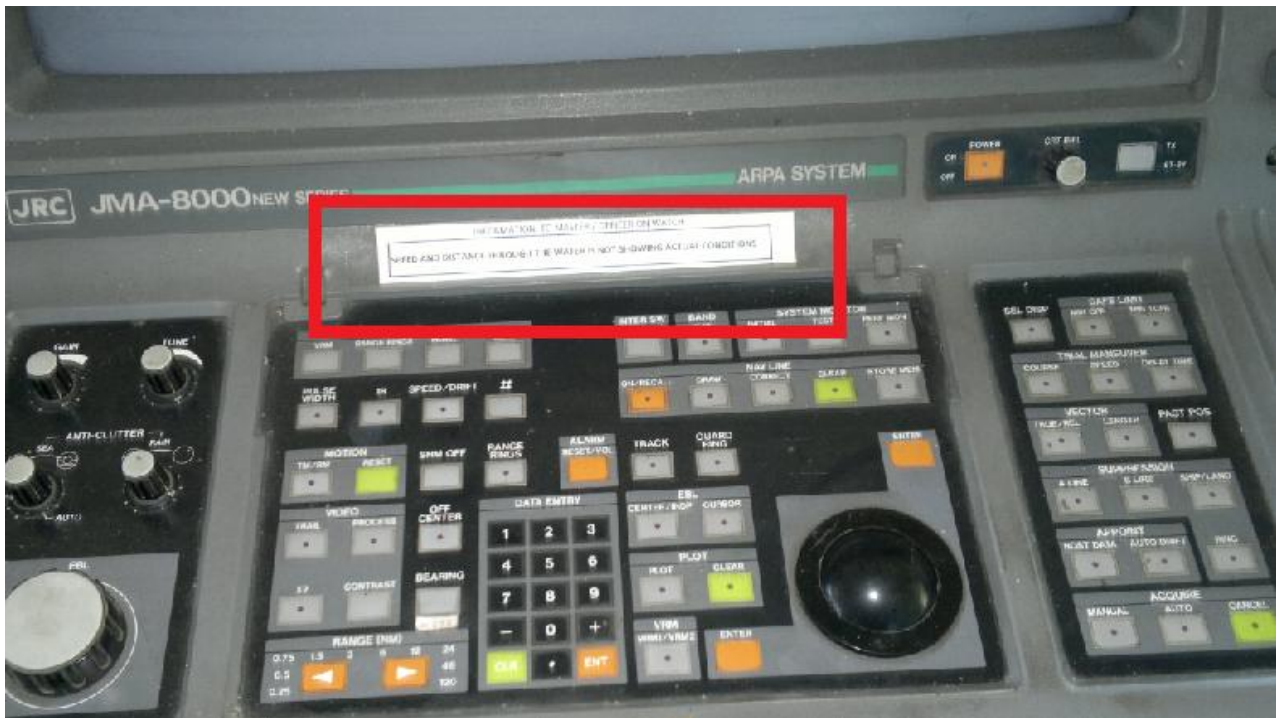
**Figure 32:** Vessel's radar equipment marked with note that speed and distance through the water is not showing actual conditions.
