HELLENIC REPUBLIC
HELLENIC BUREAU FOR MARINE CASUALTIES INVESTIGATION
MARINE CASUALTY SAFETY INVESTIGATION REPORT
15/2013

Collision between
M/V BARU SATU & M/V KATHERINE
4.5 n.m. SE from Mantili Isl., Steno Kafirea, Greece

July 2018

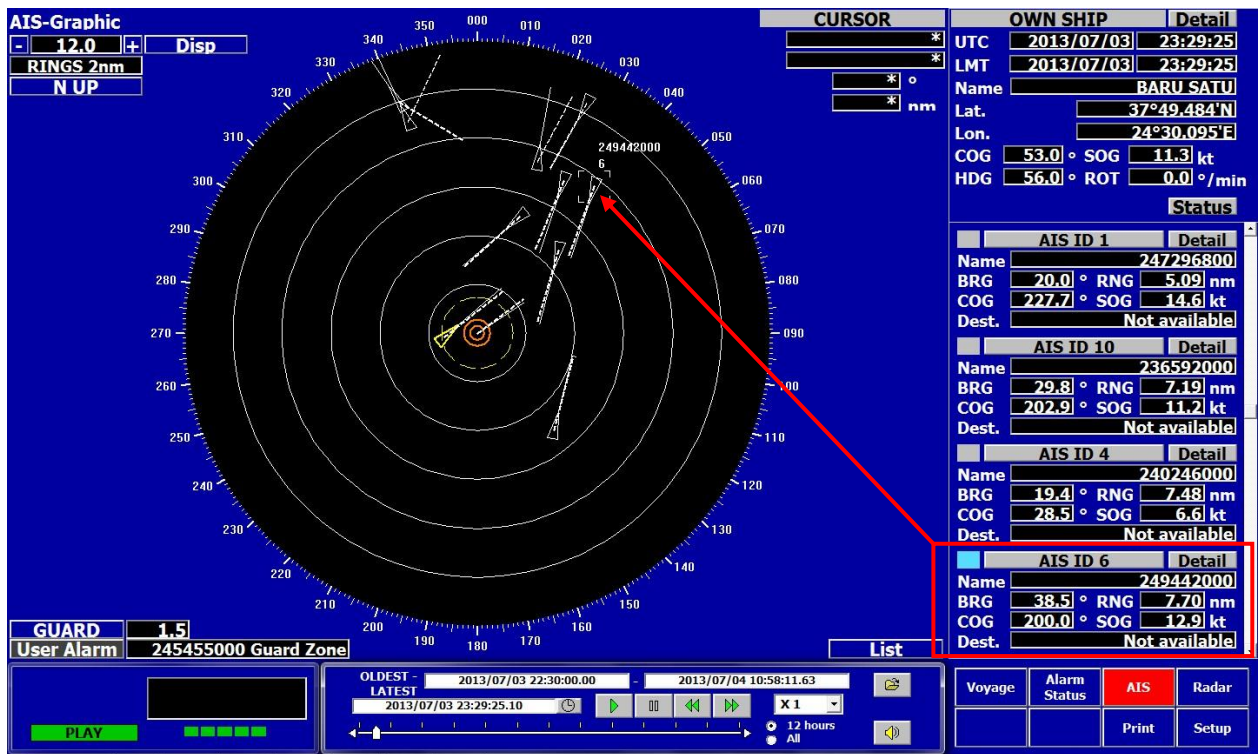
Baru Satu had overcome a vessel at her port side which was approximately at a distance of 2nm to her port stern. Katherine was overcoming a vessel at approximately 1 nm distance to her starboard side which was steaming with a speed of approximately 11 knots and with a COG of 203° while one more vessel was at 3 nm ahead steaming at a speed of 12,9 knots and with a COG of 198° (see **picture 3.3/1**).

Picture 3.3/1: Depiction of AIS feature from Baru Satu VDR data at a range of 12 nm. Katherine target and navigational data are marked with red.

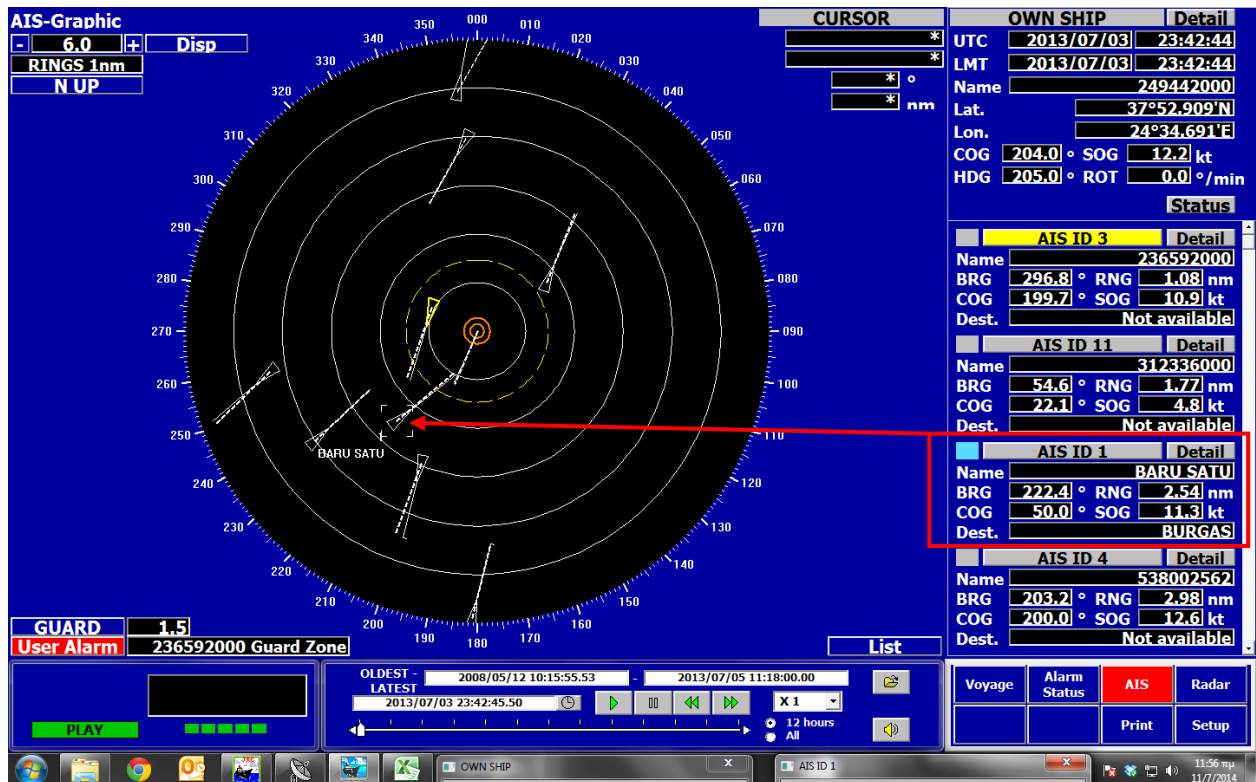
The two vessels proceeded with the same course and speed until 02:42:45 when Katherine started altering her course to Starboard. At that time the vessel that was ahead of Katherine was cleared from Baru Satu's course and the distance between Katherine and Baru Satu was approximately 2.5 nm (see **picture 3.3/2**).

Picture 3.3/2: Depiction of AIS feature from Katherine VDR data at a range of 6 nm. Baru Satu target and navigational data are marked with red.

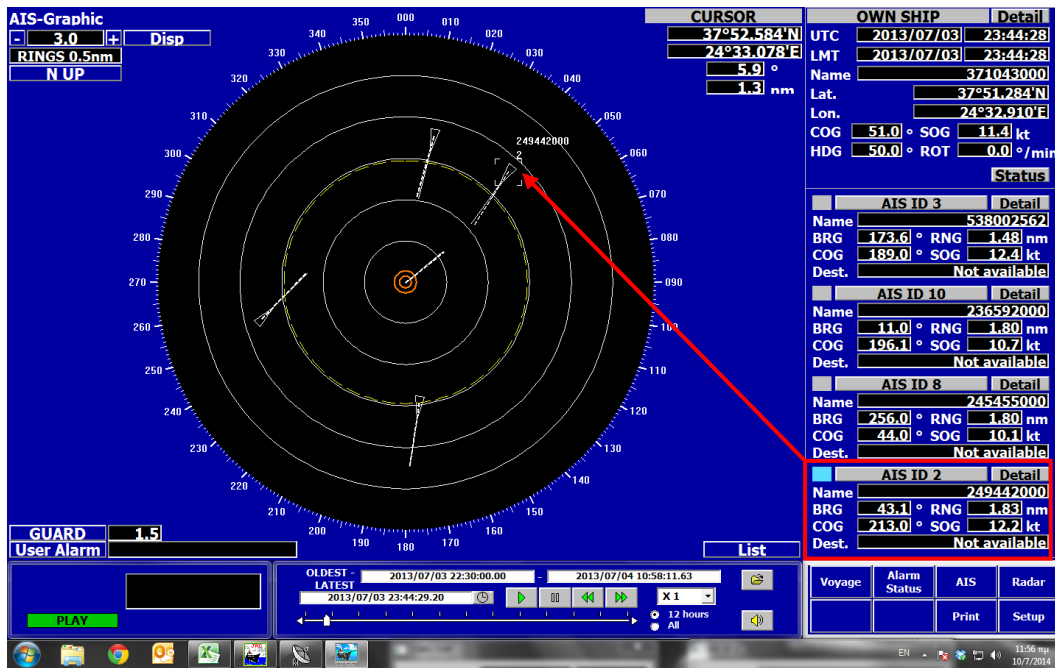
Picture 3.3/3: Picture of AIS feature from Baru Satu VDR data at a range of 3 nm indicating the position of the two vessels when Baru Satu started turning to port. Katherine target and navigational data are marked with red.

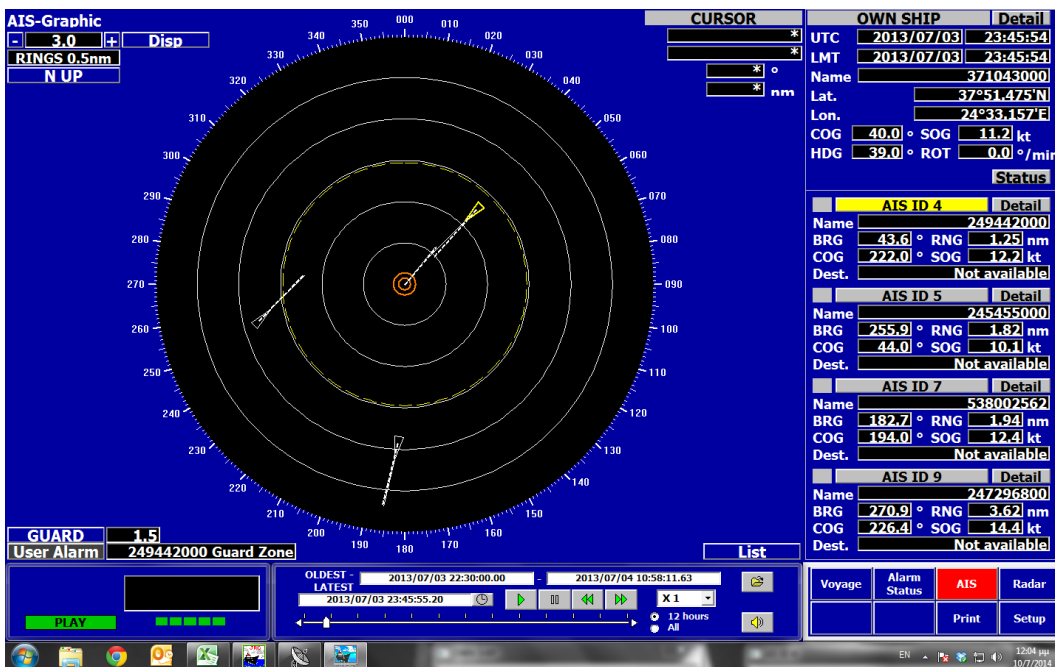
Shortly after, at 02:44, and while the vessel was keeping a course of 050°, the OOW of Baru Satu ordered the AB to put the rudder 5° port. At that time Katherine was still turning to starboard and she was at 1,8 nm distance with a bearing of 007° to the port, that means that she was almost at the bow of Baru Satu. More specifically, Katherine's heading was 216°, and her COG was 213° (see **picture 3.3/3**). It was reported that the OOW of Baru Satu attempted to turn the vessel to port in order to increase the distance between the two vessel's as he assessed that Katherine would cross Baru Satu's starboard bow. For said assessment of the situation he used only the vector feature of the radar and he didn't check other parameters such as the CPA and TCPA. Baru Satu continued turning to port until 02:45:45 when the OOW ordered the helmsman to maintain a course of 040°. At that time Katherine's heading was 224° and she was at a distance of 1,3 nm (see **picture 3.3/4**).

Picture 3.3/4: Picture from AIS feature of Baru Satu VDR data at a range of 3 nm shortly after the OOW ordered a 040° course.

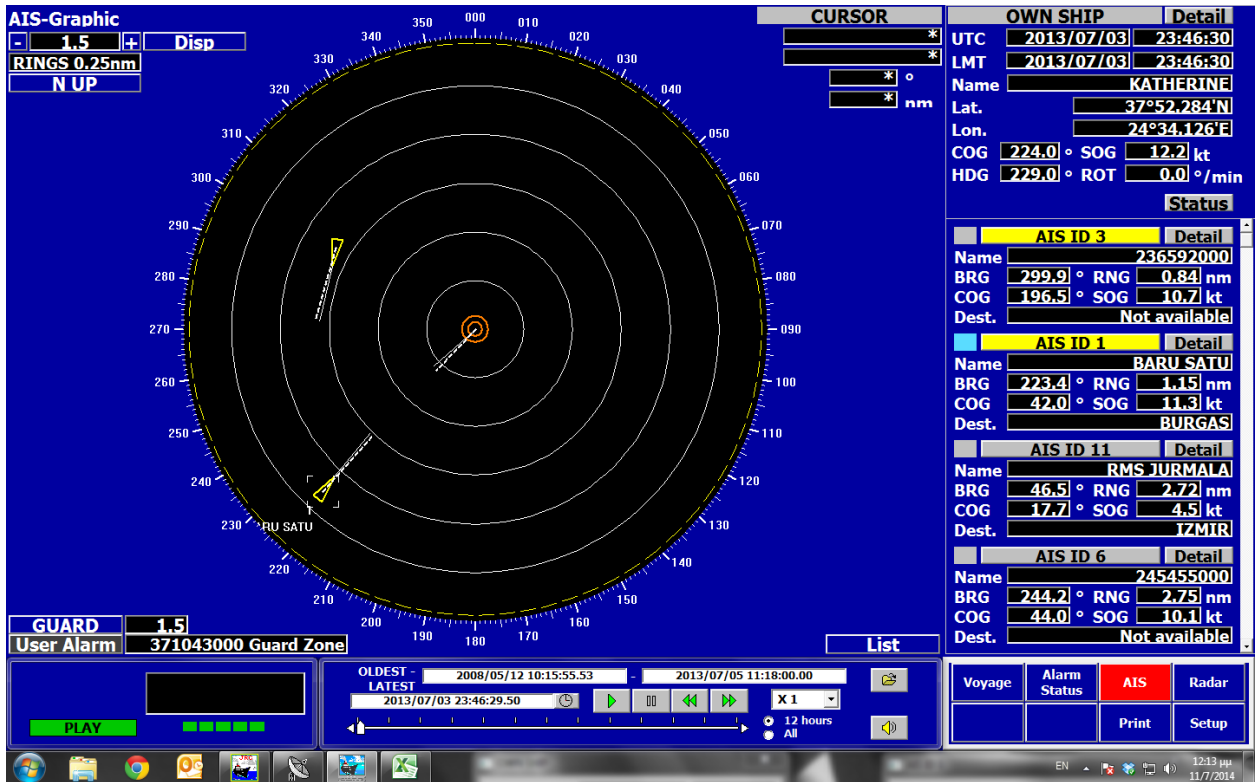
At 02:46:30 Baru Satu OOW ordered the AB to put the rudder 5° to the Port, while at the same time Katherine had stopped turning to Starboard. At that time the two vessels were steaming at almost opposite courses and the distance between them was 1.15 nm (see **picture 3.3/5**).

Picture 3.3/5: Picture from AIS feature of Katherine VDR data, at 23:46:30.

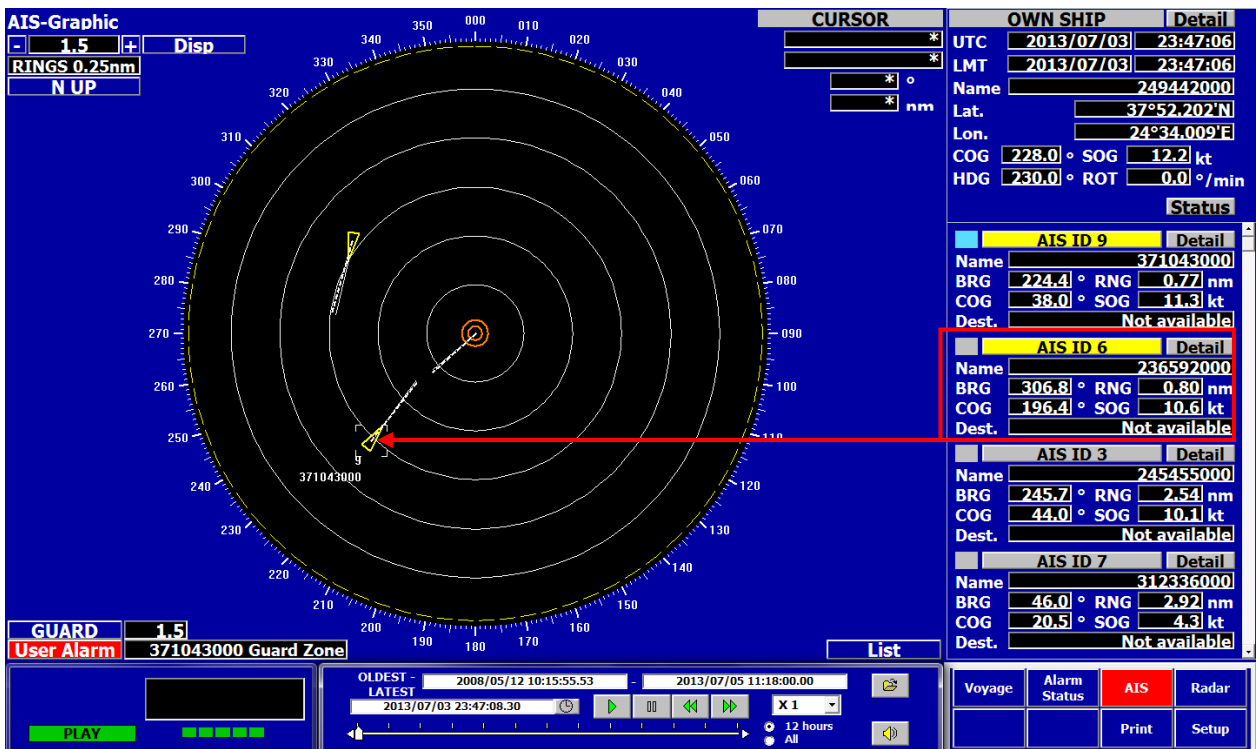
Shortly after, Katherine OOW called again on the VHF stating the name of his vessel and asking again for a Port to Port passage. At 02:47:00 Baru Satu OOW responded on the VHF and informed Katherine that he was already turning to port. At that time the distance of the two vessels was 0,82 nm, Baru Satu was turning to port with her rudder at 5° Port, and Katherine started turning heavily to Starboard, most probable following a hard to Starboard order of her OOW (see picture 3.3/6).

Picture 3.3/6: Picture from AIS feature of Katherine VDR data, at 23:47:06.

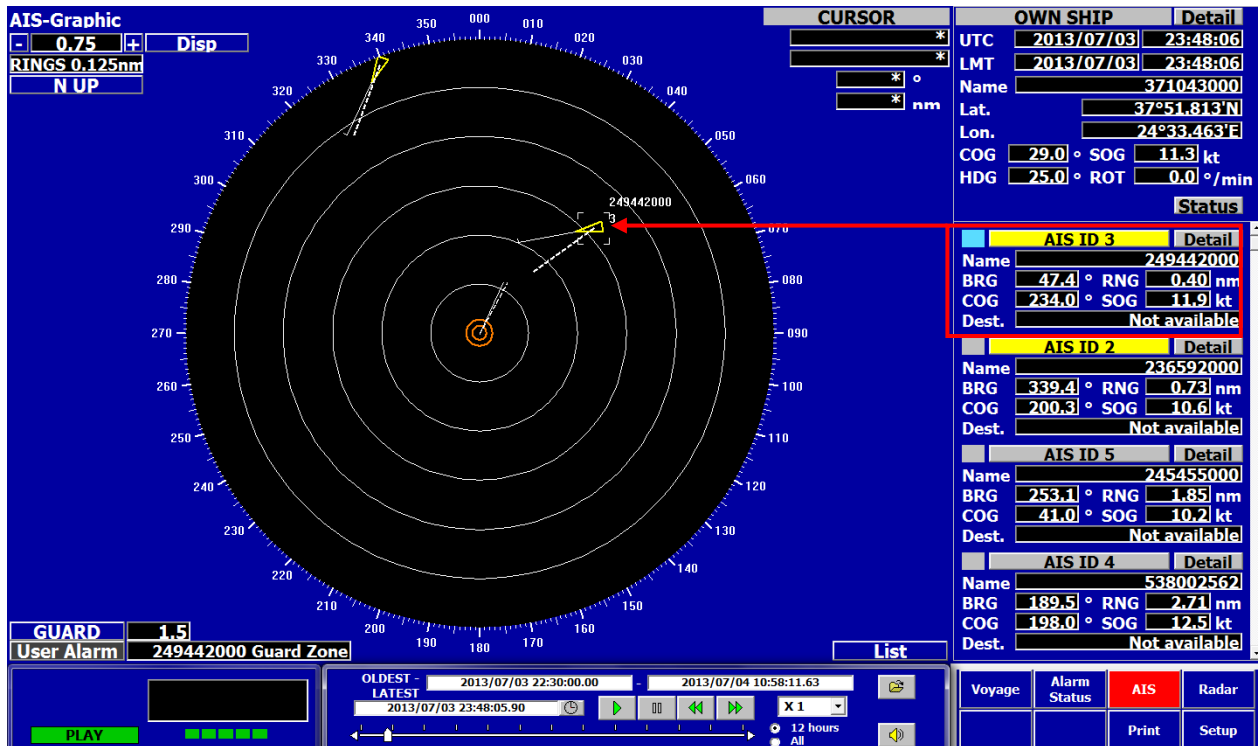
At 02:48:05 Baru Satu AB reported to the OOW that the vessel’s course was 025° and the OOW ordered him to keep it steady. The distance of the two vessels at that time was 0,4 nm and Katherine was still turning hard to starboard (see **picture 3.3/7**).

Picture 3.3/7: Picture from AIS feature of Baru Satu VDR data, at 23:48:06.

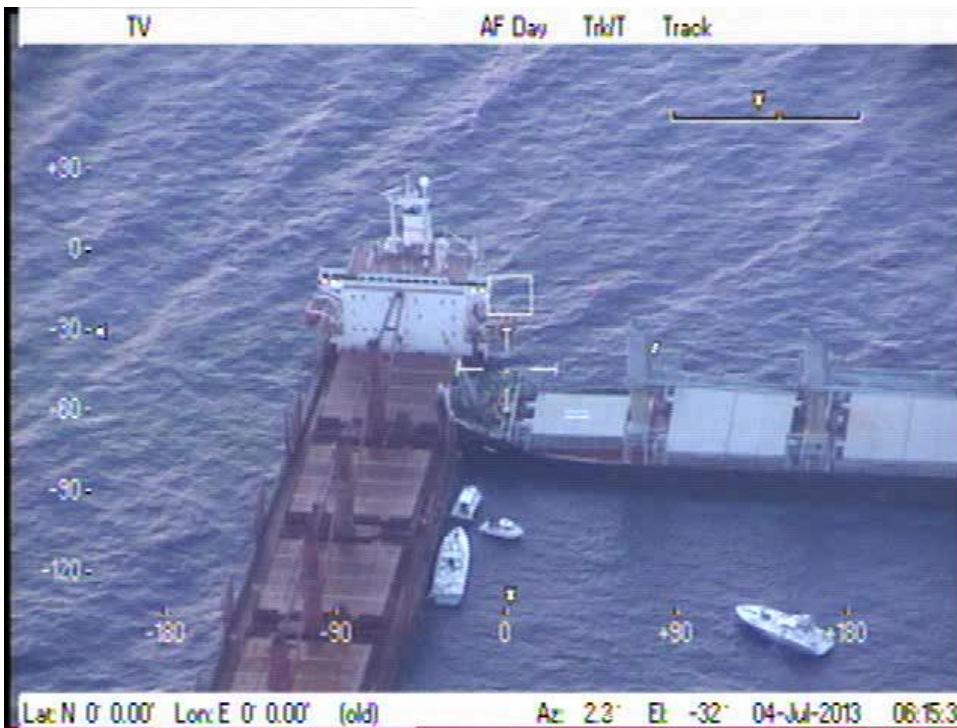
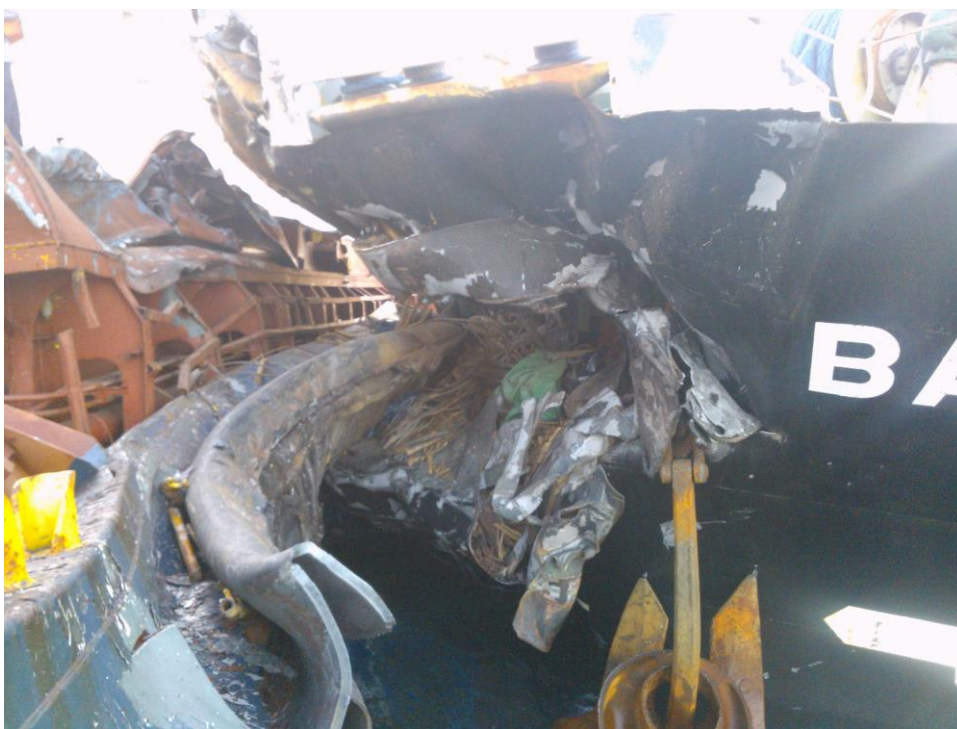
The OOW of Katherine requested again through VHF a port to port passage and at 02:48:25 Baru Satu OOW ordered a hard to starboard turn. However the vessels were already very close and at 02:48:56, at position lat: 37° 52,036 N, long: 24° 33,639 E, Baru Satu hit with her stem post the starboard side of KATHERINE at No 5 cargo hold. At the time of the collision Baru Satu and Katherine heading were 030° and 278° respectively and both vessels were steaming at a speed of approximately 11 kts.

Pictures 3.3/8 & 3.3/9: Photos of the collided vessels and the point of contact.

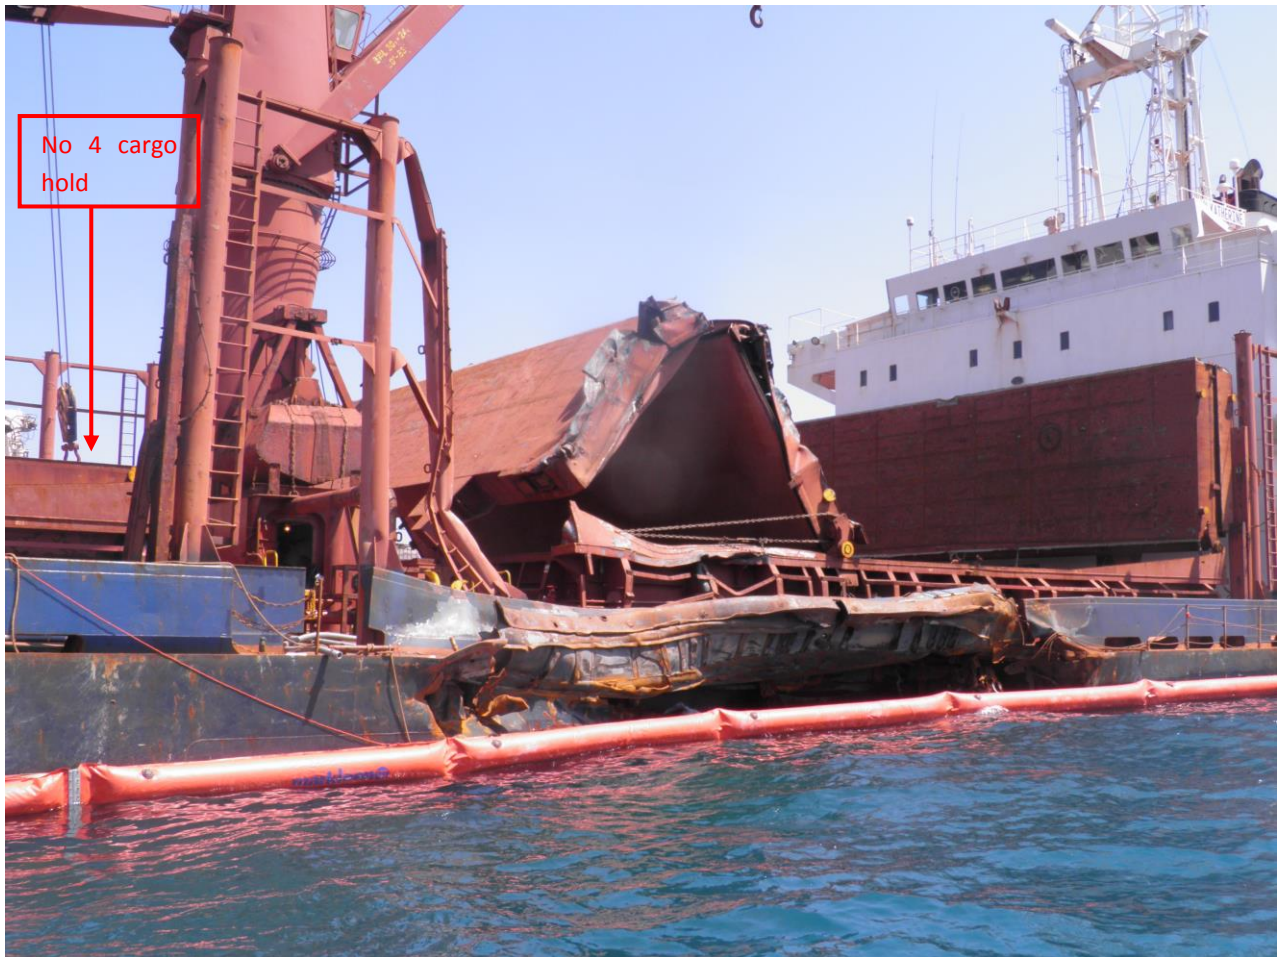
It should be noted that if the point of contact and the sustained damages on Katherine were not localized to the area of No 5 cargo hold and were expanded also to one of the adjacent compartments (engine room or No 4 cargo hold) the vessel might not have remained afloat.

Picture 3.5/1: Photo of Katherine collision area showing the proximity of No 4 cargo hold.

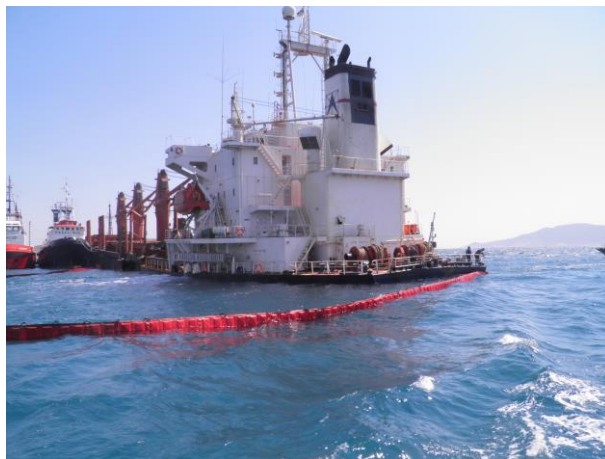
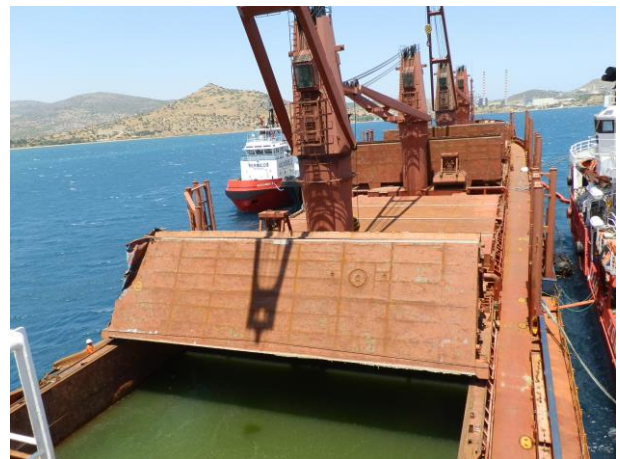
vessel suffered damages around the collision area and that No 5 cargo hold and three water ballast tanks had flooded.

Pictures 3.5/2 & 3: Photos of Katherine at Thoriko bay and the flooded No 5 cargo hold.

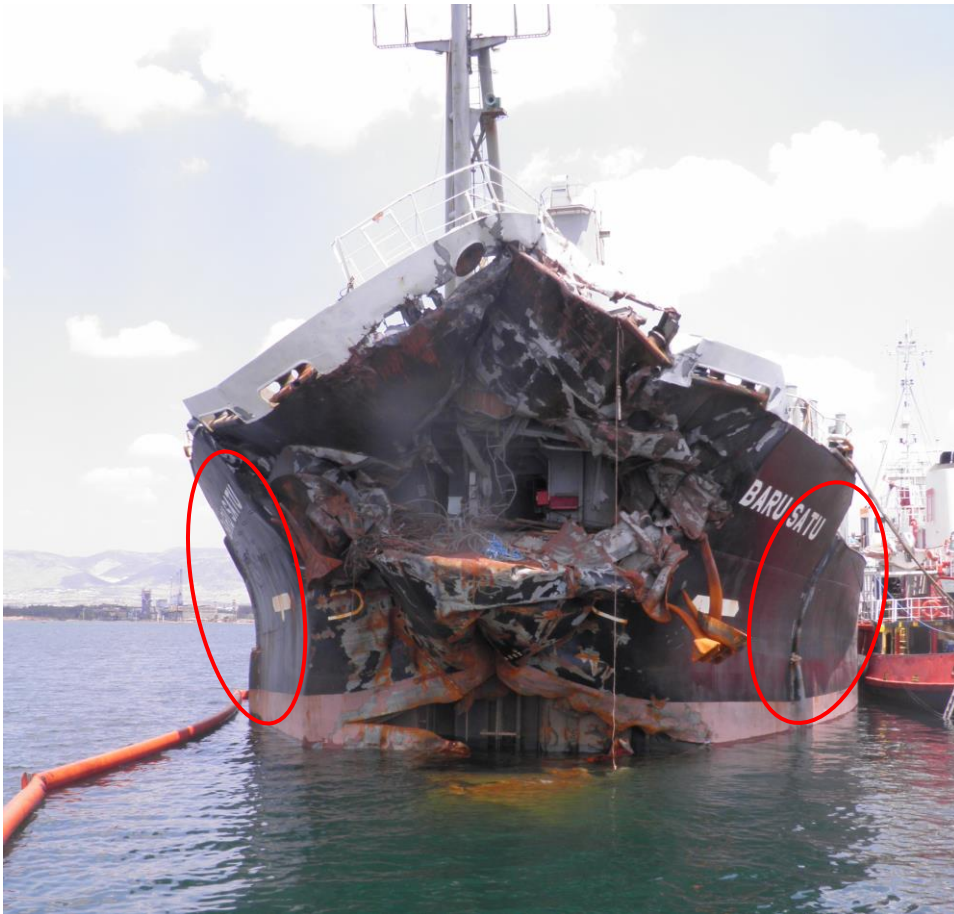
Picture 3.5/4:

Baru Satu fore part was severely damaged. The bow area over the bulbous was completely destroyed, and the area of the fore collision bulkhead including the side shell plating of No 1 Top Side Ballast tanks suffered heavy deformations and cracks which allowed the sea water to enter into the No 1 cargo hold.

Photo of Baru Satu bow at Elefsis Gulf indicating the side shell plating deformations.

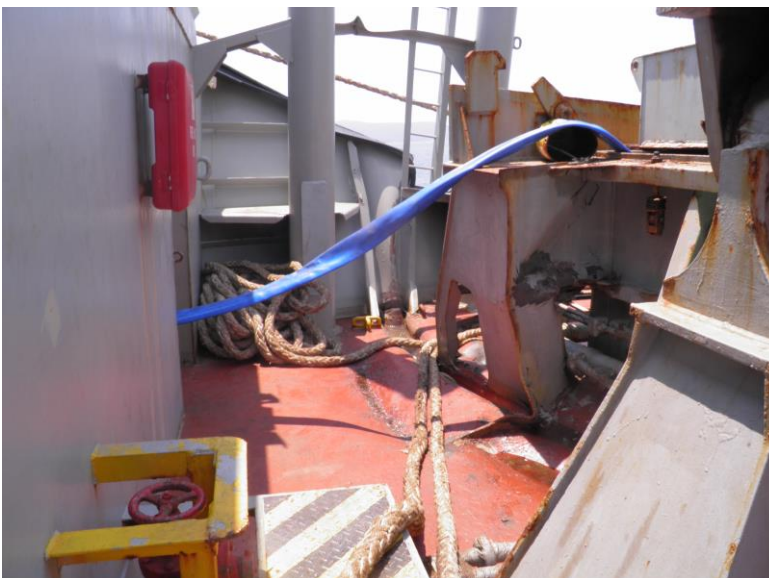
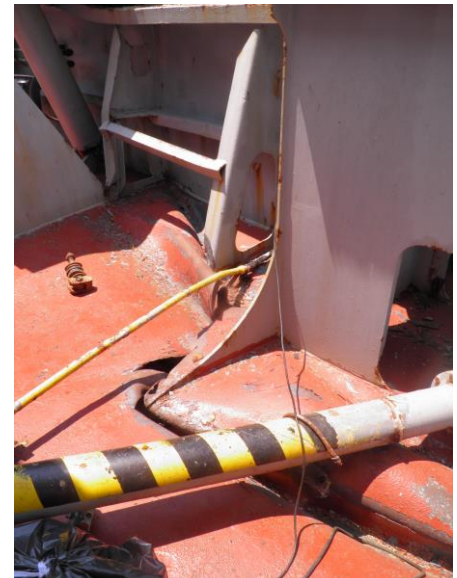
The Master ordered the C/O to go to the bow and inspect the damages and sound the tanks and cargo hold bilges. The inspection revealed that sea water had entered into the Fore Peak Tank as well as to No 1 Cargo Hold. It is noted the cargo of sugar that was in No 1 cargo hold prevented the water from reaching at the bottom level and therefore the sounding of the hold's bilges did not indicate any water level. Nonetheless the water ingress to No 1 cargo hold was visible from the deck through the openings on the hold's cover caused by the denting of the shell plating.

Pictures 3.5/5 & 6: Photos of Baru Satu indicating the deck plating deformations at the area between No 1 cargo hold and the forecastle.

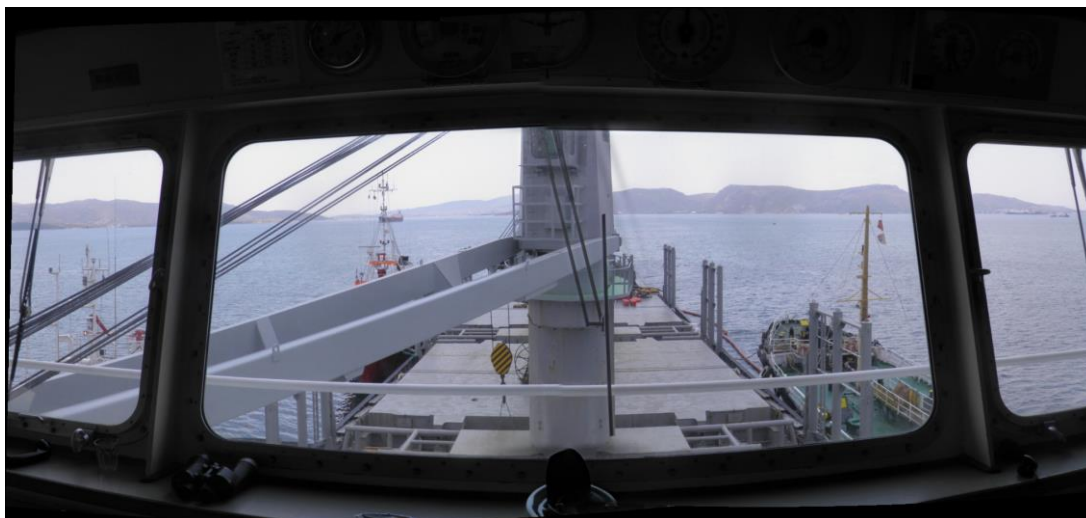
The wheelhouse arrangement offered a good field of vision to the navigated sea area apart from the straight ahead view sector which was obstructed by the vessel's deck cranes. Said blind sector is common to this type of vessels with deck cranes and can be administered by the continuous movement of the navigational watch crew.

Picture 4.1.1/3:
View from Baru Satu conning position

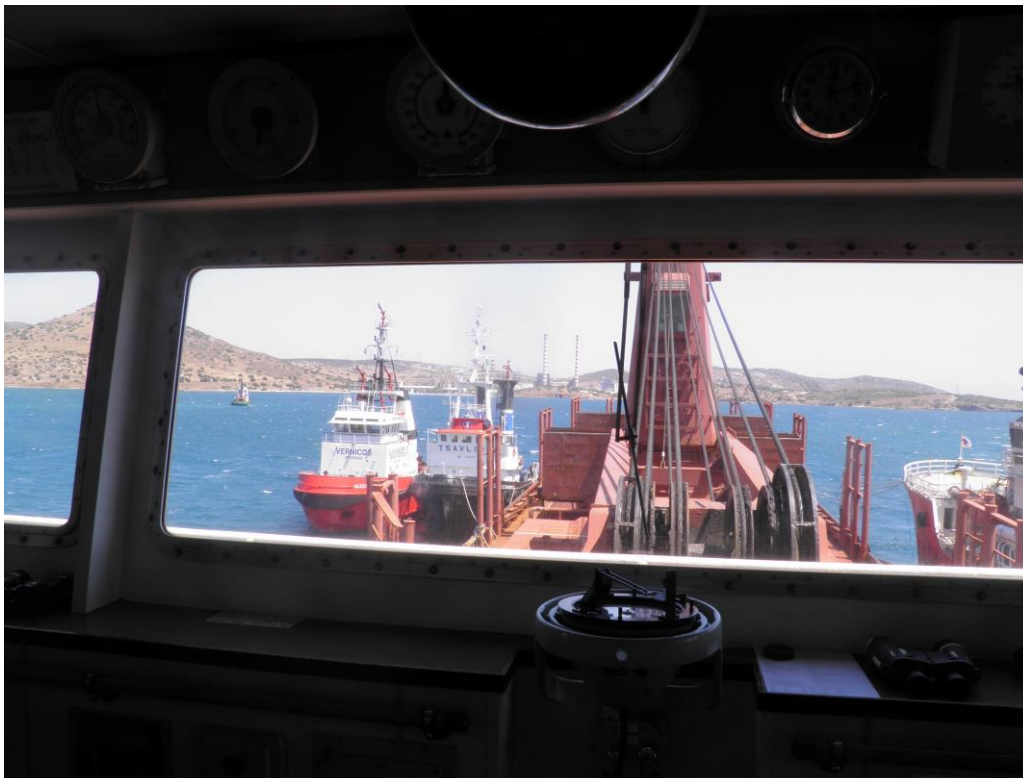
The wheelhouse arrangement offered a good field of vision to the navigated sea area; however a blind sector was created by the vessel's deck cranes.

Picture 4.1.2/3:
Photo of the view from the conning position

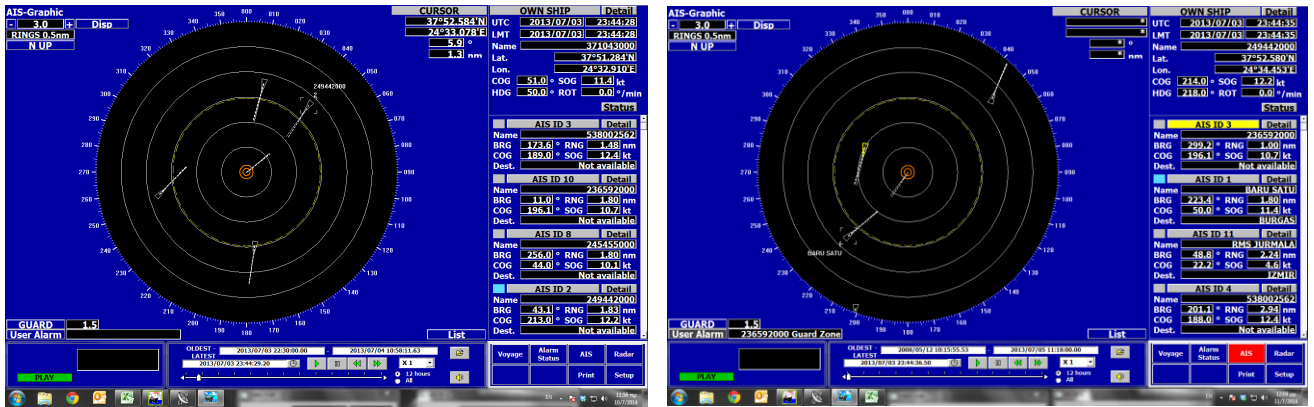
In light of the above and taking into account that the OOW of Baru Satu had not noticed the course alteration when he decided to put the rudder 05° to Port, it is inferred that Katherine's alteration of course was not large enough to be readily apparent to Baru Satu. Nonetheless it should be noted that a larger alteration of Katherine's course might have been restricted by the presence of another vessel at her starboard side which was at a distance of 1 nm and was following almost a same course (**Picture 3.3/2**). Moreover, an earlier action by the OOW of Katherine would have provided more time to the OOW of Baru Satu to assess Katherine's course and identify her starboard turning.

Pictures 4.2.2/1&2: Depiction of AIS feature of VDRs at the time when Baru Satu altered her course to port at 02:44:36.

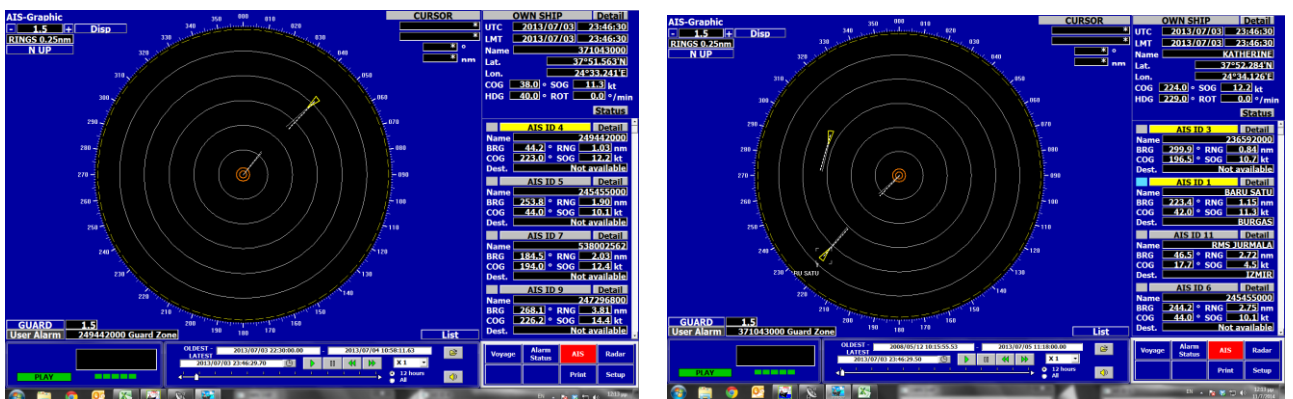
Based on the above it derives that the decision of Baru Satu OOW to alter the vessel’s course to port during a “head-on” situation was in total disregard to the applicable Rule of the COLREGs. It is noted that the same stands also for the decision to turn again to port at 02:46:30 as according to AIS feature of the VDRs, Katherine was still at Baru Satu bow, although she could have passed slightly to her starboard (pictures 4.2.2/3 & 4).

Pictures 4.2.2/3 & 4: Depiction of AIS feature of VDRs at the time when Baru Satu altered her course to port at 02:46:30.

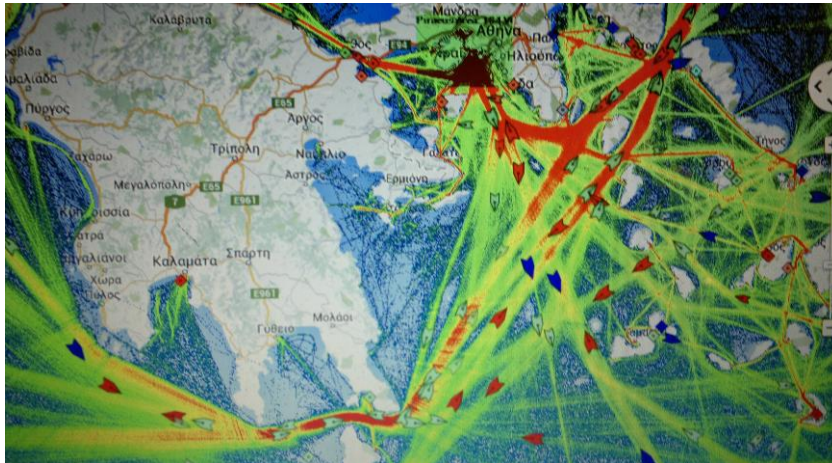
Picture 4.6/1:

In relation to the above, it is noted that the South Evoikos area and the Steno Kafireas are included to the ordinary routes of vessels that are trading between ports of Mediterranean Sea, Marmaras Sea and Black Sea and therefore an increased vessel traffic should be anticipated. Indicatively **picture 4.6/1** provides a statistical depiction of said navigational area for the last semester of 2013.

Depiction of vessel traffic at South Evoikos and Steno Kafireas.

COLREGs. The failure to identify the risks due to the increased traffic at the area is considered a contributing factor to the examined marine casualty.
