HELLENIC BUREAU FOR MARINE CASUALTIES' INVESTIGATION

MARINE CASUALTY SAFETY INVESTIGATION REPORT
18/2013

DEATH OF SEAFARER ON BOARD C/V EVER URBAN

October 2019

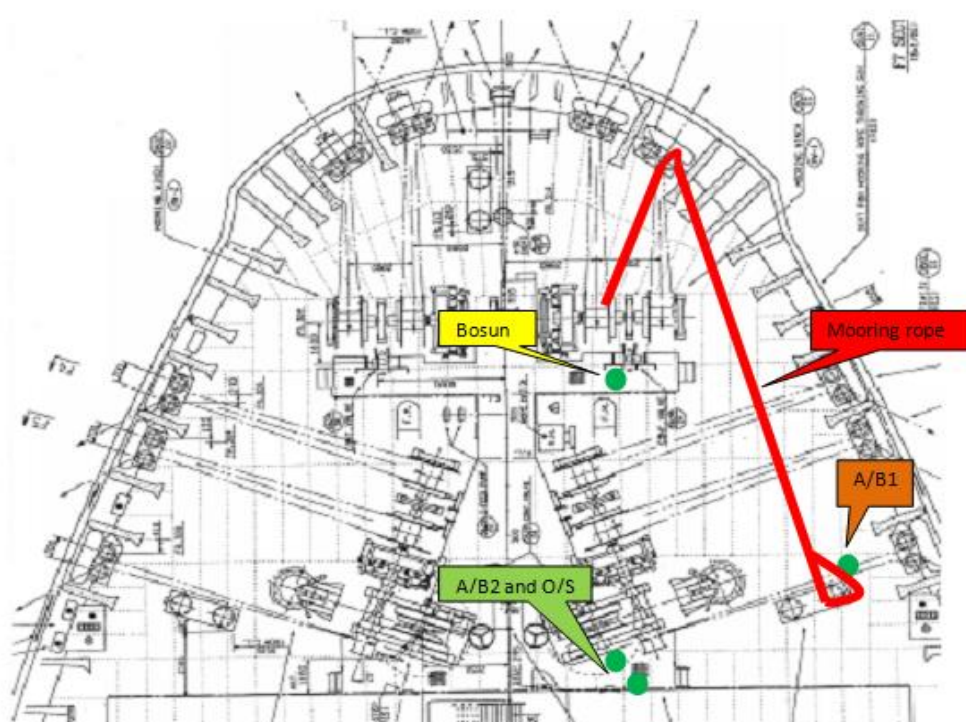
Figure 3: Overview of the forecandle deck with the rope under repair and the positions of the crew members at the moment of the accident.

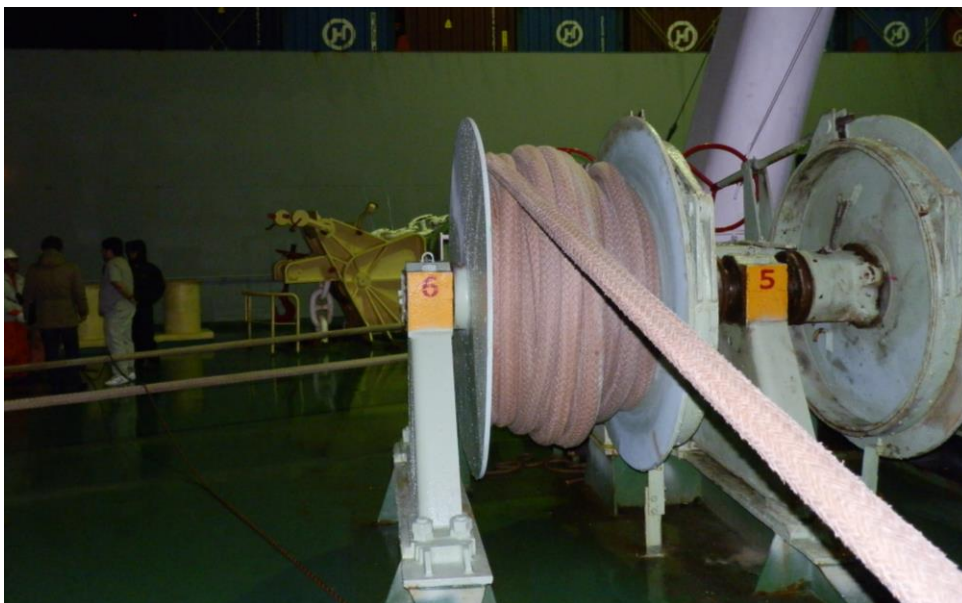
During the investigation visit on board EVER URBAN while berthed at Piraeus Container Terminal the winch was used for her mooring and found to be operational and in very good condition.

Figure 4:
Winch nr.5 (forecastle deck) was used for applying tension on the rope.

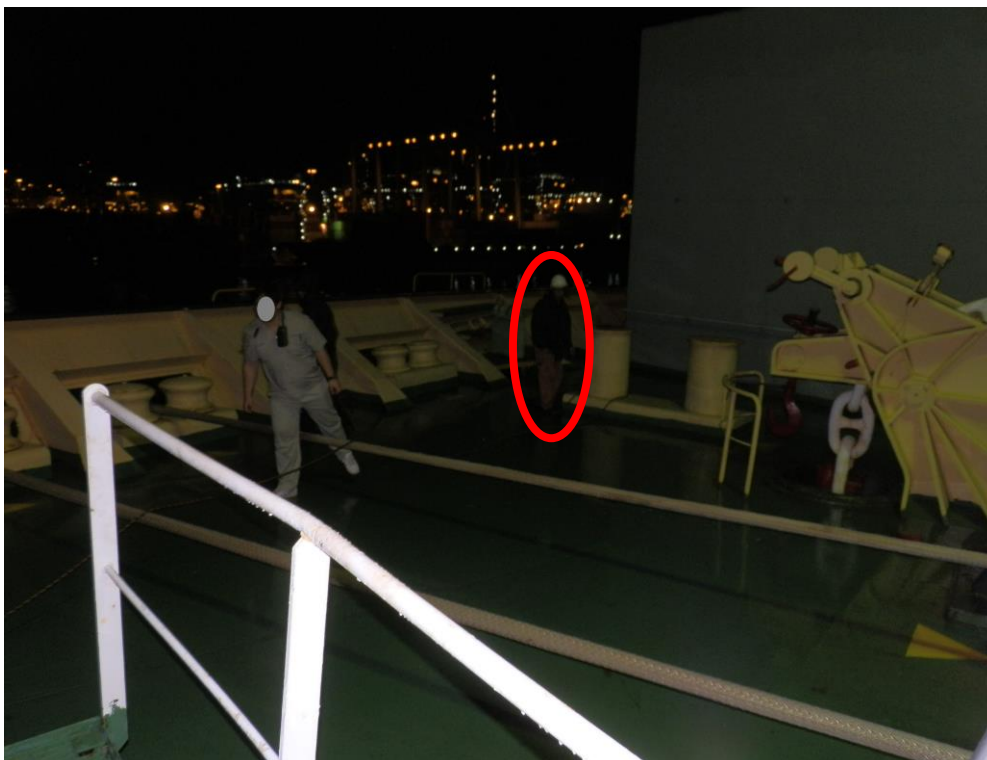
It should be noted that the view from the operating platform of the winch towards the location where the A/B1 was standing was unobstructed as shown in the next **figure 6**.

Figure 6:
View from the operating platform of the winch nr.5, towards the place where the injured A/B was standing at the moment of the accident (in red ellipse). The photograph was captured in terms of simulating the accident. It should be noted that the view is quite good even at night, while the accident happened during daytime.

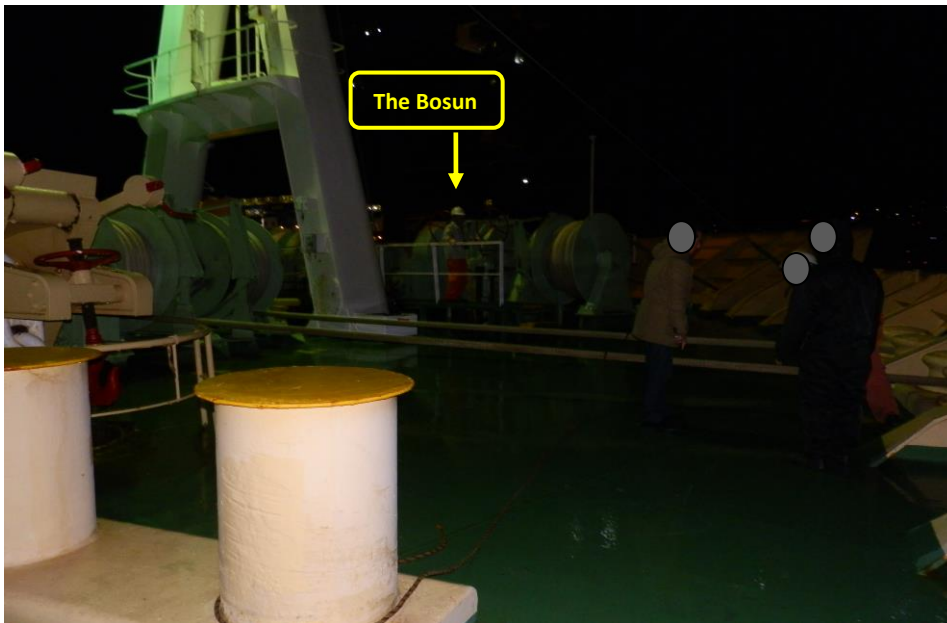
**Figure 7 :**

The vertical fairleader used during the «eye splice» tensioning was welded at the starboard bow bulwark and it was found in very good condition. It was the fourth roller to starboard from the panama chock. Its position was in straight line with the capstan in use and could facilitate an easy mooring rope pattern from the winch around the roller and straight towards to the double bollard. The double bollard used for the securing (hauling over) of the new «eye splice» was in very good condition and was fitted at the starboard stern side of the mooring deck as shown in **figure 7**.

Capture of the winch from the bollards which were used to fix the eye of the rope.

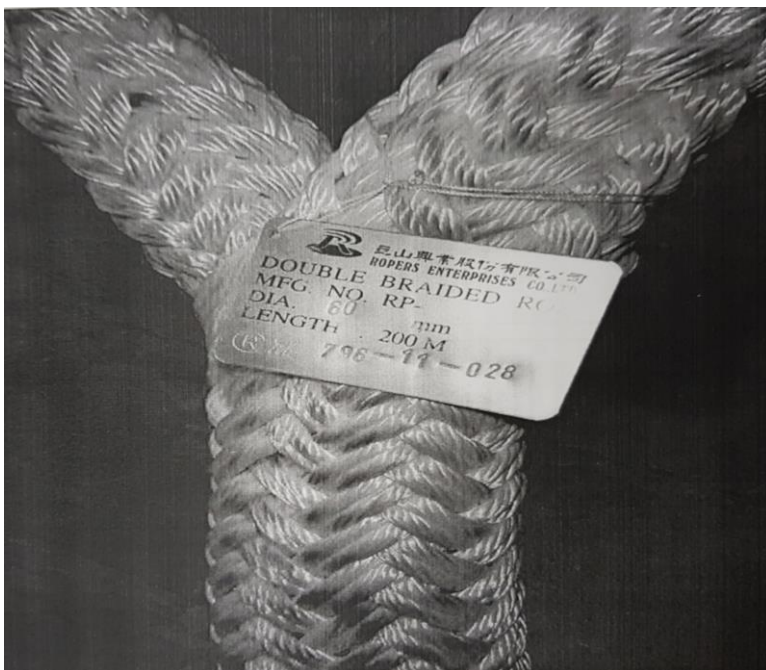
The mooring rope under repair was a «Double Braid Fibre Rope», (see figures 7 & 8) that was certified in November 2011 by a Classification Society and was delivered on board in December 2012.

Figure 7: The Double Braided Rope as delivered on board EVER URBAN

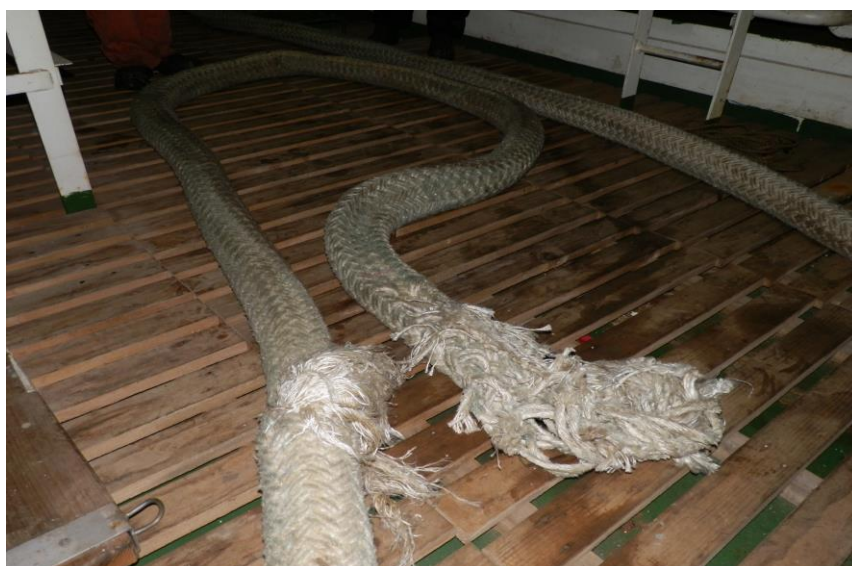
Despite the fact that the task's steps as described during the investigation process (see par. 3.1) were followed by the Bosun and the participating crew under his command, the most significant step of tightening & reinforcing the bond of the eye splice by heaving the winch and gradually applying tension on the rope for the purpose of testing it against working load fell short as the eye splice parted at the point of the bond (**figure 9**).

Figure 9: The spliced eye of the rope which the crew members tried to repair.

In this context it is deriving that the Bosun's and the participating crew members' performance for preparing the new eye splice was poor and considered to have been a contributing factor in the marine accident.

In consideration of the above it derives that the rope could have parted either due to an over its limit applied load - beyond its tensile tolerance which was not known for the repaired part near the eye – or due to poor splicing utilized practices.

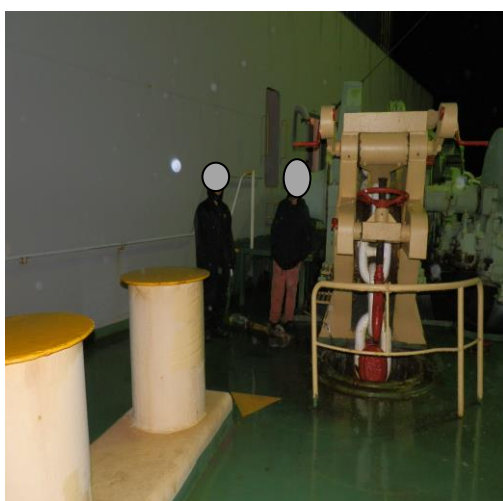
Moreover according to the information collected during the investigation process that indicated that the A/B2 and the O/S, during the second time the Bosun heaved the mooring rope, moved away from the bollard over which the rope was hauled and went to a location protected (**figure 10**) against a potential parting of the mooring rope and its snap back zone without being instructed, as well as the fact that the A/B1 remained standing very close to the bit and within the snap back zone of the eye splice under tension (**figure 11**), implies that the A/B2 and the O/S protected themselves on their own initiative and the Bosun was neither monitoring the situation closely or following any safety measures.

Figure 10: The position where the A/B2 and the O/S were standing at the moment of the accident (photo captured during the simulation of the accident).

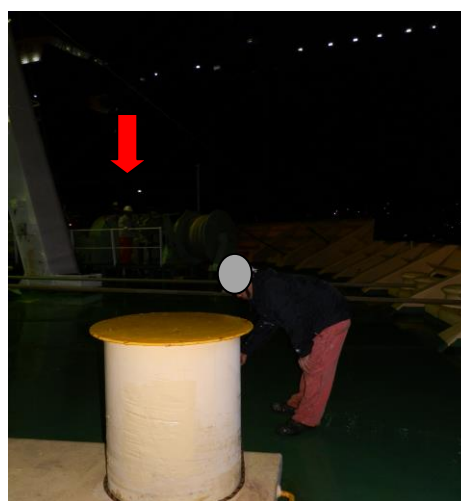
Figure 11: Approximate position of the A/B1 at the moment of the accident; in the background the position of the Bosun, controlling the winch, is indicated with a red arrow (photo taken during the simulation of the accident).

It is consequently conceived that had a risk assessment been carried out or safety instructions been provided to the Bosun and the crew involved in the task or to the A/B 1 on spot, in order to keep a safe distance and stand at a place protected from a possible snapback while the load on the rope was applied, the A/B1 would not have been struck and injured by the parted mooring rope.
