**Collision between Cruise Ship Aegean Paradise and HCG SAR Boat 519**

**Serious marine casualty**

**JULY 2016**

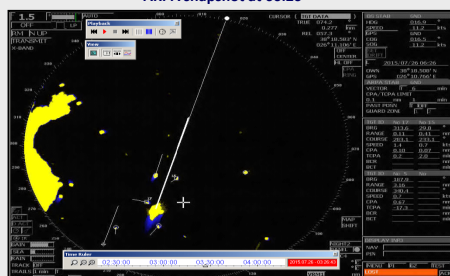
ARPA snapshot at 06:26
