Hellenic Bureau for
Marine Casualties
Investigation

Very serious marine casualty

November 2024

M/V "ATA 2"

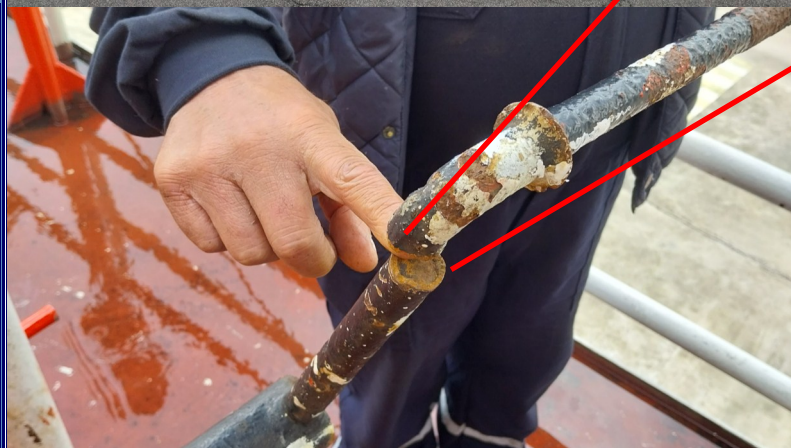
During the PSC inspection, one of the various operational tests carried out was the lowering of a life boat. The port side life boat was selected for lowering. The lowering of the life boat and an operational test in sea commenced without any problem and the PSC Inspection continued to other areas of the vessel. Then Bosun and one A/B proceeded to heave up the life boat to the stowage position. During that operation it was observed that one davit arm could not get attached to the "stowing" position so the AB engaged the crank handle in order to manually heave up the davit. As the crank handle was turning with difficulty, the AB applied more force. Suddenly the lever broke at a point which was welded in the past, possibly by the crew and the crank handle rotated speedily in reverse hitting severely the AB on the face near his right eye.

Figure2: The broken lever of the handle
