**HELLENIC REPUBLIC  
HELLENIC BUREAU FOR MARINE CASUALTIES INVESTIGATION  
INTERIM SAFETY INVESTIGATION REPORT**

**Fire on Ro-Pax  
EUROFFERY OLYMPIA**

**June 2023**

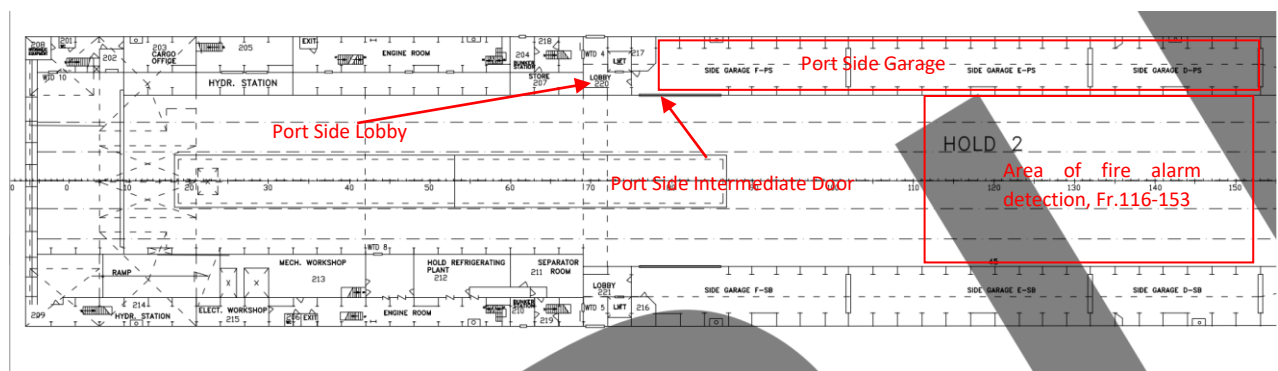
Figure 3. Abstract of General Arrangement of main garage, Deck 2

At 03:56, as the vessel was navigating 12 nm northeast of Corfu Island with a speed of approximately 17 Knots, the first fire alarm was activated on the bridge for the area of the main garage on Deck 2, between frames 116 and 153. The OOW ordered the patrol AB and the Bosun to proceed to the area and check for possible fire. The patrol AB proceeded to check Deck 2 from the Port side Lobby and when he saw the existence of smoke emanating from the main garage, he reported to the OOW and started closing the intermediate door between the main garage and the Port Side garage (Fig. 3).

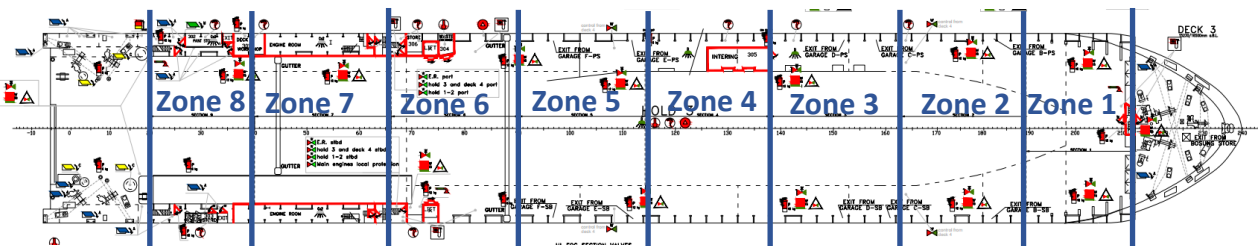
Figure 4. Abstract of Fire Fighting Equipment Plan. Blue lines indicate the operating zones of the Drencher System

At approximately 04:32 fire was spotted at the center of the open garage on Deck 3 and was reported to the Master. Immediately the Master ordered the Chief Engineer to operate Zones 4 and 5 of the Drencher system which covered the center area of garage on Deck 3, between frames 90 and 138 (Fig. 4). At 04:38 Master ordered the Chief Engineer to stop Zone 4 of the Drencher system and operate Zone 6 that was covering the area between frames 66 and 114. Following, the Master ordered the C/E to change the operation Zones of the Drencher system, as per below:

- At 04:39 Master ordered C/E to stop Zone 5 and open Zone 7 covering the area between frames 40 and 90,
- At 04:40 Master ordered C/E to stop Zone 6 and open Zone 8, that was covering the area between frames 20 and 66,
- At 04:42 Master ordered the C/E to stop Zones 7 and 8 and open for a short time Zones 2 and 3, that were covering the fore garage area between frames 138 and 89,
- At 04:46 Master ordered to stop Zones 2 and 3 and open Zones 4 and 5,
- At 04:49 Master ordered the C/E to stop the operation of the Drencher system, to assess the situation,
- At 05:00, following a report from the crew about explosions of the truck tires on Deck 3, Master ordered to start again the operation of the Drencher for Zones 4 and 5,
- At 05:01 Master ordered to operate Zones 1 and 2,
- At 05:08 Master ordered to operate Zones 3 and 4.

As already stated, the Drencher System was activated for the firefighting operation on Deck 3 and it was operated with regard to the existed instructions, which provided guidance for operation of two zones at the same time.
