**Marine casualty**

**Very serious marine casualty**

**OCTOBER 2021**

**Container Vessel MAERSK LAUNCESTON**

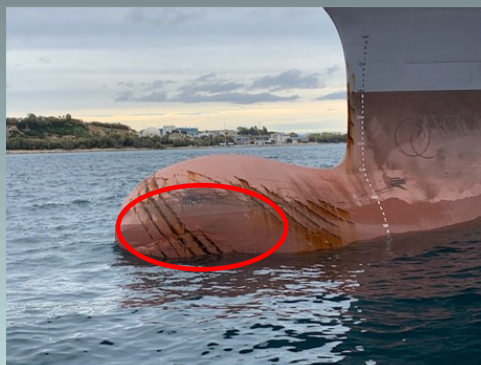
MAERSK LAUNCESTON sustained only scratches and coating damages on her bulbous bow and port bow quarter.

**Figure 1: The abrasions in the bulbous bow of MAERSK LAUNCESTON**

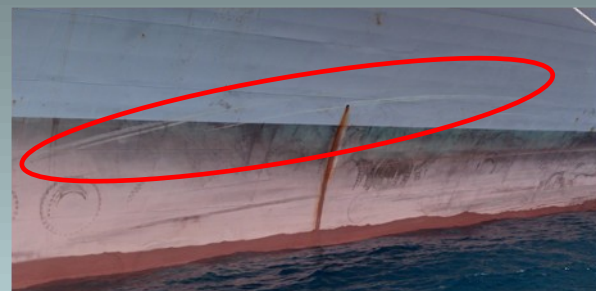
**Figure 2: The scratches on the port bow of MAERSK LAUNCESTON**

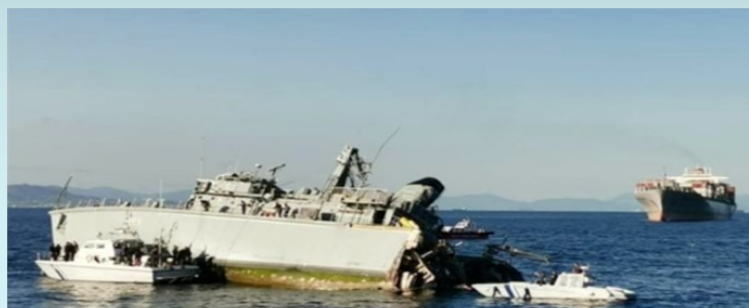
As a result of the collision and the developed forces KALLISTO was broken in two pieces; the aft part was detached and sank within seconds, while her fore section remained floating and listing to approximately 60° to starboard. Due to the heavy impact, 4 crew members of KALLISTO fell overboard and were rescued by HCG patrol boat.

**Figure 3: HNS KALLISTO minutes after the collision.**
