INTERIM REPORT

MARINE CASUALTY SAFETY INVESTIGATION

Death of one truck driver inside the garage of Ro-Ro Cargo EUROCARGO TRIESTE

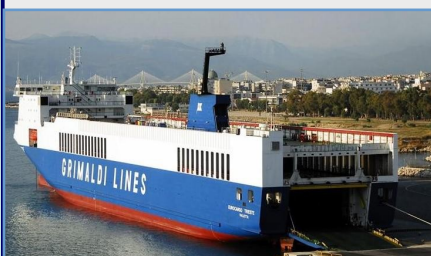
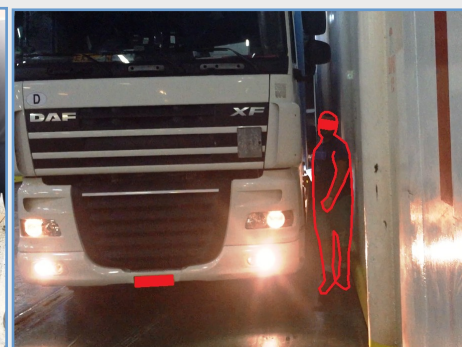
Container's supporting leg and estimated position of the casualty

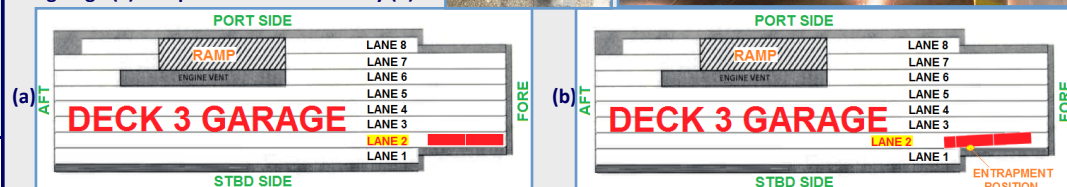
Intended position of containers stowage in the garage (a) and position of the casualty (b):
