**Very serious marine casualty**

**September 2026**

**M/V “UNION MARINER”**

**HBMCI**  
Hellenic Bureau for  
Marine Casualties  
Investigation

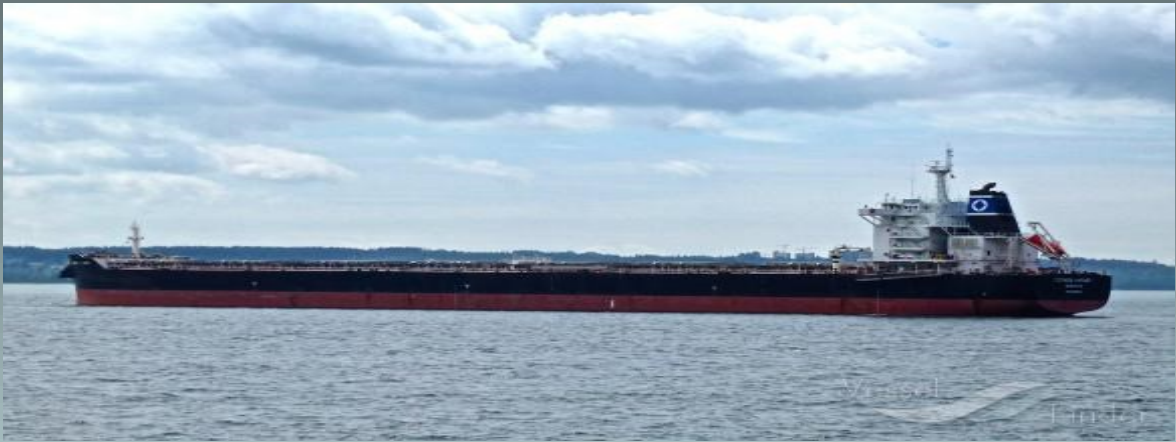
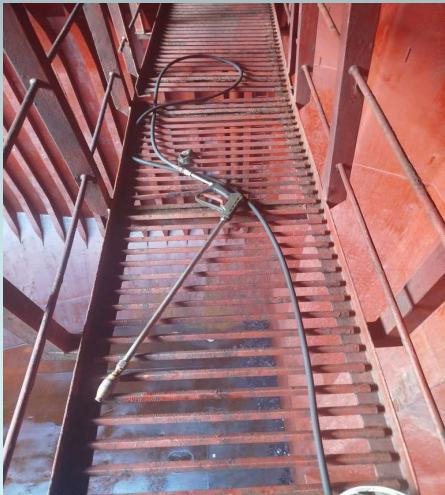
| FACTUAL INFORMATION | |
|---|---|
| <div> <div>M/V "UNION MARINER"</div> </div> <div> <div>Depiction of the inspection platform (PMA) in Cargo Hold No. 7.</div> </div> | |
