**Marine casualty
Safety Investigation
Law 4033/2011**

Very serious marine casualty

June 2023

M/V "BULK VALOR"

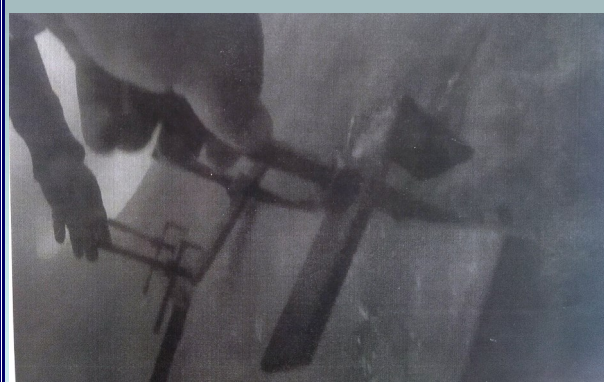
The marine plywood patch

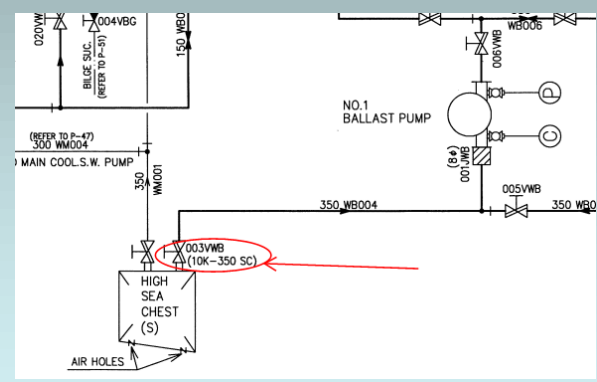
On 14th of June 2023 "Bulk Valor" was at Lavrio anchorage and underwater operations from local diving services company were scheduled. More specifically, the vessel's managers had arranged with the diving company the inspection of the vessel's hull as well as the sealing of the high sea water chest (starboard side) in order for the engine crew to replace the suction valve of the No1 ballast pump because it could not isolate the pump from the high sea water chest.

Drawing of ballast piping indicating the No1 Ballast Pump suction valve
