HELLENIC REPUBLIC

HELLENIC BUREAU FOR MARINE CASUALTIES INVESTIGATION

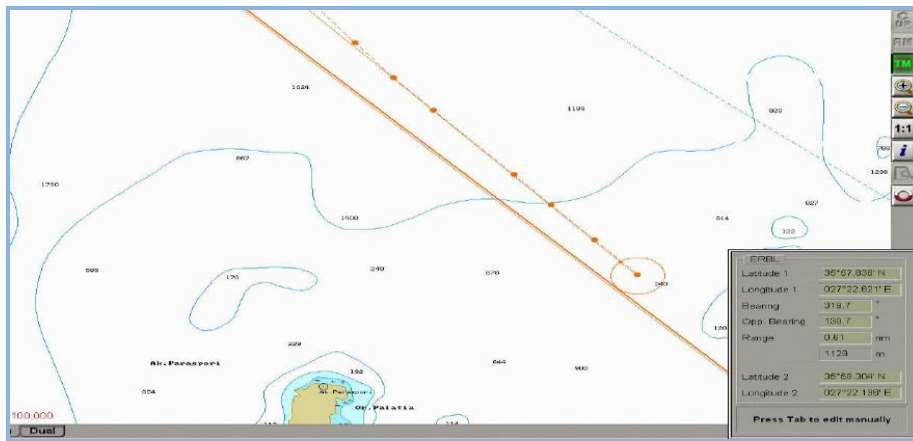
Figure 3. Ship's position at hand over of the watch (0000).VRM shows the extend of drifting to starboard (source HBMCI plotting chart).

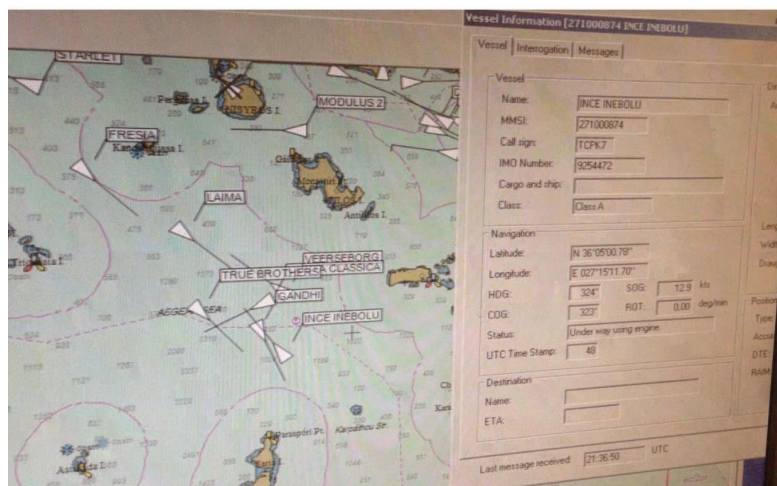
Figure 4. Ince Inebolu sailing in slightly increased traffic at 0035.(source HCG AIS).

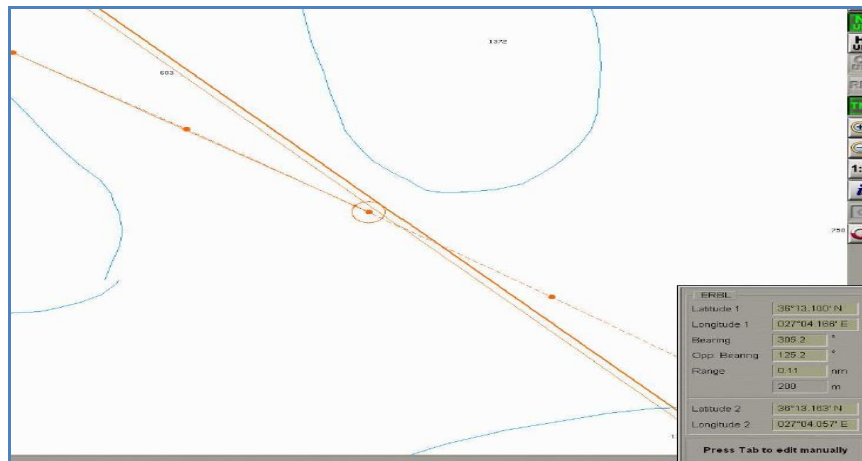
Figure 8. Ince Inebolu off course position to port at 0131(source HBMCI plotting chart).

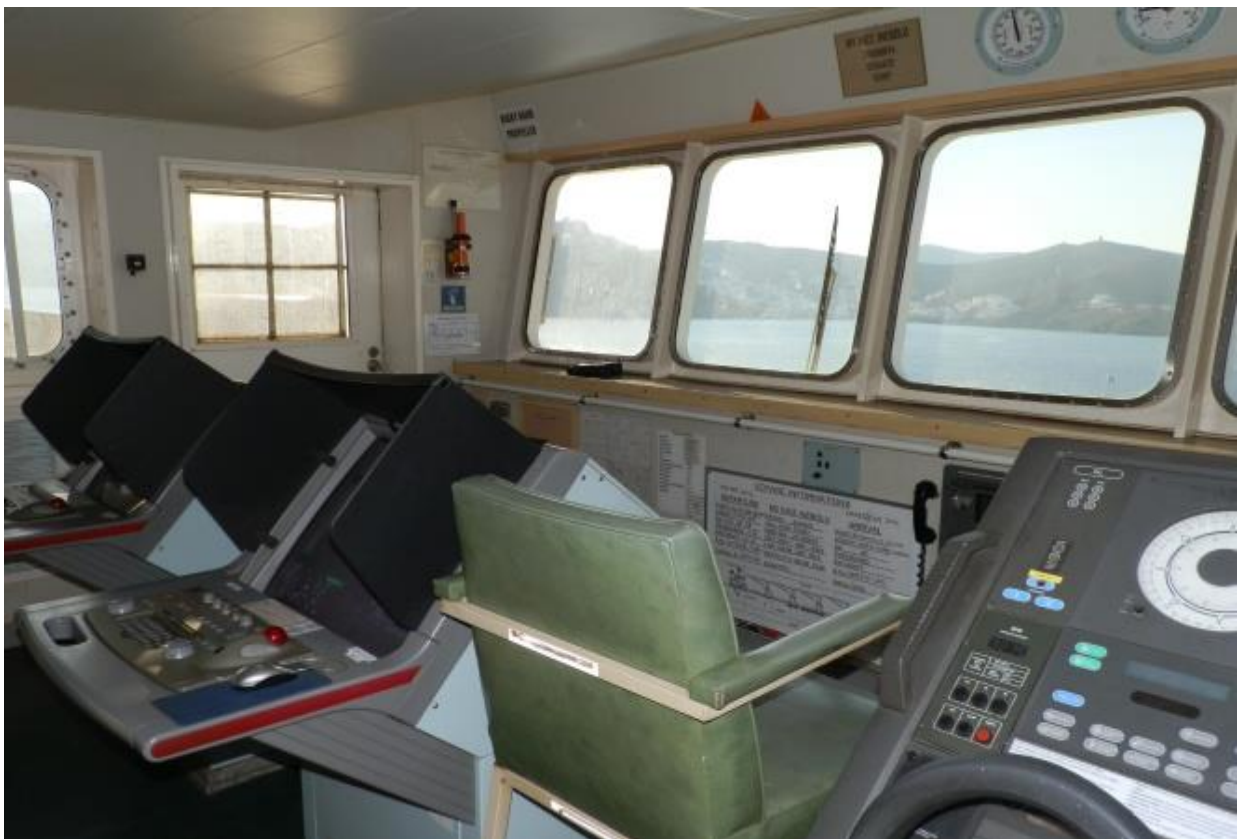
Figure 9. The chair placed at the center of the bridge.

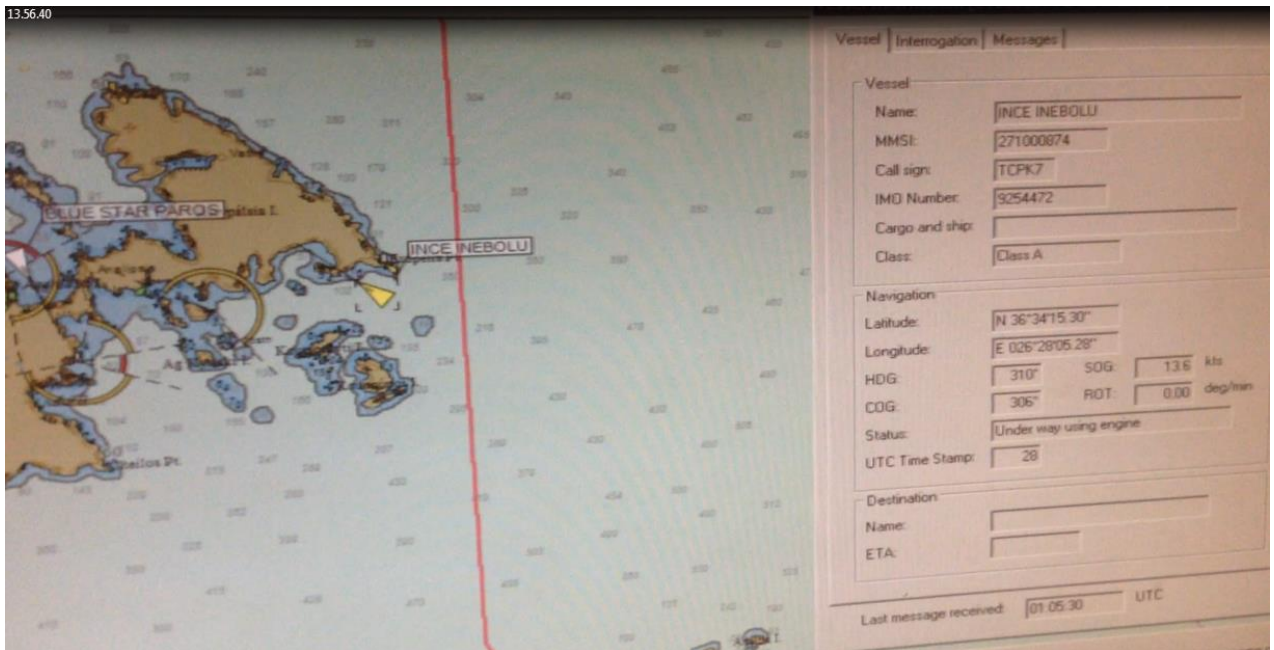
Figure 13. Ince Inebolu navigating data at 0405, seconds before grounding. HDG 310° and COG 306° at 13.6 knots (source HCG AIS).

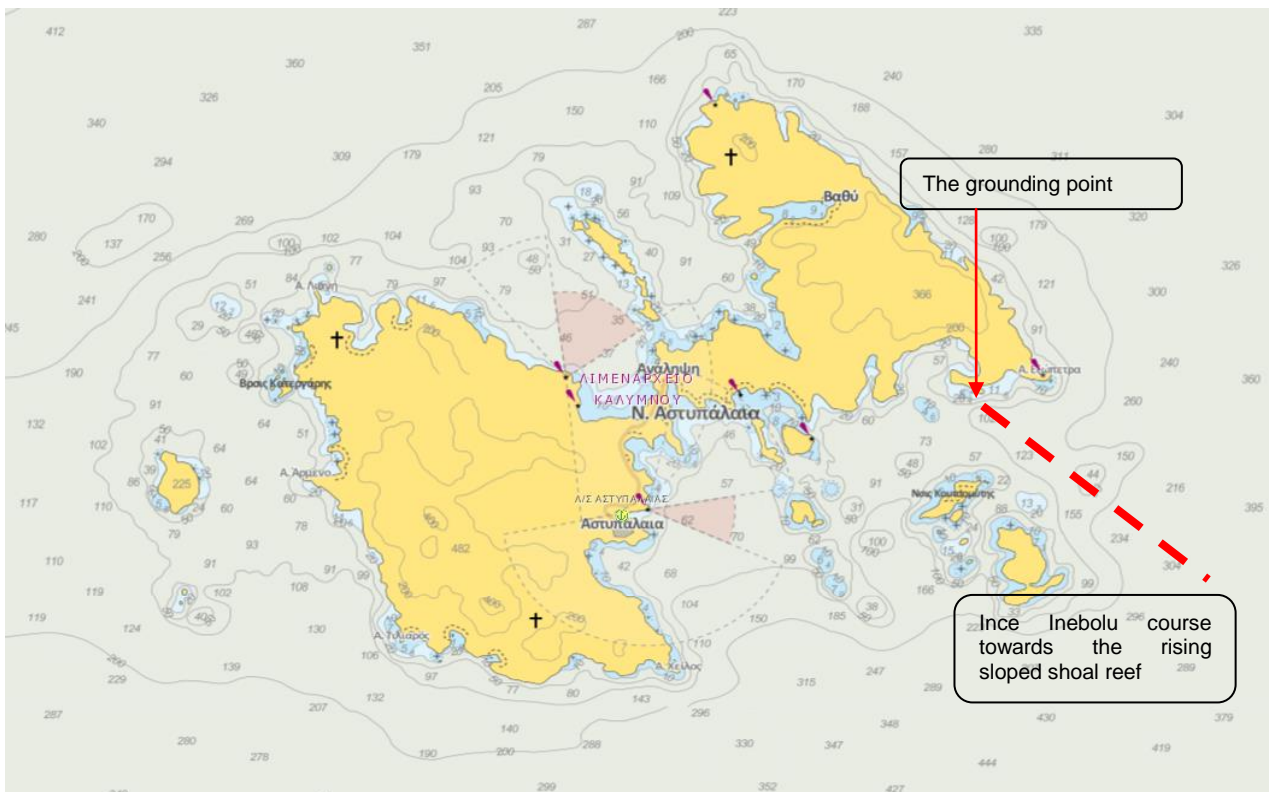
Figure 14. The grounding point and the sketched course towards it.

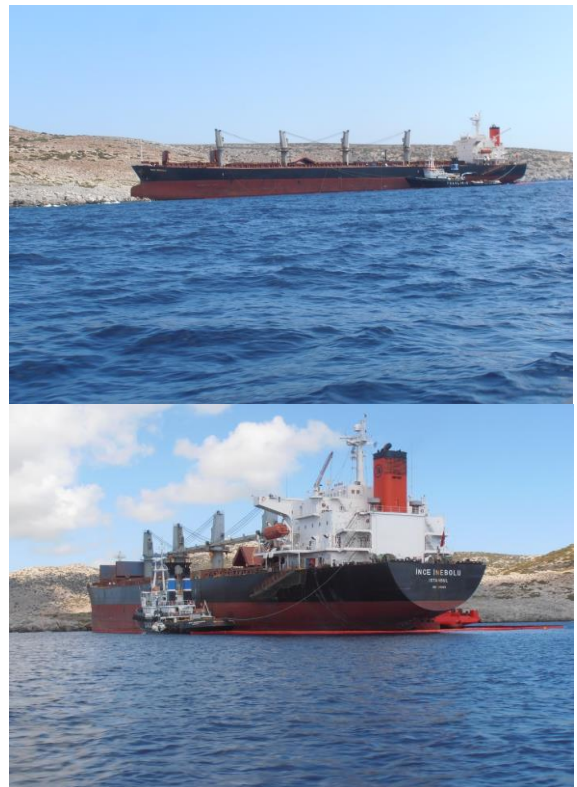
Figure 19. Ince Inebolu grounded at Astypalaia coastline.

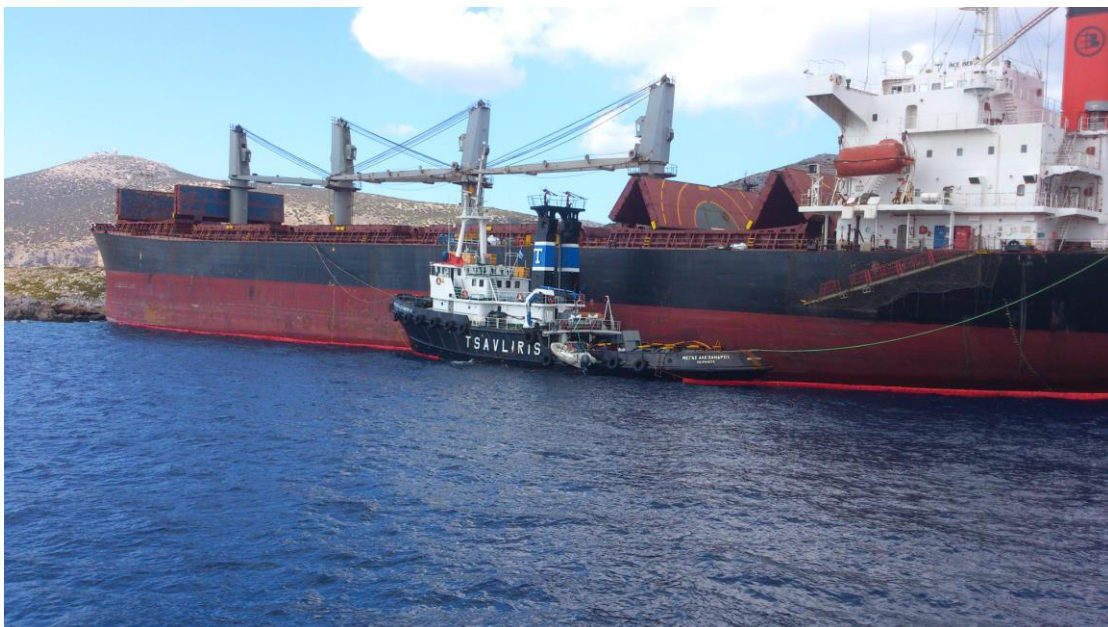
Figure 21. Rescue Tug Megas Alexandros alongside Ince Inebolu at grounding site.

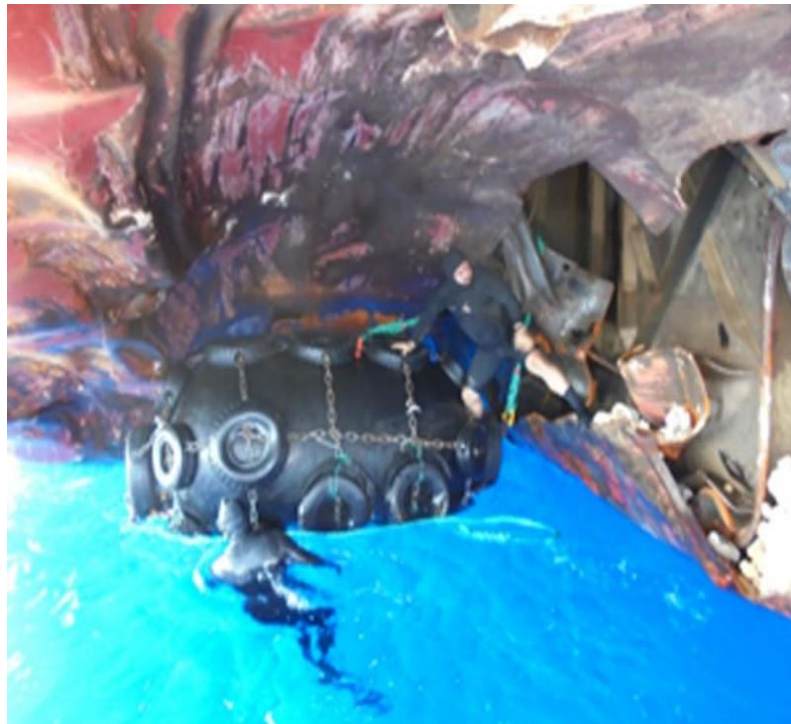
Figure 22. The yokohama fender secured on Ince Inebolu bulbous bow (source Tsavliris Salvage).

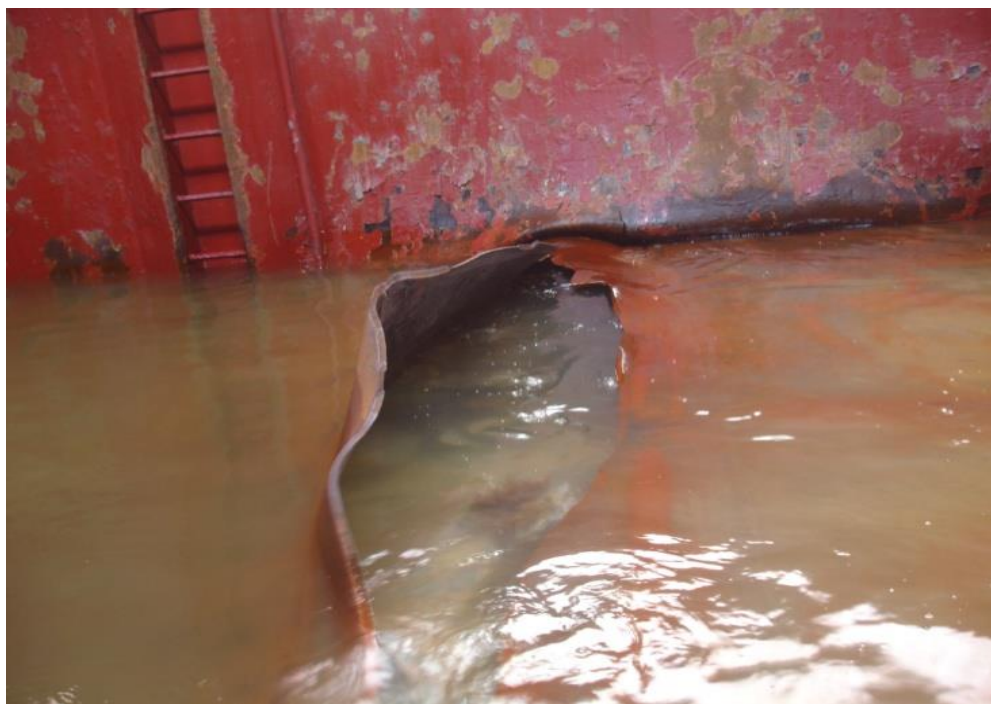
Figure 23. The crack at inner bottom plate of No 1 cargo hold as seen from inside .

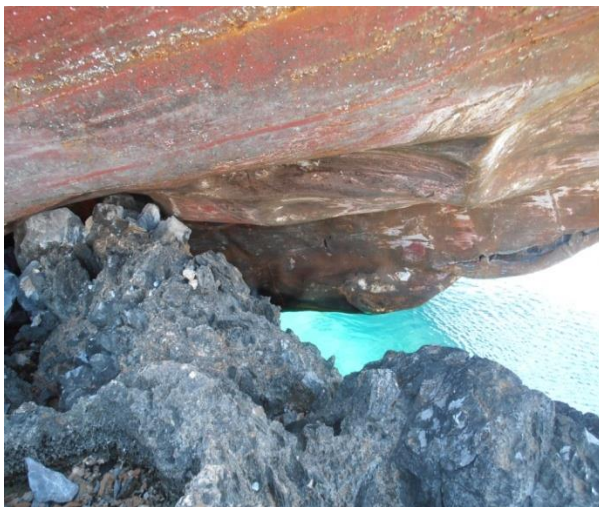
Figure 24. Deformed starboard fore section.

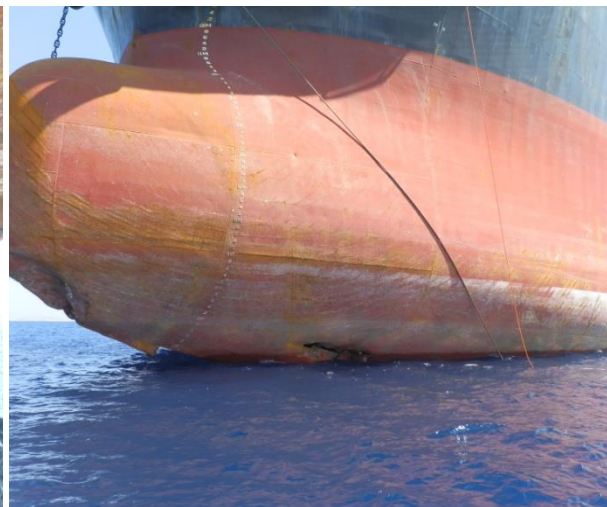
Figure 25: Forward bulbous bow structural damages.
