SAFETY RECOMMENDATION No: 28/2013

No of Safety Investigation Report:	05/2013: Death of visitor on board Ro-Pax "NISOS RODOS" <i>(See the full Report here.)</i>
---	---

Death of visitor on board Ro-Pax

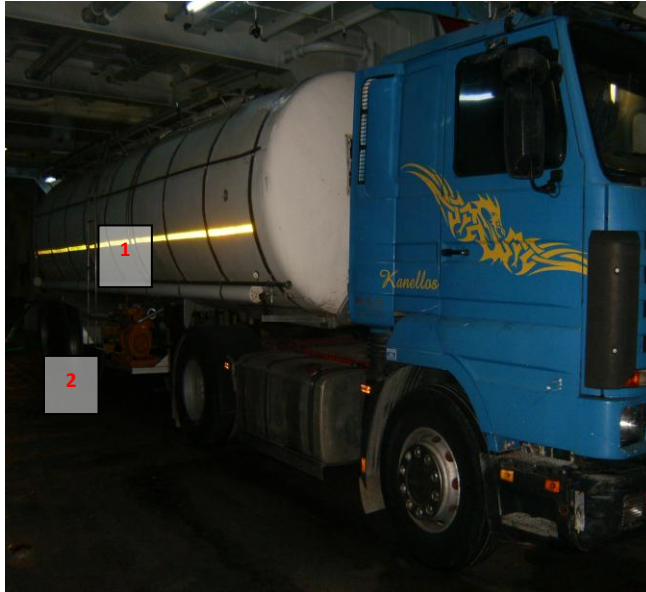
At that point, the co-driver of the vehicle, who, based on the collected evidence, had climbed or had attempted to climb to the truck’s tank, slipped and fell to the deck resulting to the injury of his head and neck.

Picture 2: The tank truck parked at the point of the water supply, in the garage of the Ro-Pax "NISSOS RODOS". The ladder on the right side of the tank (1) and the place where the injured was found (2) have been marked.

According to the findings of the forensic report, the loss of life of the visitor of the Ro-Pax occurred "as a result of head, neck and chest injuries, compatible with a fall" and therefore it was the result of falling off the tank truck's ladder.

Ensuring of the provision that during supplying water to ships, from tanker-vehicles of the company, only the necessary and suitable personnel for the task should be allowed in such vehicles.
