INTERIM REPORT

MARINE CASUALTY SAFETY INVESTIGATION

**Grounding of Turkey Flagged Container vessel YUSUF CEPNIOGLU
at North Coast Of Mykonos Is. Greece**

Very serious marine casualty

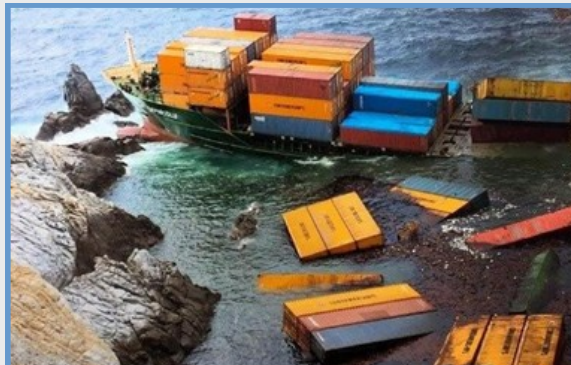
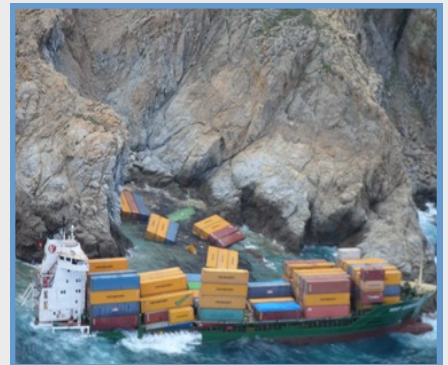
The hull of the vessel suffered multiple cracks and deformations on her bow and port side and several compartments including engine room, cargo holds and void spaces were flooded. Also pollution from bunkers was reported.

Yusuf Ceptioglu grounded
