SAFETY RECOMMENDATION No: 03/2014

No of Safety Investigation Report: 01/2014: Grounding and Foundering of F/V "AGIA MARINA" Registry of Mytilene no. 363
(See the full Report [here.](#))

Grounding and Foundering of F/V "AGIA MARINA", Registry of Mytilene no. 363

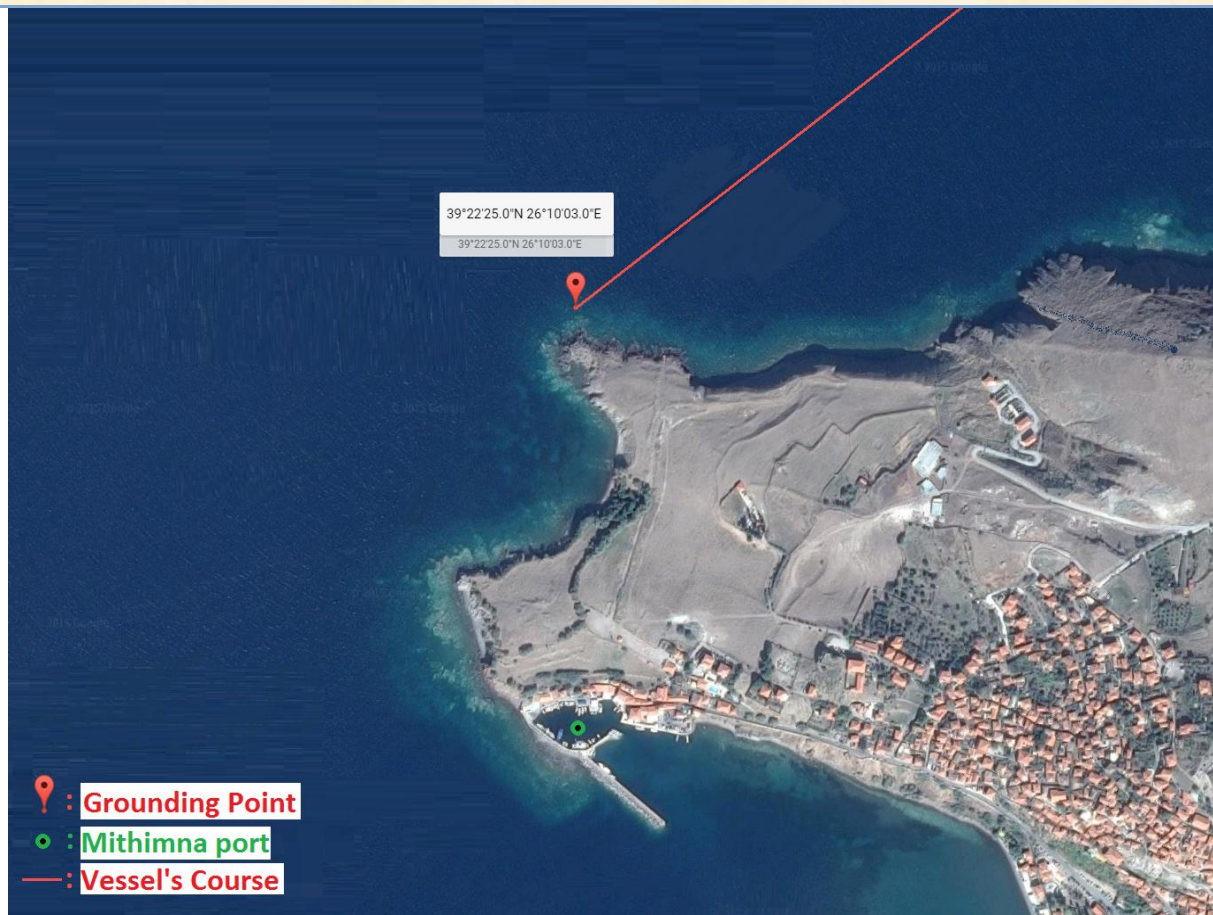
While sailing near the northern coast of Mithimna port and at approximately 18:49, a malfunction of the steering mechanism occurred causing the loss of control and the vessel's grounding at a distance of 04 m from the rocky coast. The Captain and three (03) Fishermen abandoned the vessel falling into the sea. With the Captain's assistance the Fishermen who did not know swimming managed to go ashore using a rope, whereas one (01) Fisherman was recovered by an auxiliary boat of a fishing vessel which was in the area and had rushed for assistance. No injury was reported.

Grounding point of «AGIA MARINA»
(Source: HCG/Safety of Navigation Directorate – Map Source: Google Maps)
