## SAFETY RECOMMENDATION No: 22/2014

03/2014: Explosion on board M/V "NAKHODKA"  
(See the full Report [here.](#))

**Name of vessel:** NAKHODKA  
**Type of vessel:** General Cargo  
**Year of built:** 1978  
**Flag:** Russian

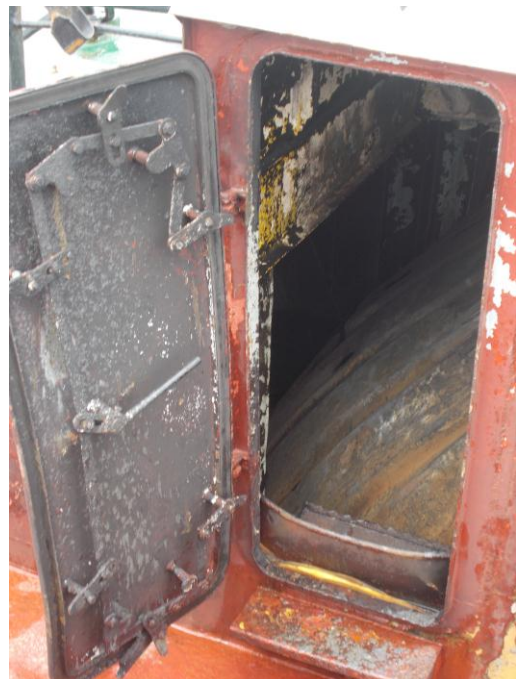
The vessel sustained damages due to the explosion and the fire, in the forecabin, such as distortion of bulkheads and burning of equipment.

The casualty was caused by the ignition of propane gas that had leaked from the storage bottle and accumulated at the lower levels of the Boatswain's Store. The ignition source could not be identified; however spark from unprotected lighting equipment found at the area or spark caused by static electricity or friction/impact of metal tools or other metallic equipment were highlighted as possible sources.
