## SAFETY RECOMMENDATION No: 26/2014

03/2014: Explosion on board M/V "NAKHODKA"  
(See the full Report [here.](#))

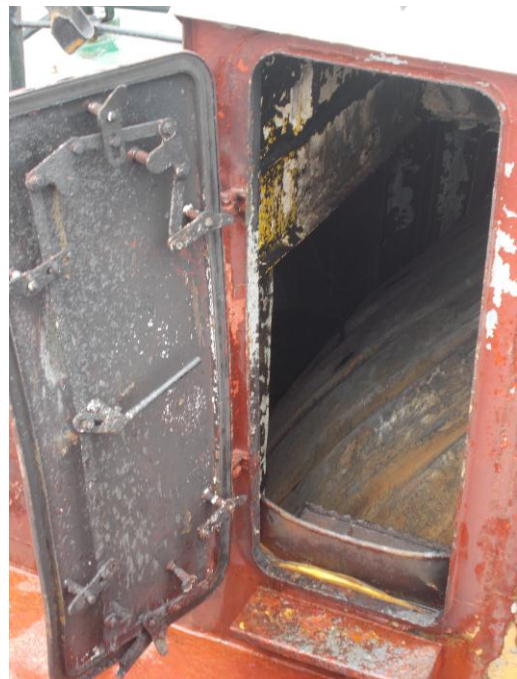
The vessel sustained damages due to the explosion and the fire, in the forecandle, such as distortion of bulkheads and burning of equipment.

*Capture of the cracked bulkhead of the Paint Room caused by the explosion.*
