SAFETY RECOMMENDATION No: 28/2014

03/2014: Explosion on board M/V "NAKHODKA"
(See the full Report [here.](#))

Name of vessel: NAKHODKA
Type of vessel: General Cargo
Year of built: 1978
Flag: Russian

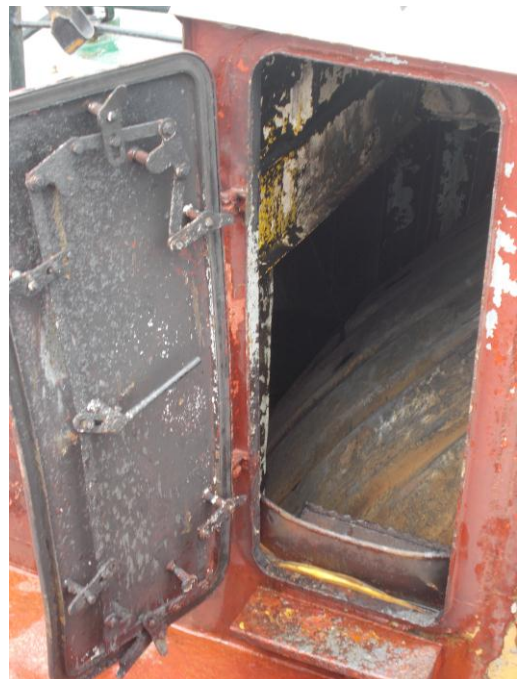
The vessel sustained damages due to the explosion and the fire, in the forecastle, such as distortion of bulkheads and burning of equipment.

Capture of the cracked bulkhead of the Paint Room caused by the explosion.
