## SAFETY RECOMMENDATION No: 46/2013

<b>No of Safety Investigation Report:</b>	07/2013: Impact of M/T “MANTOUDI” with the pier (See the full Report <a href="#">here.</a> )
---	---

### **Impact of M/T with the pier**

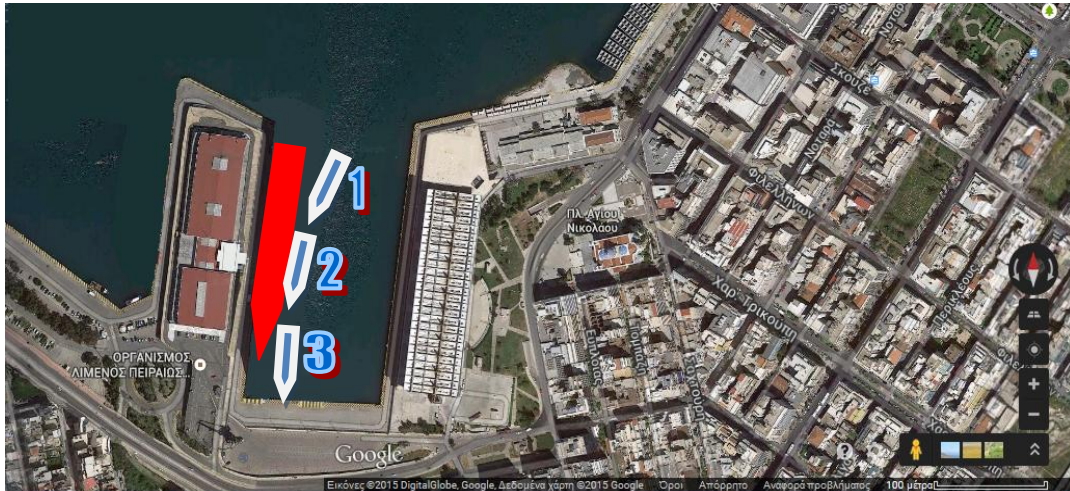
**Picture 1:** View of the area of Pier No.3 (Xaveri Coast) in the Central Port of Piraeus. The positions of the ships involved, SEABOURNSPIRIT (red) and MANTOUDI (white - blue) are shown (without the use of a scale) as follows:

- 1: MANTOUDI approach for mooring to SEABOURNSPIRIT
  - 2: MANTOUDI not able to reduce speed
  - 3: MANTOUDI impacts with the jetty
- (Map Source: Google Maps)
