## SAFETY RECOMMENDATION No: 46/2014

Consider supplementing the existing regulatory framework so that the embarkation / disembarkation areas of the launch boats should be recorded on the issued Certificates of General Inspections and that a lifering with line should be placed close to them.

06/2014: Fatal fall into the sea of technician during disembarkation from Oil Tanker ROYAL OAK to launch boat DRAKON TAXIARCHIS  
(See the full Report [here.](#))

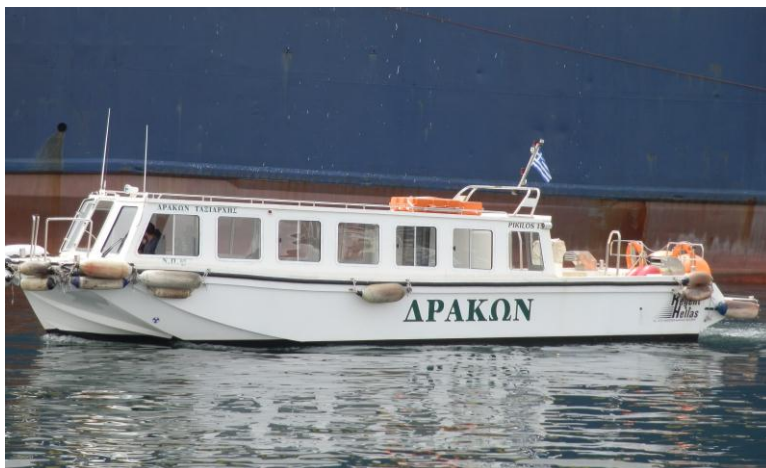
**Name of vessel:** DRAKON TAXIARCHIS  
**Type of vessel:** Passenger launch boat  
**Year of built:** 2010  
**Flag:** Greek

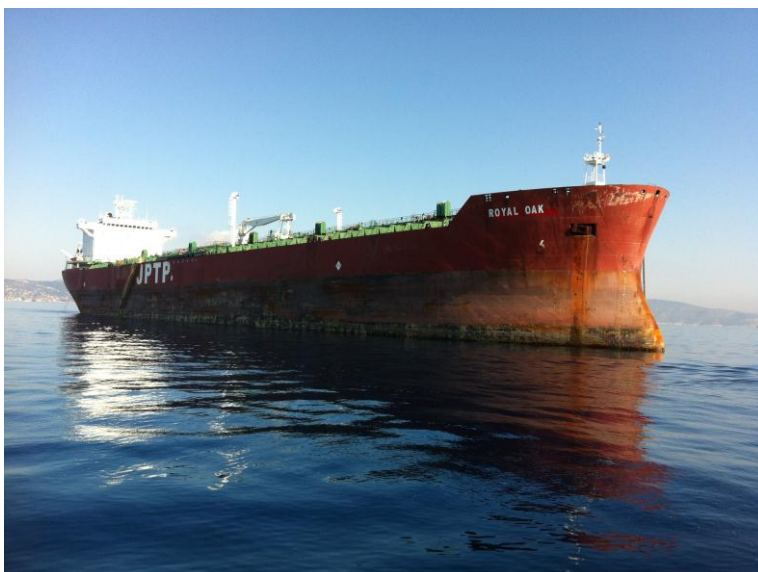
**Name of vessel:** ROYAL OAK  
**Type of vessel:** Oil Tanker  
**Year of built:** 1999  
**Flag:** Marshal Islands
