HELLENIC BUREAU FOR MARINE CASUALTIES INVESTIGATION

**MARINE CASUALTY SAFETY INVESTIGATION REPORT
01/2016**

**Fatal Fall of Bosun inside the Cargo Hold of
Bulk Carrier Doric Spirit**

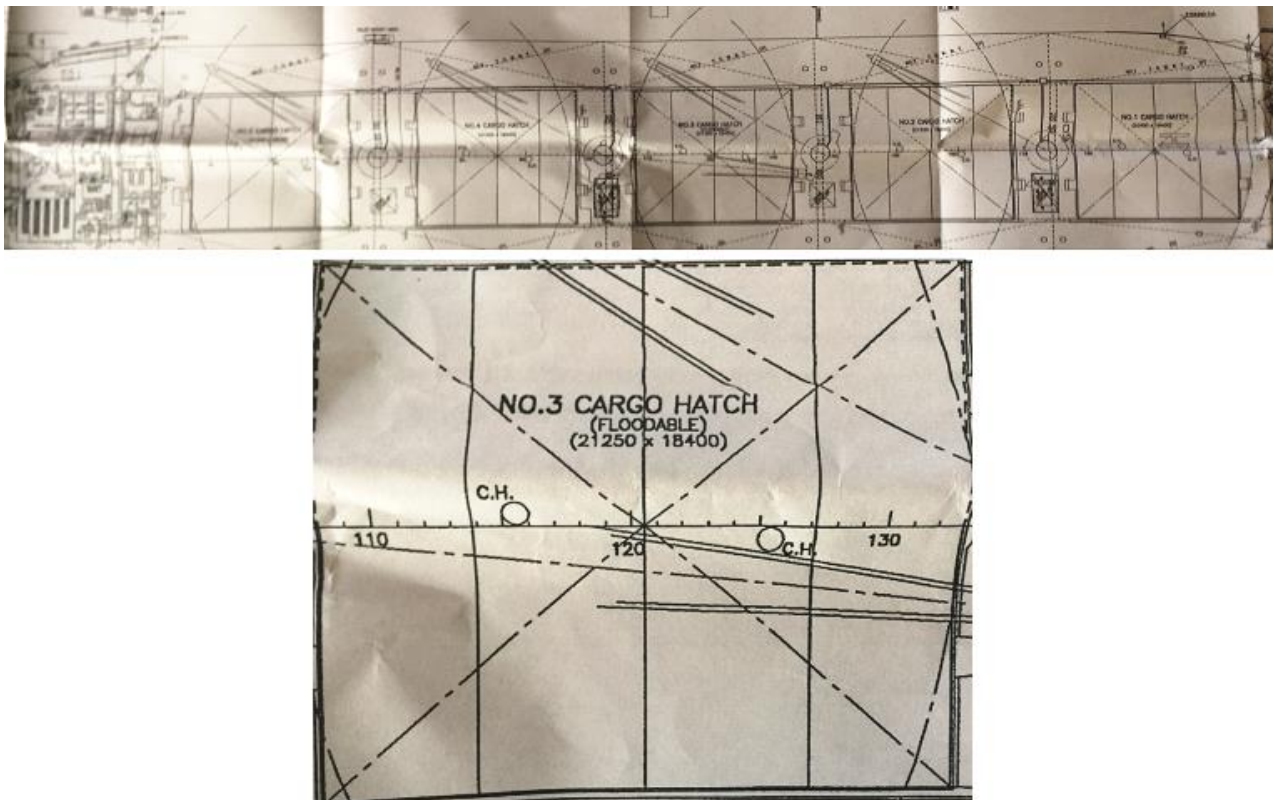
Figure 9: Overview from general arrangement plan, showing upper deck cargo holds arrangement and zoomed in the cargo hold No.3.

Doric Spirit is a standard design bulk carrier with 5 cargo holds structured forward of the accommodation superstructure. The No.3 Cargo hold is fitted between cargo holds 2 and 4 and is extended from frame No.108 to frame No.133 (figure 9).

The cargo hatch dimensions are 21.25 X 18.4 meters wide and are about 17 meters high. Additionally No.3 cargo hold carries the notation floodable, meaning that it can be used as a water ballast tank in a heavy ballast condition.
