HELLENIC BUREAU FOR MARINE CASUALTIES INVESTIGATION

MARINE CASUALTY SAFETY INVESTIGATION REPORT

01/2018

**PARTING OF A MOORING ROPE
OF M/T "BYZANTION", FLAG GREECE, IMO 9315898
DURING UNMOORING OPERATION
RESULTING TO THE DEATH OF AN O/S, PHILIPPINE NATIONALITY
AT DORTYOL, TURKEY ON 7TH JUNE 2018**

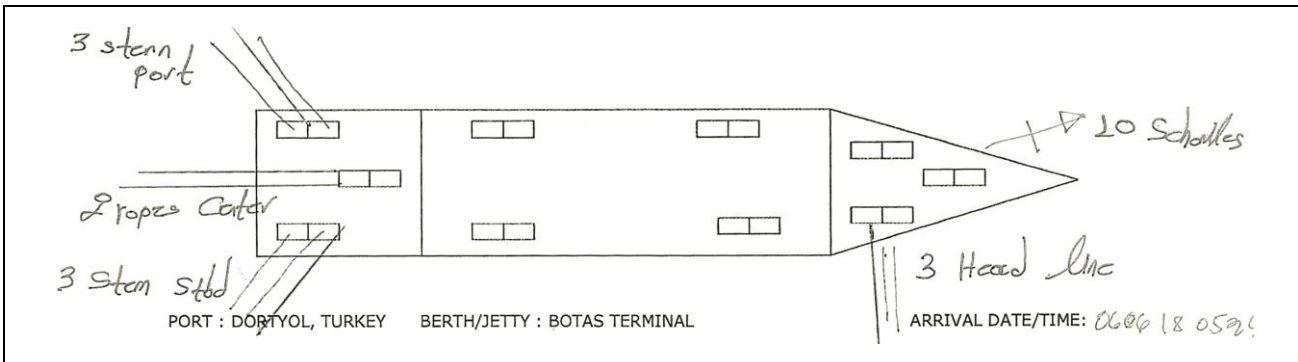
Figure 3.1/1: The mooring arrangement of BYZANTION at BOTAS terminal.

For the FWD mooring arrangement, the Port anchor was dropped (10 shackles in the water) and 3 mooring lines from the Stbd side Forecastle Deck mooring drums were connected to a dolphin fender of the terminal.

For the AFT mooring arrangement, 3 lines from the Stbd side Stern mooring drums and 3 lines from the Port side Stern mooring drums were connected to the pier, as well as 2 loose ropes on stern bits, passing through the stern centre chock.

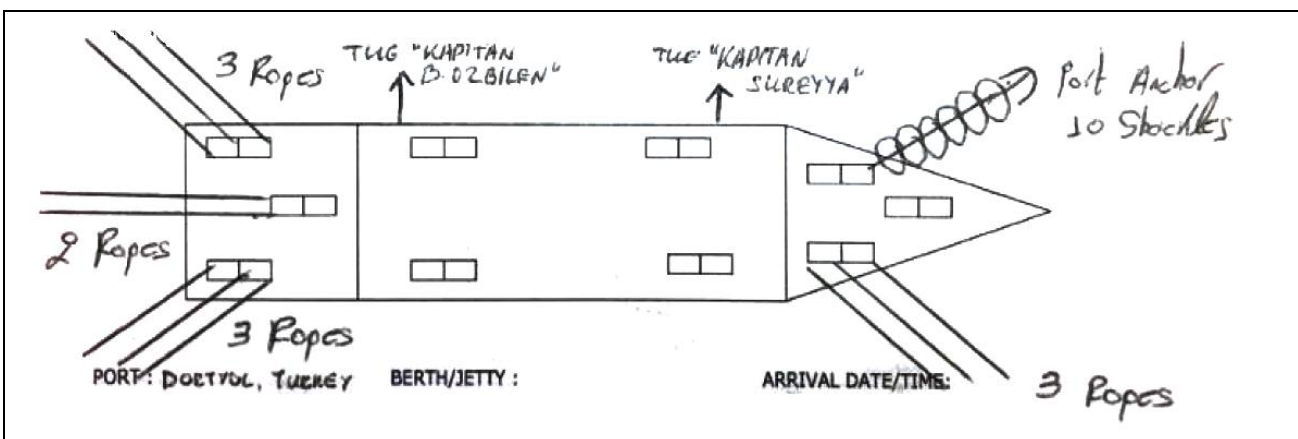
Figure 3.2/1: The mooring arrangement of BYZANTION at BOTAS terminal.

The part of the drawing included in the relevant “Master-Pilot Exchange” Form, contained in the Company’s Navigation Procedures Manual, as prepared by the Master and the Pilot on 7th June for the unmooring operation of BYZANTION is shown in the following **Figure 3.2/1**.

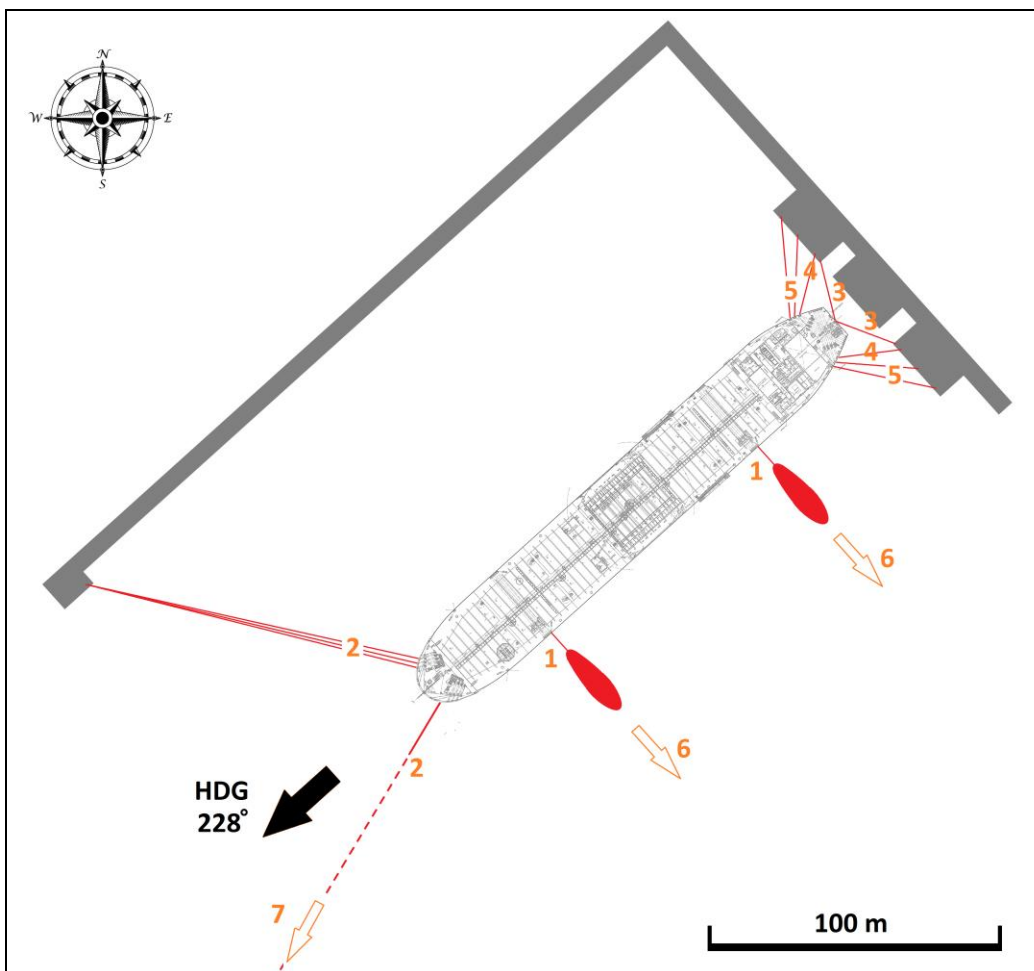
Figure 3.2/2:
(Scaled) depiction of the sequence for the unberthing of BYZANTION as planned during the Master-Pilot exchange.

1. Both Tug Boats to be fasted at the Port side towing positions Fore (fr. 152) and Aft (fr. 51).
2. The 3 mooring lines from the Stbd side Forecastle Deck mooring drums to be released and the anchor to be engaged.
3. The 2 loose ropes at the aft bitts to be released from the pier and collected through the stern centre chock.
4. The 2 aftmost ropes (1 of total 3 on each side) to be released and collected on their drums.
5. All rest 4 ropes (2 of total 3 on each side) to be released and collected on their drums.
6. Both Tug Boats to pull the vessel sideways in order to clear her from the pier.
7. Heave up the anchor.

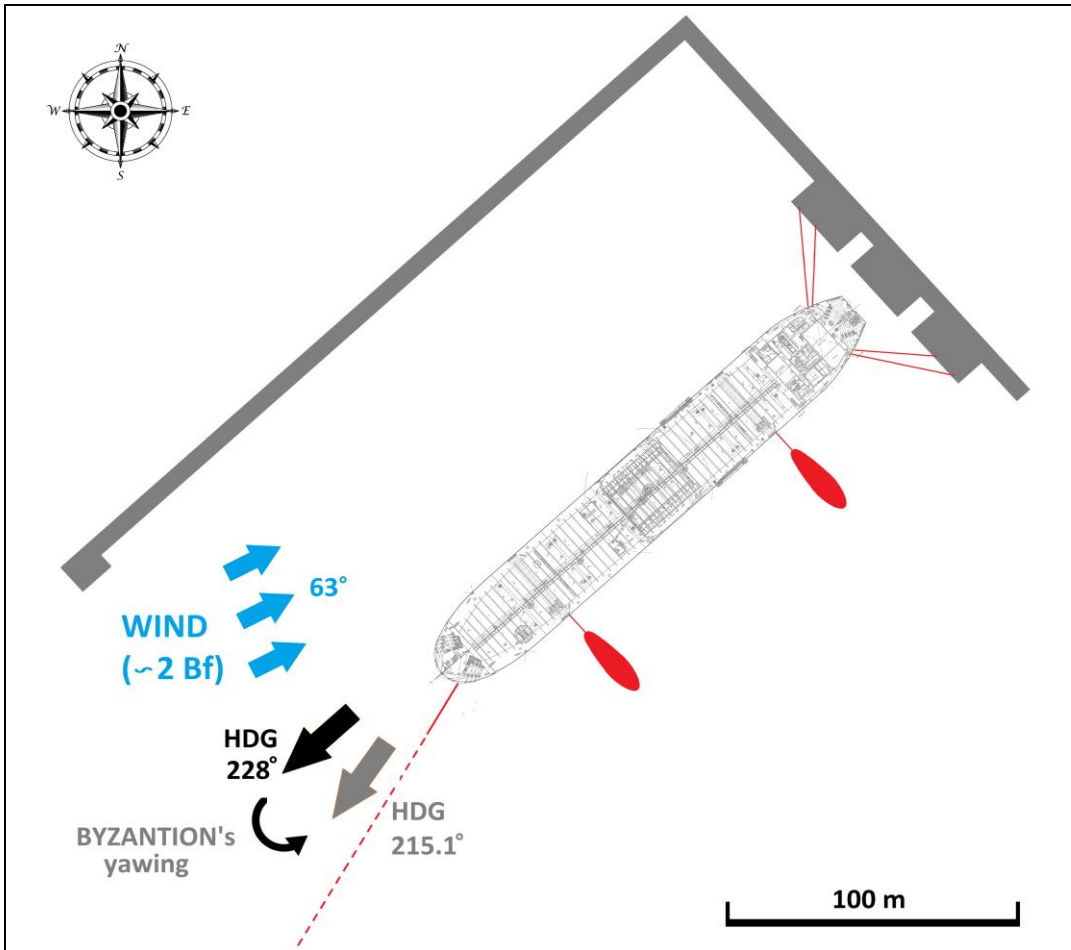
Figure 3.3/1:

From the beginning of the unberthing operation, until 19:24:16", BYZANTION kept yawing anticlockwise, due to the fact that the 3 ropes stbd fwd were released and a quartering light breeze from S-SW direction (10°-15° off her stbd bow) was affecting her. Her HDG kept dropping from 228° to 215.1°.

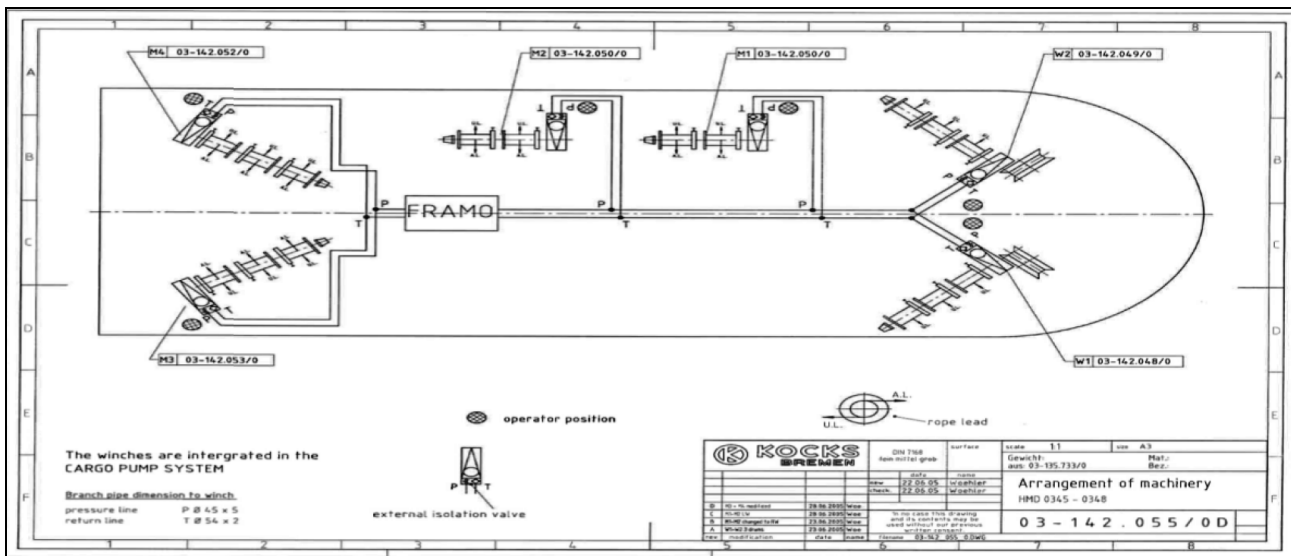
Figure 4.2.1/1: The mooring equipment machinery arrangement.

BYZANTION was originally fitted with TTS KOCKS GMBH Windlass and Winches integrated system. There were a total of 2 Windlasses and 4 Winches hydraulic motors in the system, facilitating the vessel's mooring needs. The Aft part of mooring arrangement was equipped with 2 hydraulic winches that drove 3 mooring drums each. The mooring equipment machinery arrangement is shown in the following **Figure 4.2.1/1**.

The last Mooring Equipment 2-month routine inspection, according to the vessel’s records had been conducted on 4th June 1018, with no findings.
