**HELLENIC REPUBLIC
HELLENIC BUREAU FOR MARINE CASUALTIES INVESTIGATION**

**MARINE CASUALTY SAFETY INVESTIGATION REPORT
03/2015**

**Death by asphyxiation of the Bosun of Bulk Carrier KOSMAS V
after entering a cargo hold**

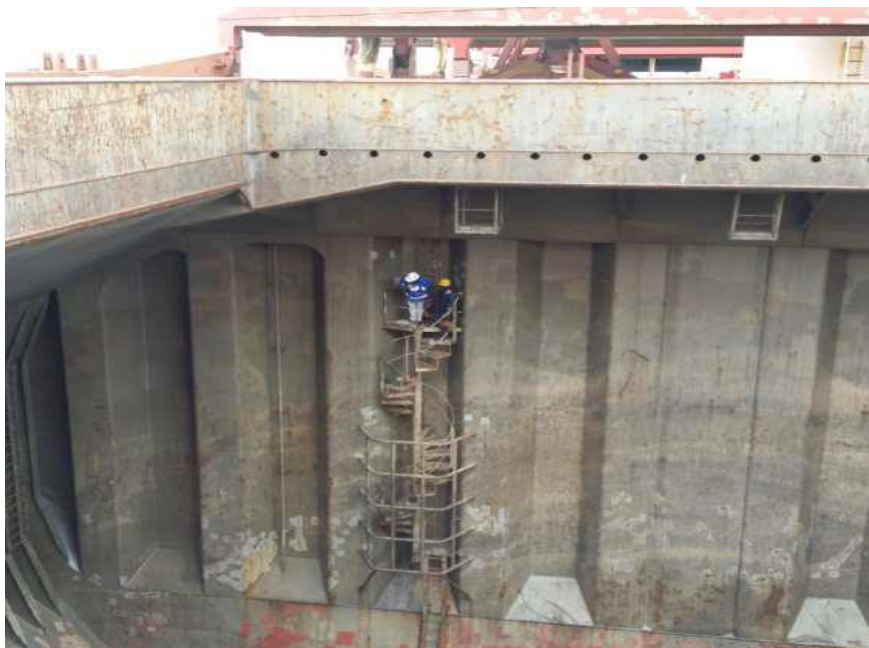
Each entrance was structured with a vertical ladder leading to a landing platform and following to a spiral ladder, also called "Australian ladder" (figure 3.1/2). The ladders' combination facilitated the crew access into cargo holds.

Figure 3.1/2: Australian Ladder and vertical ladder's landing platform at cargo hold no 3 aft entrance.

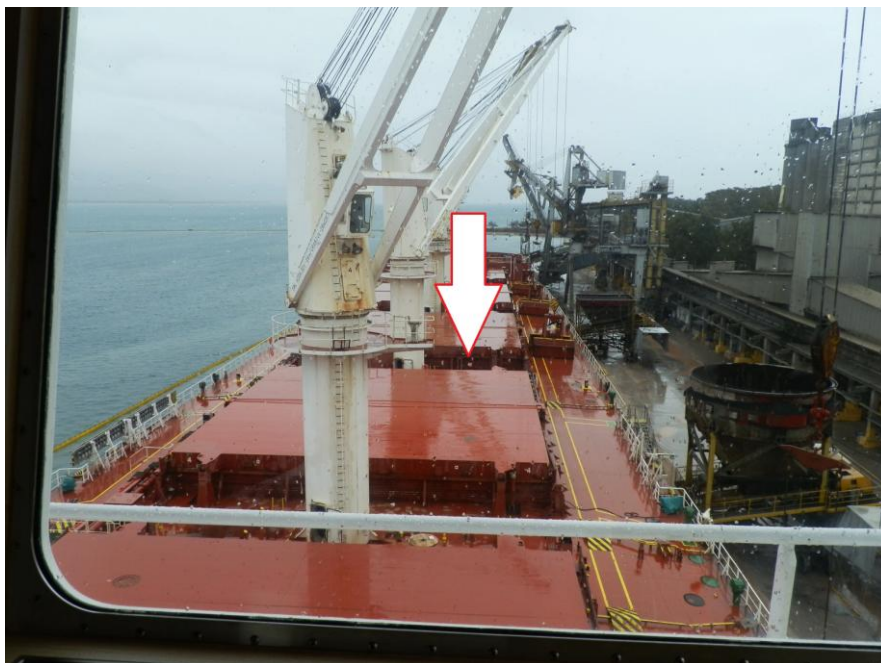
Fig. 3.5/1: The view from the fore window of the Master's cabin. The location of the aft entrance of the Cargo Hold no 3, is indicated by the arrow.

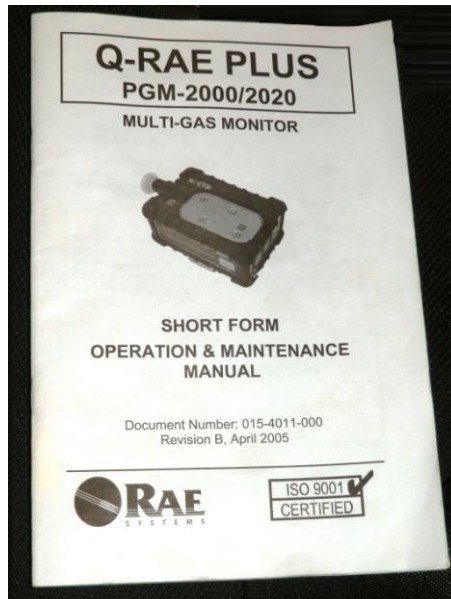
Kosmas V was equipped with a Q-RAE Plus PGM "Multi-Gas monitor Instrument" (figure 4.3.2.2/1), a programmable multi-gas monitor device designed to provide continuous monitoring of toxic gases and combustible gases emissions as well as oxygen concentration in enclosed spaces such as cargo holds as well as their exposure limits to ship and shore personnel.

Fig. 4.3.2.2/1: Operating manual of the gas detection equipment.

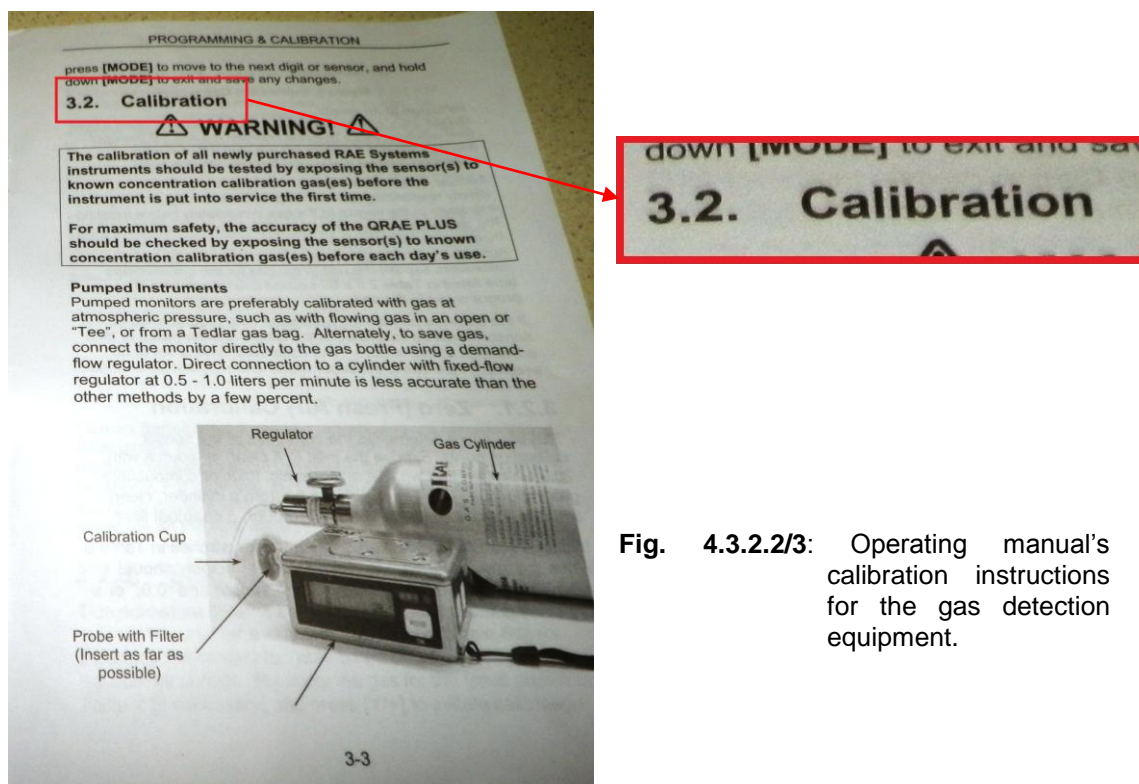
It was witnessed by the investigation team that when trying to set it in operational mode a warning “*Calibration date expired*” would appear on its screen and reported that thereon competent crew could not operate it. Furthermore, crew statements pointed out that the instrument had not been used prior to the casualty. The operation manual of the monitor included also instructions in English regarding its calibration method on board (Figure 4.3.2.2/3), however no one had managed to perform this operation until the casualty date.

Fig. 4.3.2.2/3: Operating manual's calibration instructions for the gas detection equipment.

Aforementioned malfunction had been reported to Kosmas V Company since 11 December 2014, together with other safety related issues found during an inspection of LSA and FFE Certificates, by noting that the last calibration date was carried out in 10 September 2010, that is before Kosmas V was even brought into service, and requesting calibration to be conducted at first convenient port.
