HELLENIC BUREAU FOR MARINE CASUALTIES INVESTIGATION

**MARINE CASUALTY SAFETY INVESTIGATION REPORT
05/2018**

**Death of Security Guard
during embarkation on M/T ZEFYROS**

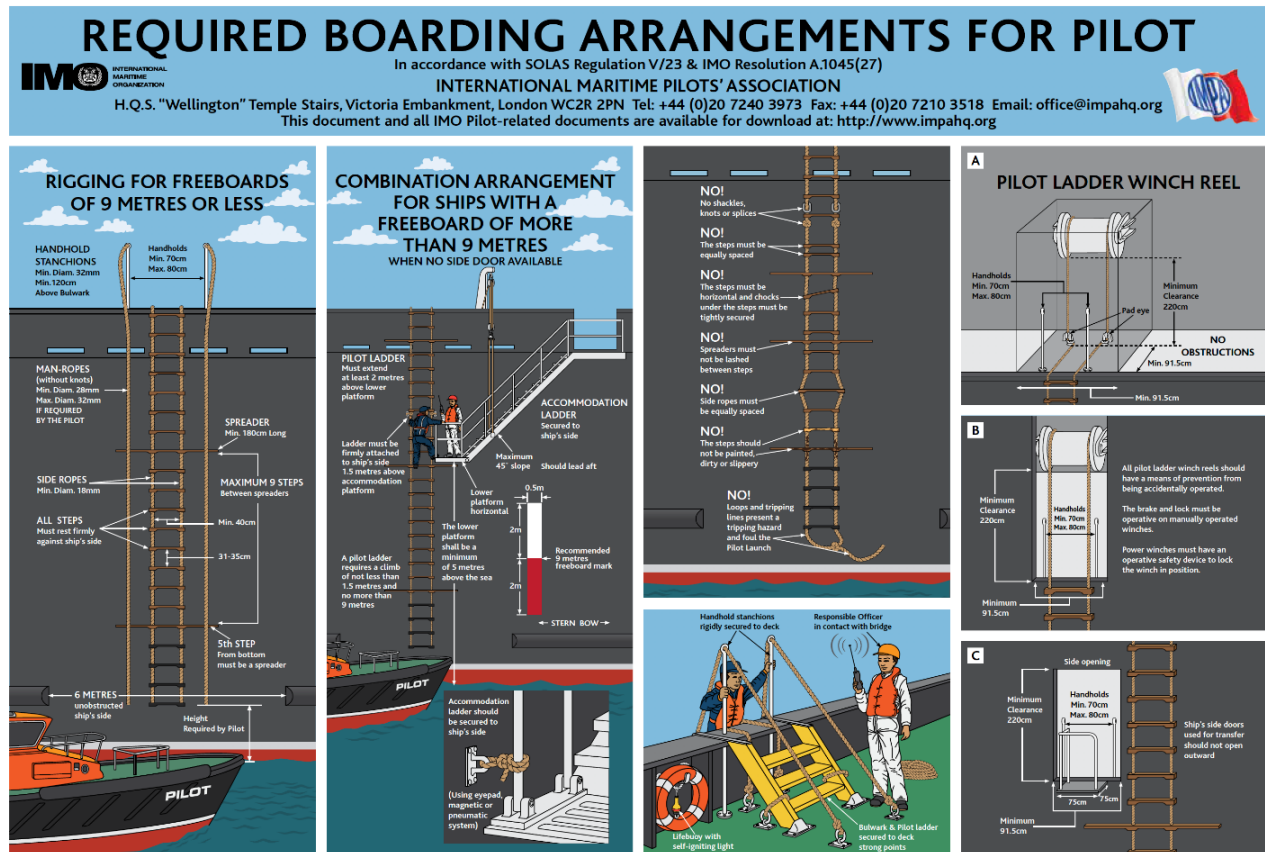
Figure 9. Poster of the pilot’s ladder arrangement of less and more than 9m, in accordance with SOLAS Regulation V/23 and IMO Resolution A.1045 (27).

- a combination arrangement of a pilot ladder and an accommodation ladder to be used when the distance from the surface of the water to the point of access to the ship is more than 9 m (fig. 9);
