**HELLENIC REPUBLIC  
HELLENIC BUREAU FOR MARINE CASUALTIES INVESTIGATION**

**MARINE CASUALTY SAFETY INVESTIGATION REPORT**  
**06/2014**

**FATAL FALL INTO THE SEA OF TECHNICIAN DURING  
DISEMBARKATION  
FROM OIL TANKER ROYAL OAK TO LAUNCH BOAT DRAKON  
TAXIARCHIS**

--- Piraeus January 2017 ---

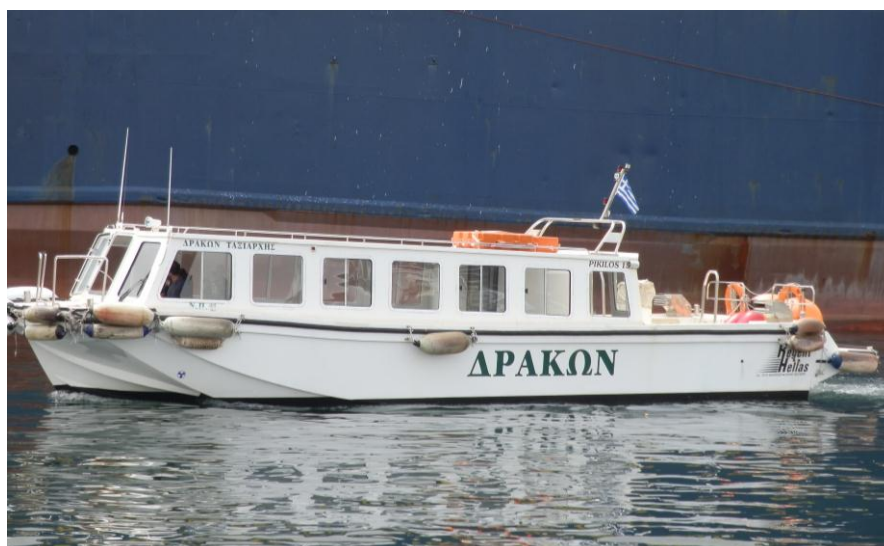
Figure 2: Launch DRAKON TAXIARCHIS at Keratsini port

The main control station provides a good visual field to the skipper when approaching a vessel's accommodation or pilot ladder and the embarkation / disembarkation is performed from the launch's fore deck. However, according to the data collected during the investigation process, when the technician fell into the sea, the skipper was looking at the engine monitoring instruments on the control panel and he didn't notice the cause of his fall.

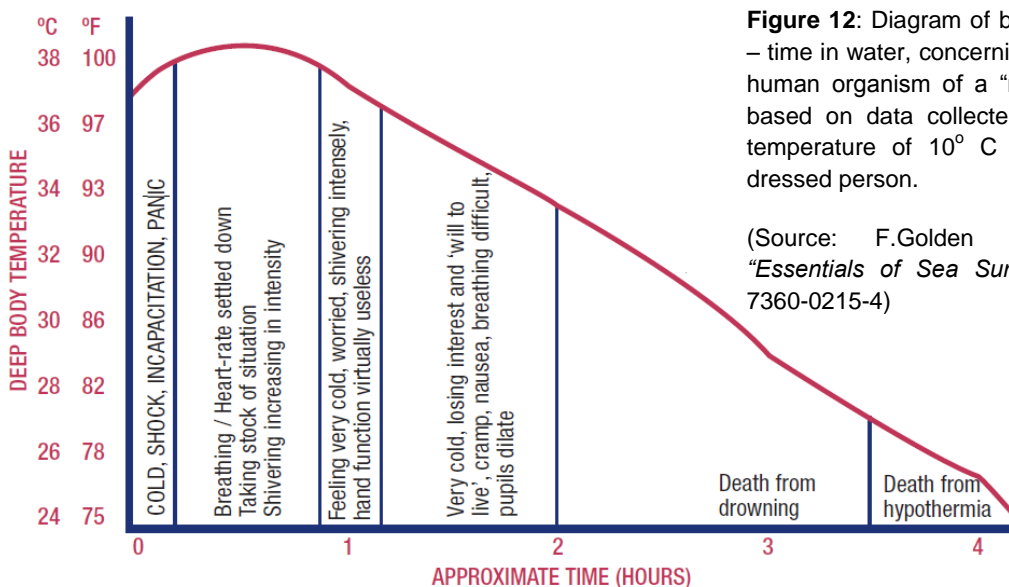
**Figure 12:** Diagram of body temperature – time in water, concerning the impact on human organism of a "man overboard", based on data collected for sea water temperature of 10° C and a normally dressed person.

In more detail and based on studies carried out concerning human behavior after falling at sea, high fatality rates are observed during the first minutes of immersion, from the so called "cold shock" which is caused concurrently with panic and immobilization (Figure 12). During the contact with the sea water, as mentioned by Frank Golden and Michael Tipton in their book under the title "Essentials of sea survival" (ISBN 0-7360-0215-4), due to the vascular contraction caused by the low temperature in conjunction with the increased heart rate due to agony or panic and the hydrostatic pressure from the water, the person's blood pressure is increased in such a level that a cardiac arrest or stroke can be caused particularly in less healthy and susceptible people.

It is noted that a person who suffers from a coronary heart disease, as in the examined marine casualty, can be included in the category of "susceptible" organisms. In addition, the technician's clothing as well as the backpack he was carrying, the weight of which could not be established, nevertheless it was stated that it was heavy, overburdened his efforts to swim and remain afloat.
