**HELLENIC REPUBLIC
HELLENIC BUREAU FOR MARINE CASUALTIES INVESTIGATION
MARINE CASUALTY SAFETY INVESTIGATION REPORT**

07/2014

**FATAL FALL OF BOSUN
FROM THE DECK CRANE OF B/C «PANORIA»**

January 2017

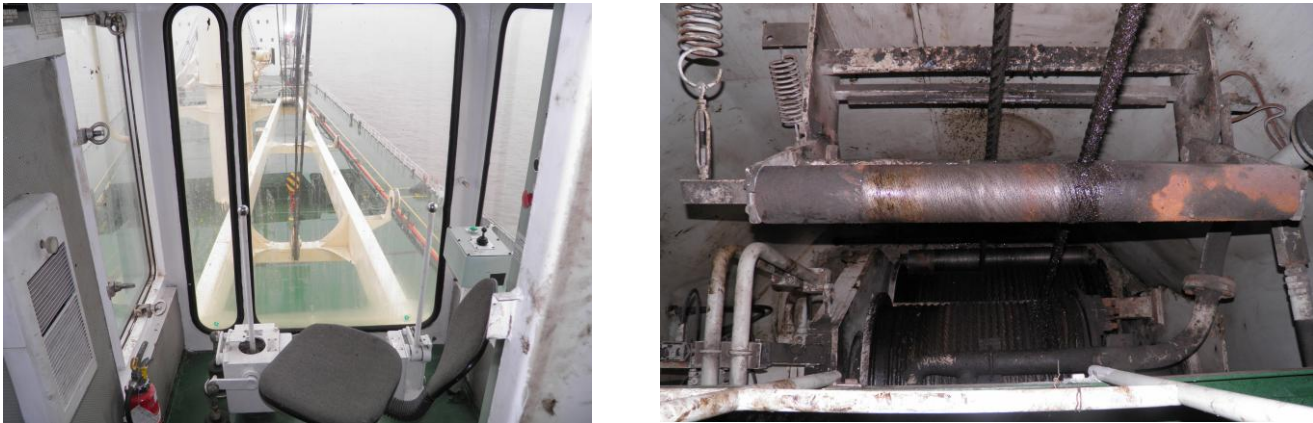
Without notifying the C/O, Bosun jumped over the crane's platform railing, walked onto the left side of the crane's jib and crawled towards the cross section to release the connection sleeve (Figure 4). His attempt to release the wire was noticed only by the AB stationed at the top of No.3 cargo hold hatch cover (Figure 5).

Figure 5: View of the inner and outer crane area from the position of the C/O.

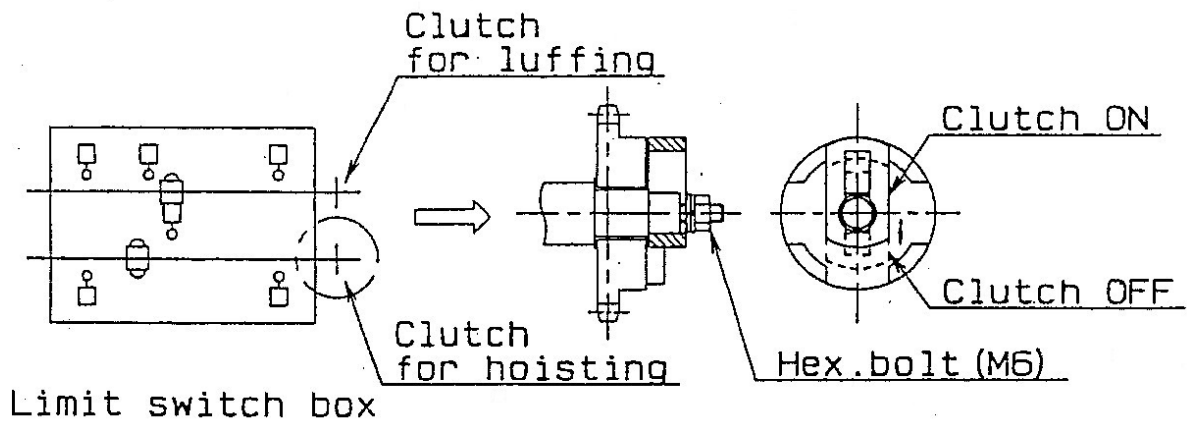
1. Lowering of the crane jib on its rest stand and the securing of the crane hook block.
2. Setting the crane limit switch to “by pass”.
3. Disengaging of the hoisting clutch, by loosening the hex-bolt and shifting the clutch (plate) from the limit switch box as shown in Figure 10. After complete disengaging of the clutch, the plate was re-fixed using the same hex bolt.

Figure 10: Disengaging the hoist limit switch clutch

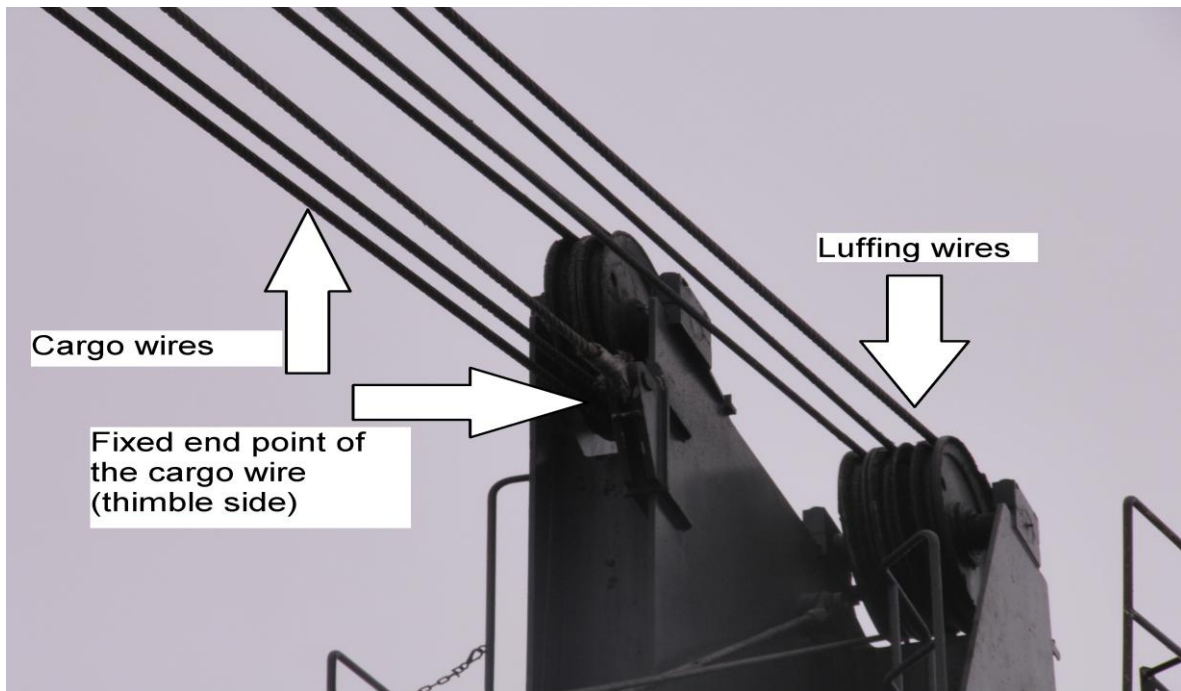
4. Disconnecting the end of the old wire from the top of the crane house (at the thimble side) and lowering it on the main deck (Figure 11).

Figure 11: Cargo (hoist) and luffing wires on top of the crane house.

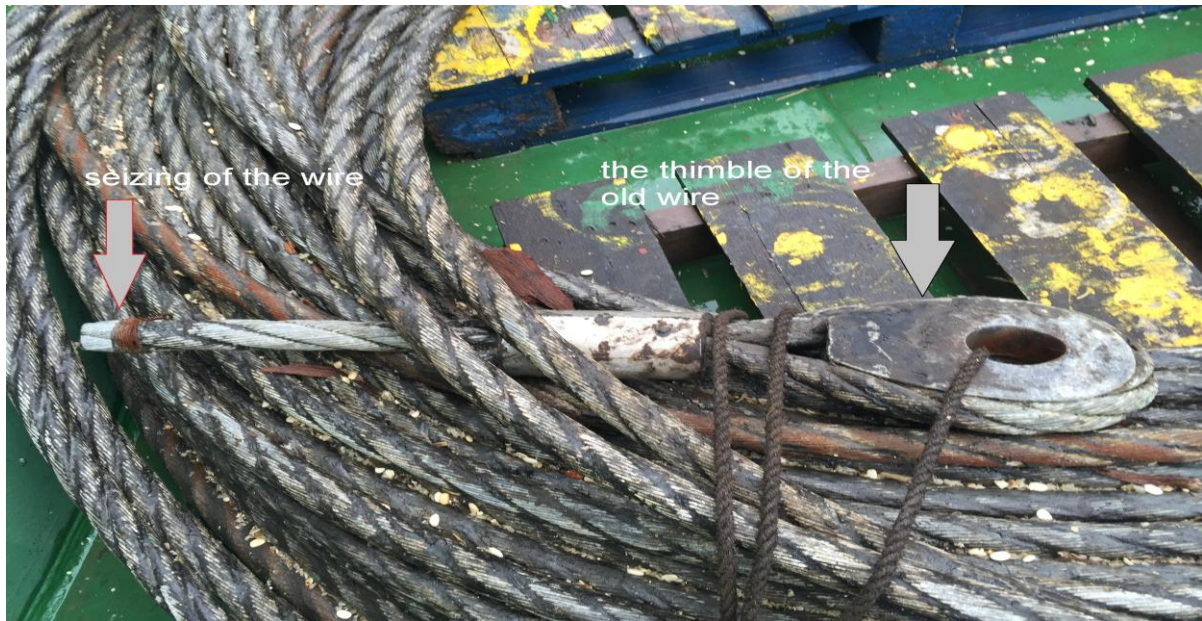
- Whipping (seizing) the end of the old wire, approximately 0,5-1m from the thimble and cutting the thimble off (see Figure 12).

Figure 12: Seizing and cutting off the end of the crane cargo (hoist) old wire.

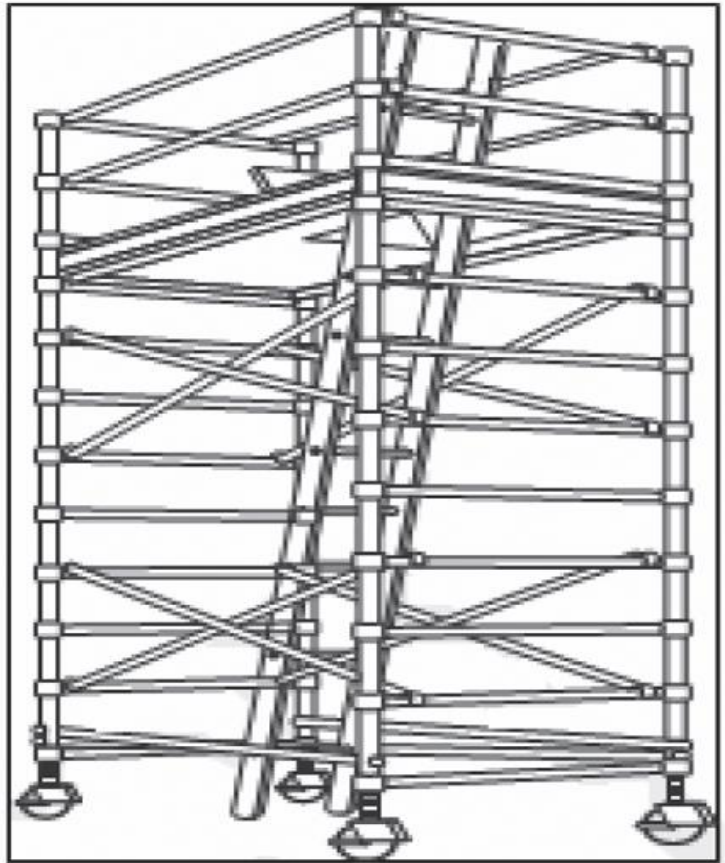
Figure 14: Mobile scaffold with an access ladder and trapdoor to provide the largest possible hazard-free working platform.

- Suitable means of access to the work area in a safe condition clearly marked and unobstructed. On this case the use of scaffolding arrangements as indicated in Figure 11, would assure a safe access to the work area (Figure 14),
- An adequate level of supervision, constantly during the whole work process,
- A new work aloft permit verifying also that the above mentioned control measures, have been put in place.
