HELLENIC BUREAU FOR MARINE CASUALTIES INVESTIGATION

**MARINE CASUALTY SAFETY INVESTIGATION REPORT
13/2013**

**Grounding and foundering of General Cargo Stella
18 nm W of Karpathos Island - Greece**

November 2016

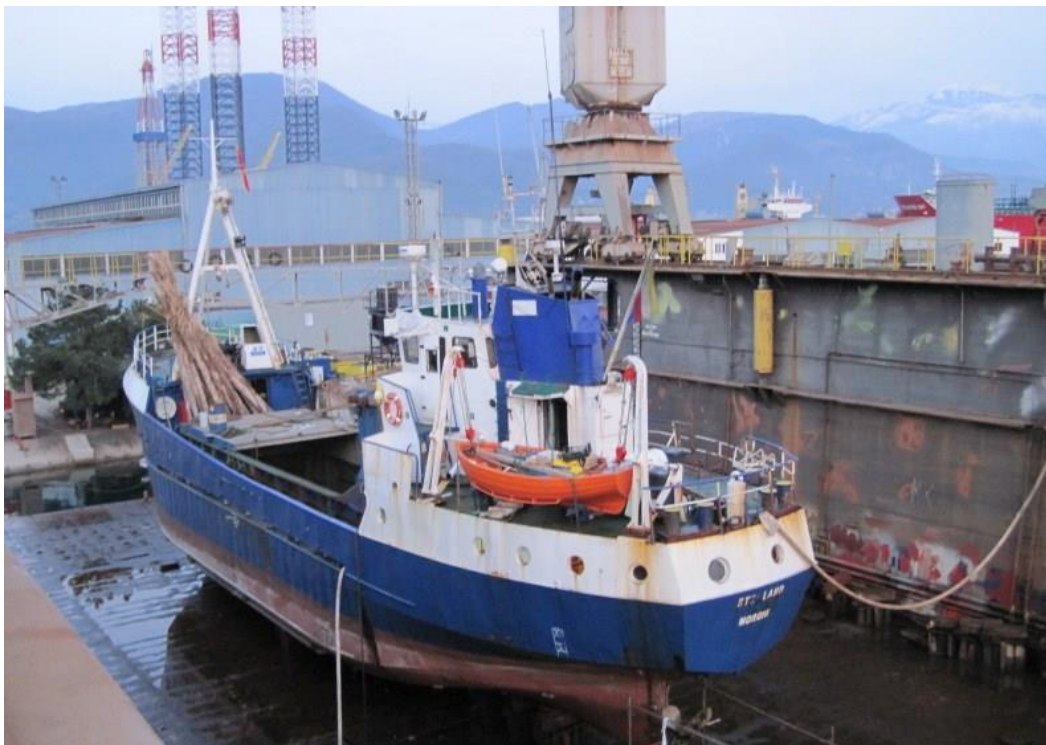
Consequently, the Chief Mate realizing the difficult situation Stella was encountering, he told the Master that it was meaningless to stay on board and suggested to abandon her. The Master ordered his crew to put on their life jackets and to prepare the life raft for abandoning the ship, as the life boat that was secured at the port side was not practically an option to be launched since Stella was progressively listing to starboard (figure 7).

Figure 7. Stella in Bijela dry-dock, located in the Adriatic Sea. The life boat is shown at her port side (photo source marine traffic taken on 05-03-2012 under the name Stenland).

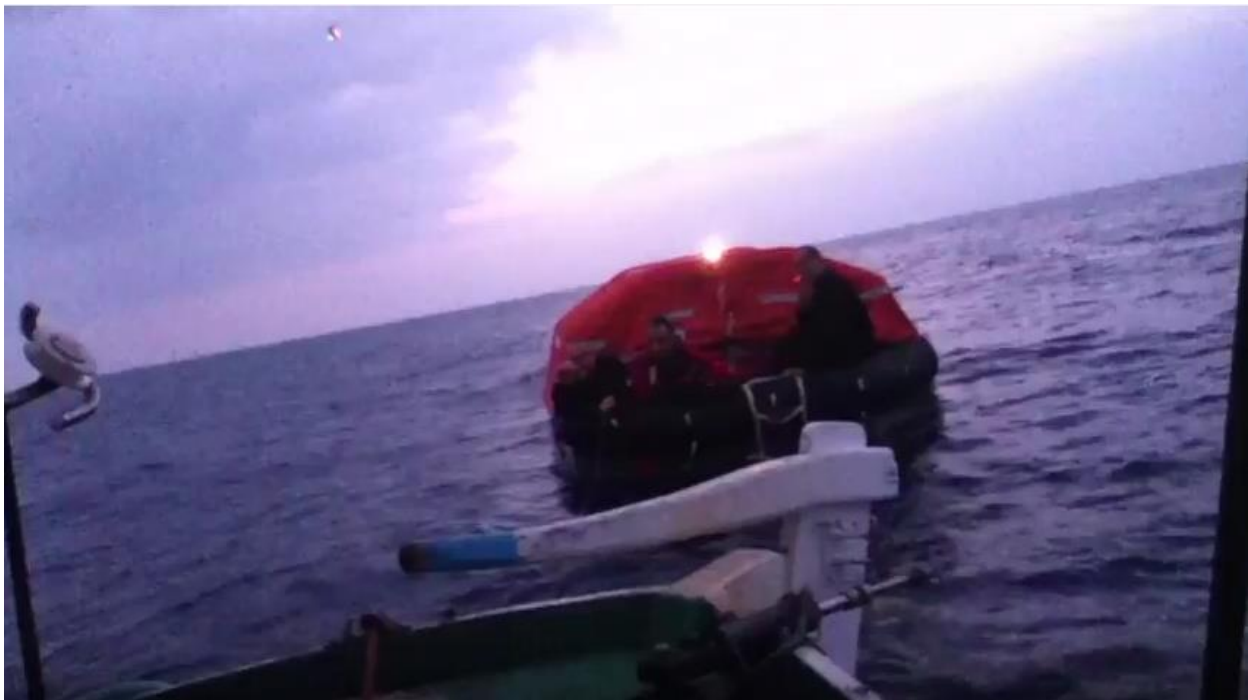
Figure 8. Stella's rescued crew in the life raft by the time it was approached by the fishing boat Alexandros. The HCG Helicopter is shown on top of the photo (source fishing boat skipper).
