**HELLENIC REPUBLIC
HELLENIC BUREAU FOR MARINE CASUALTIES' INVESTIGATION**

**MARINE CASUALTY SAFETY INVESTIGATION REPORT
10/2014**

FIRE ON BOARD RO-PAX IERAPETRA L (29-11-2014)

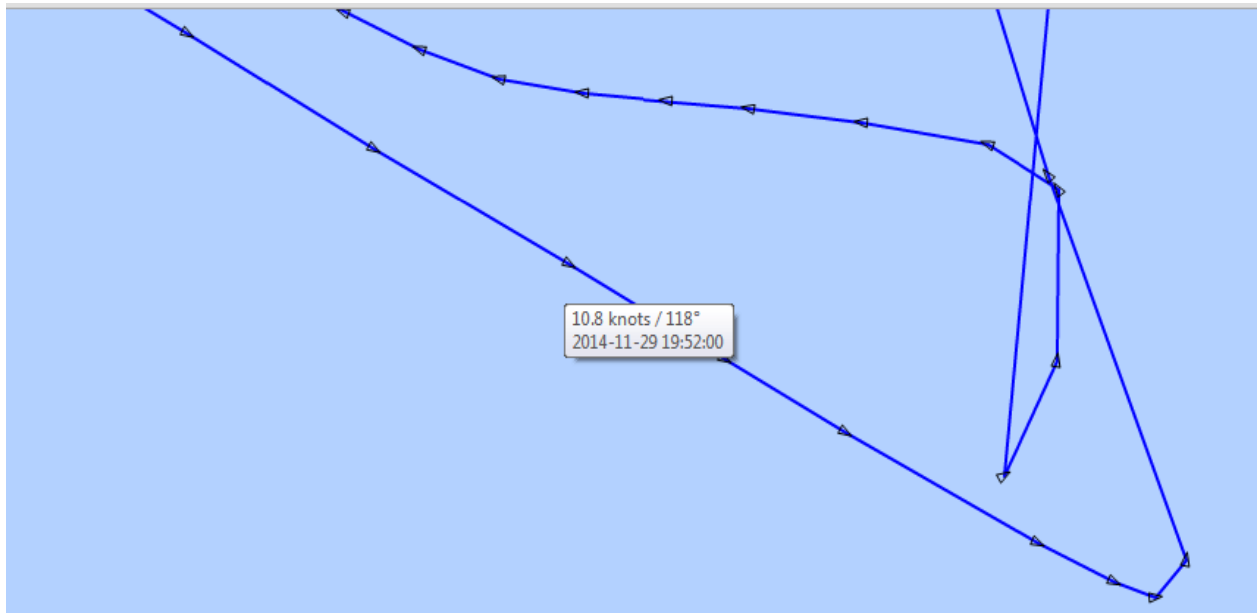
Considering the fact that the vessel had covered 27 nm in almost 3 hours from departure explains the time elapsed for the Return Chamber to have been overflowed by fuel returns, as well as the time for the fuel to have been led – unnoticed by the crew on watch in the engine room – by its extractor pipe to the port funnel duct where eventually it came in contact with hot surfaces.

Figure 16: IERAPETRA L was recorded to be sailing at approximately 10.8 knots (reduced engine load) a few minutes before the fire broke out. (source: marinetraffic.com)

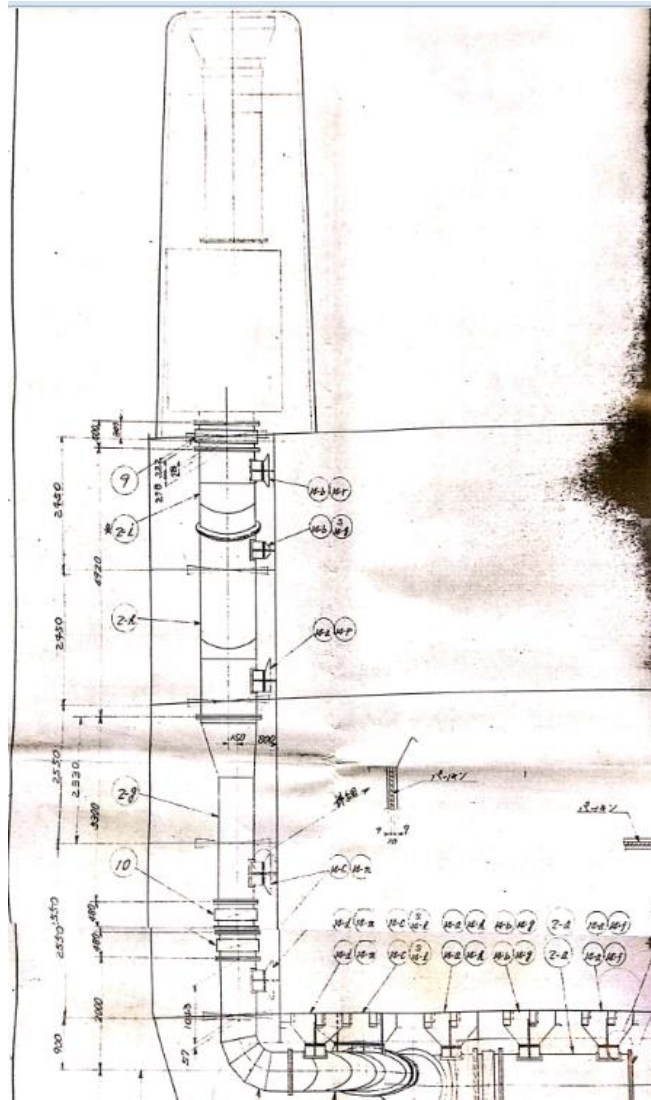
Figure 18: Capture of the port side funnel duct showing the exhaust gas pipe arrangement.

Consequently the engine personnel was unaware of this arrangement, in order to assess and implement in cooperation with the managing company, appropriate preventive measures to avoid any possible overflow leakage of fuel inside such a high risk area of the vessel, like the port funnel.
